### RESEARCH UPDATE

U 2003-5

### 3M STAMARK POLYUREA, LIQUID PAVEMENT MARKING SERIES 1200 & SERIES 1000 (INITIAL REPORT)

The evaluation of these materials was incorporated into Vermont Agency of Transportation highway rehabilitation project Lyndon-Barton IM 091-3(10). The markings were placed in the northbound lanes of I-91 between mile markers 137.49 and 146.00. Series 1200 was placed on the first 4.16 miles and Series 1000 on the remaining 4.35 miles.

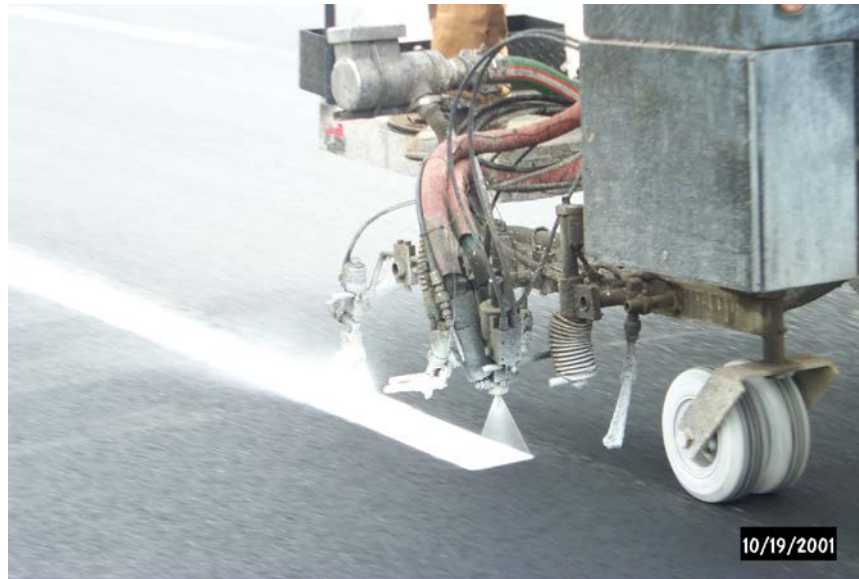
**APPLICATION OF THE SERIES 1000**

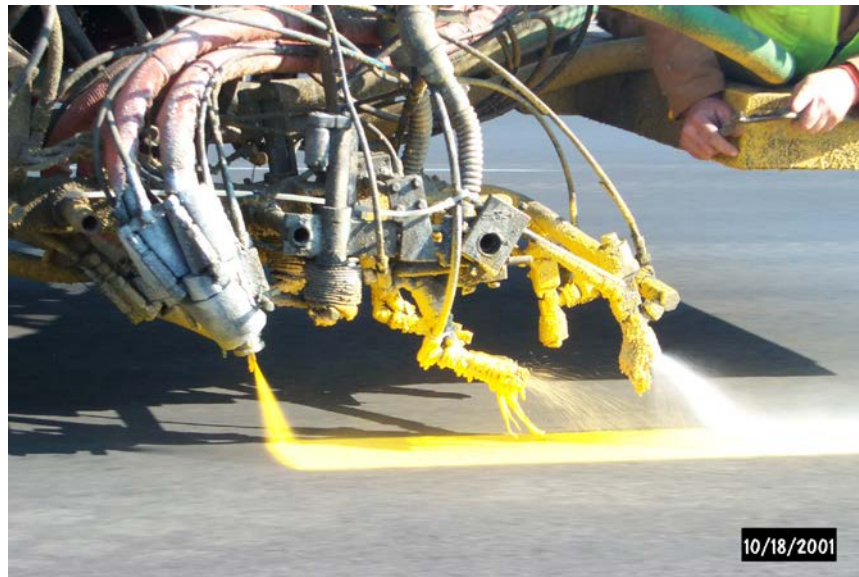
**APPLICATION OF THE SERIES 1200**

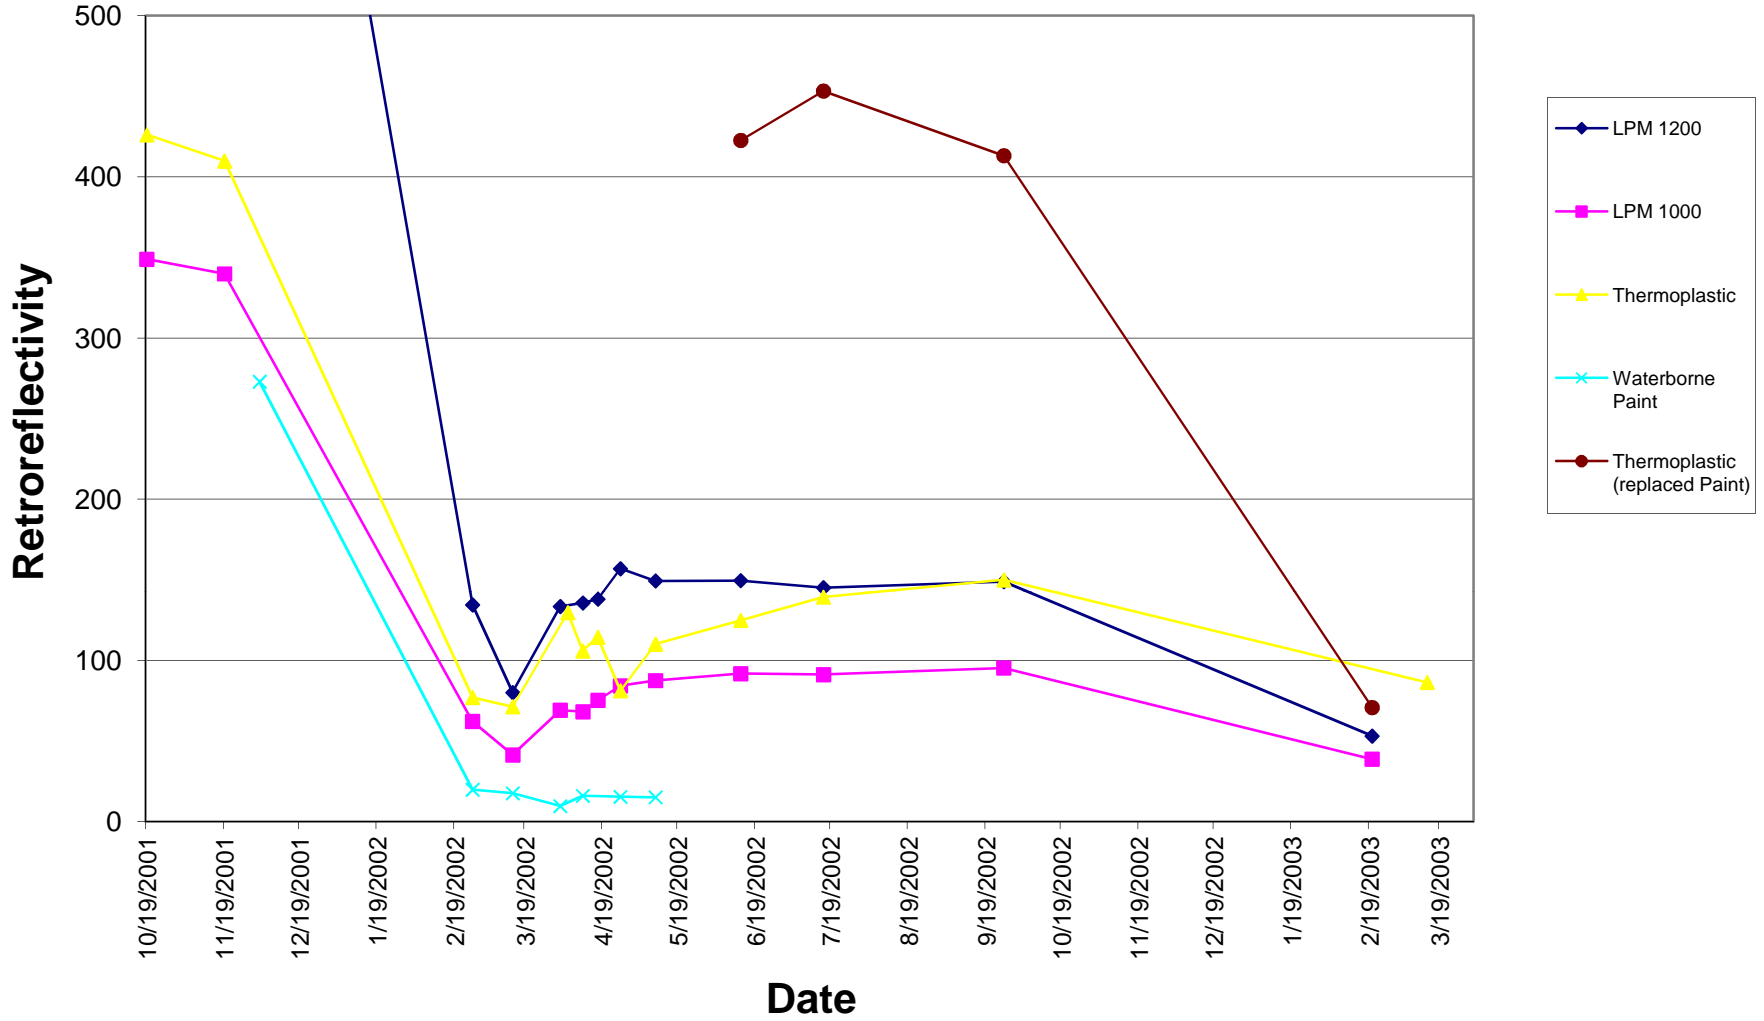
# White Skip Line

The LPM 1200 performed the best of all the materials on the white skip line. Thermoplastic was next, followed by the LPM 1000 and the waterborne paint. All materials declined in retroreflectivity until a low point at the March 16, 2002 reading. After that the readings on both LPM products increased until April 26, 2002 when the LPM 1200 began to decline again. The thermoplastic material decreased over April then began to recover in May, reaching the level of the LPM 1200 by the September 26, 2002 reading. Both the LPM products and the thermoplastic average readings were below 100 mcl/lux again on the February 19, 2003 reading, and the March 14, 2003 reading.

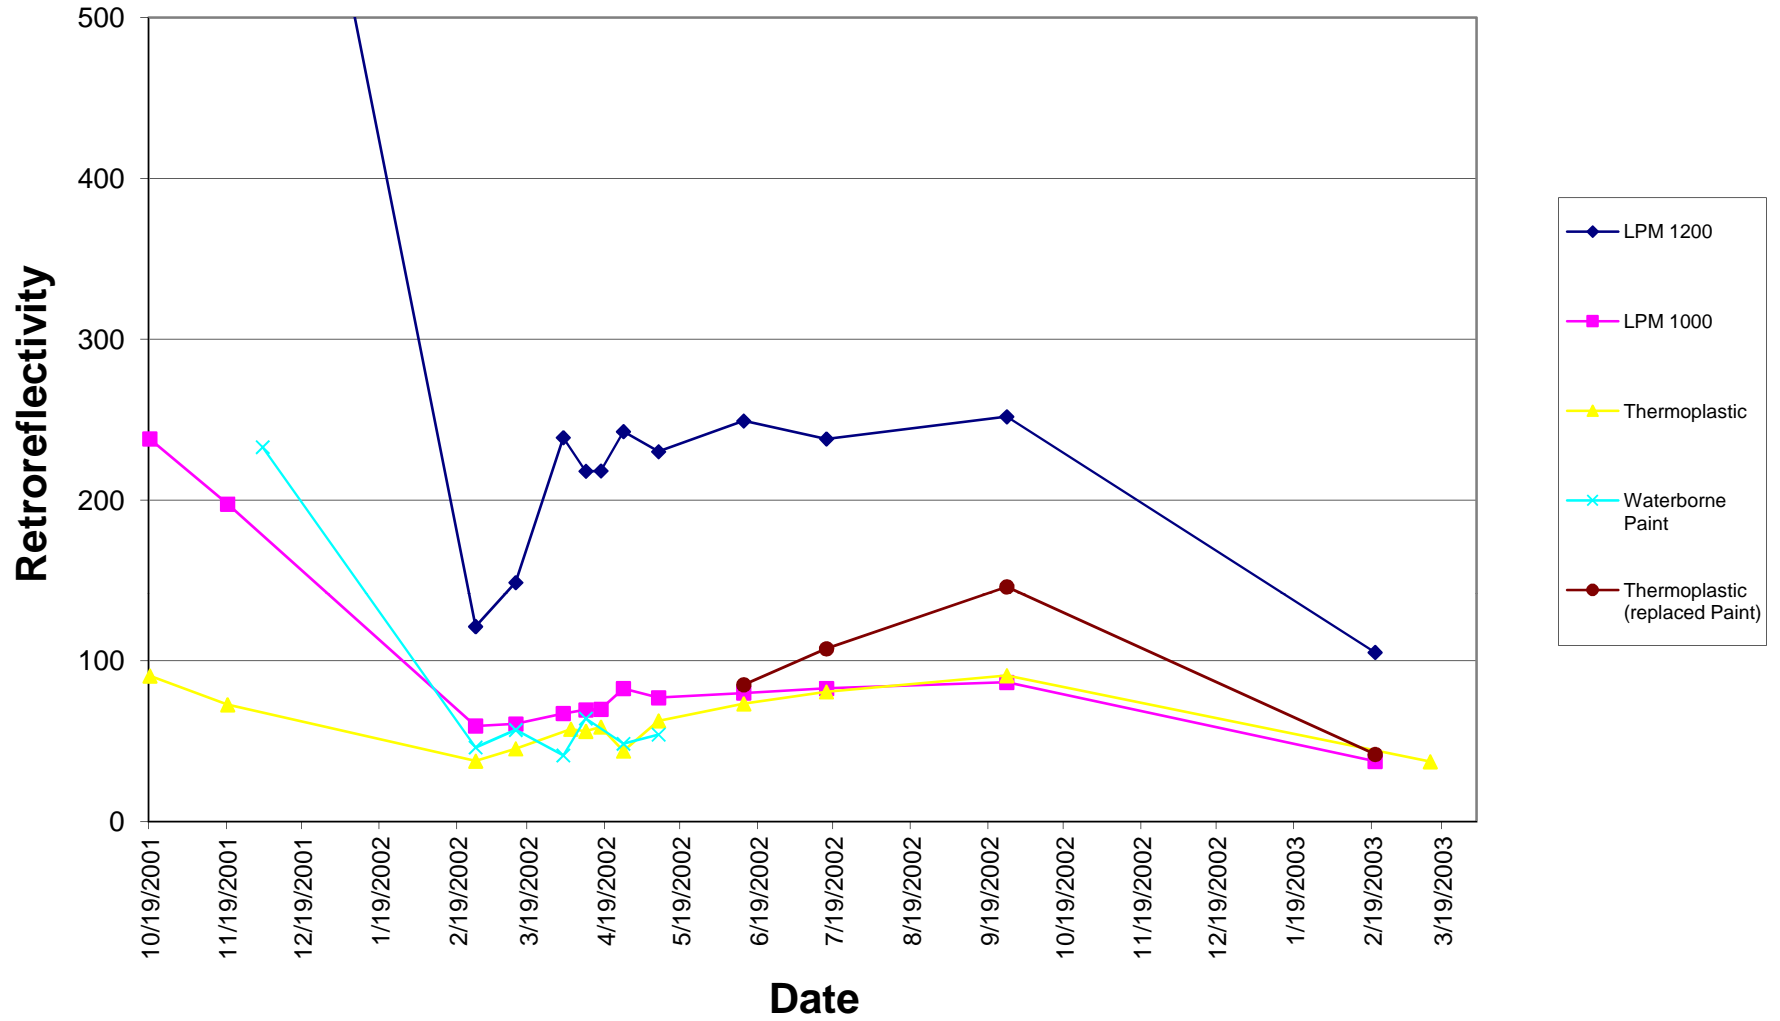
# Yellow Edge Line

The average retroreflectivity of the LPM 1200 far exceeded the other materials in the yellow line. The LPM 1000 was next highest in retroreflectivity followed by the waterborne paint on some dates and the thermoplastic on other dates. The average difference between the LPM 1200 and the LPM 1000 was over 100 mcd/m<sup>2</sup>/lux for the yellow and was between 30 and 60 for the white lines. The recovery of the LPM 1200 was more extreme in the yellow line compared to the white lines, but the recovery of the other materials was not as drastic. The dates of recovery were very similar to the other two materials. The LPM 1200 stayed above the 100 mcd/m<sup>2</sup>/lux level on the most recent reading, but the LPM 1000 fell below as well as the Thermoplastic on March 14, 2003.

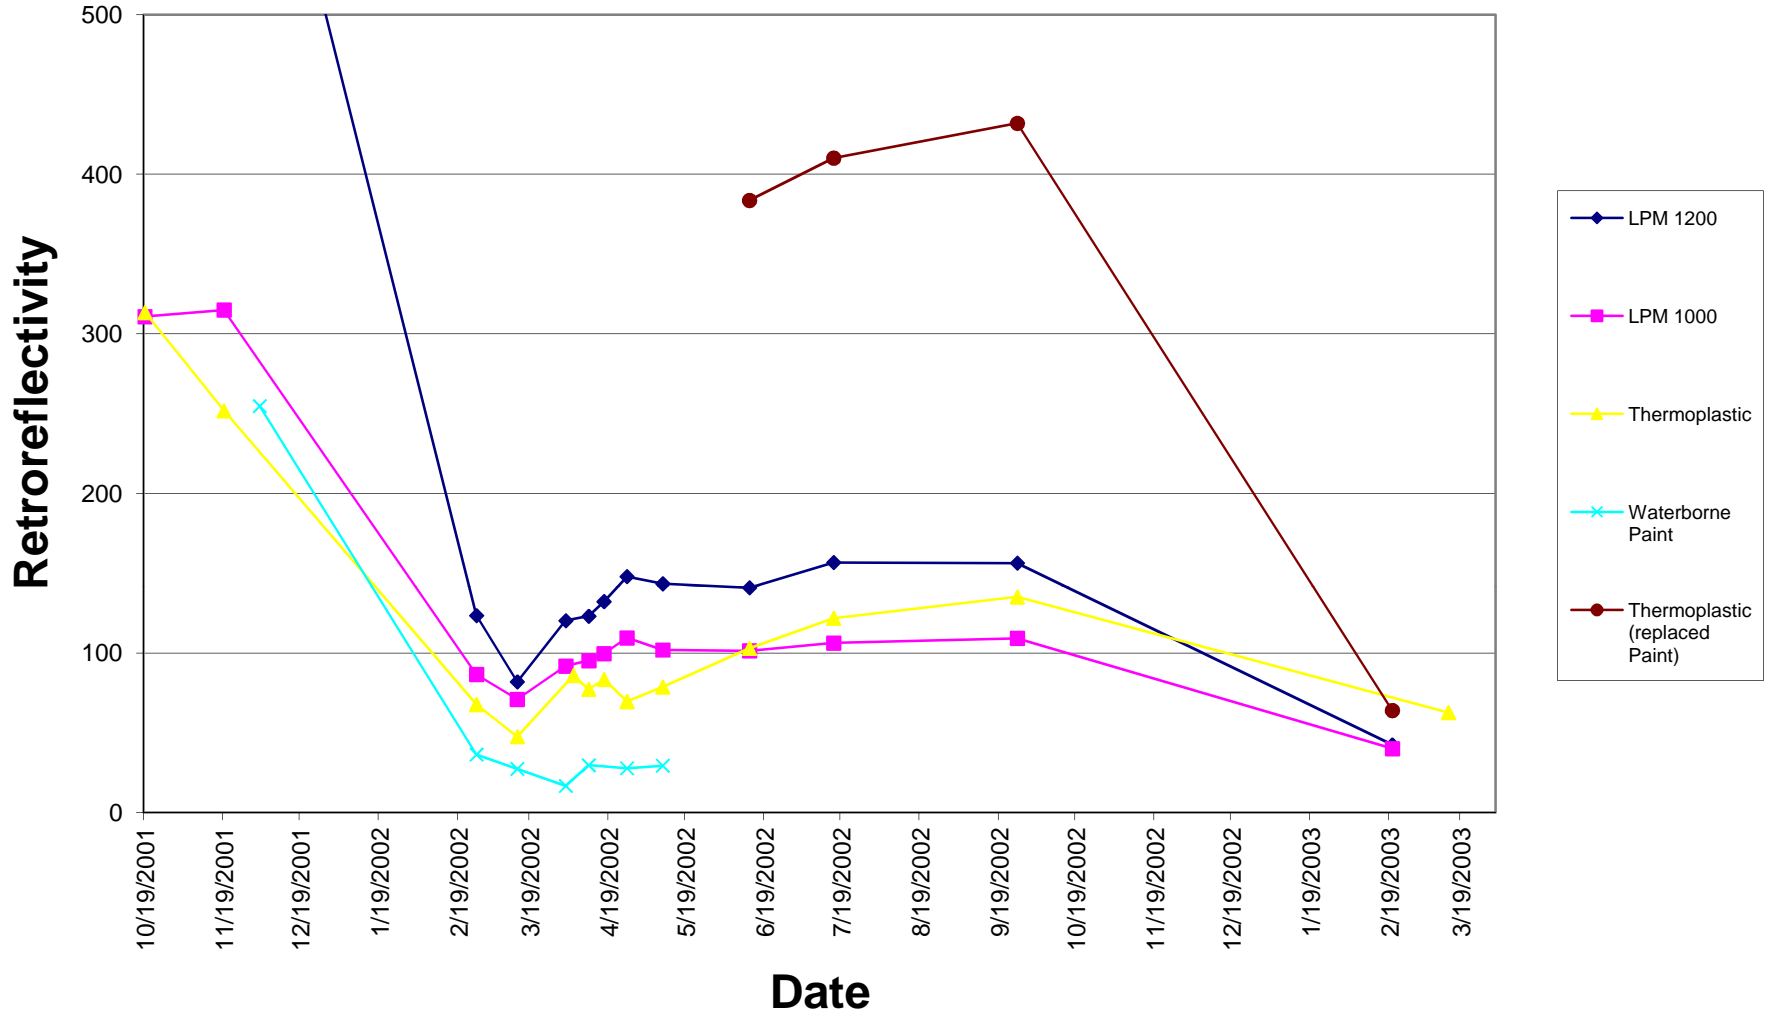
# White Edge Line

Overall the LPM 1200 performed the best on the white edge line. Initially it performed much better than the rest of the materials (1180.6 mcd/m<sup>2</sup>/lux), but by the time readings were taken on February 26, 2002 (approximately 4 months after installation) the difference in readings between all the materials was much less. This behavior is seen in all the line types. The LPM 1000 performed the next best, followed by the thermoplastic and waterborne paint, until the readings were taken on June 13, 2002 when the thermoplastic surpassed the LPM 1000 in retroreflectivity.

The average reading of all the materials fell below 100 mcd/m<sup>2</sup>/lux on the March 14, 2002 reading, however they all recovered except for the waterborne paint, which was replaced with thermoplastic by the June 13, 2002 reading. The most recent readings were taken on February 19, 2003 when all readings of the LPM 1200 and 1000 were below 100 mcd/m<sup>2</sup>/lux. Readings on the thermoplastic were not taken until March 14, 2003, and the average was also below 100 mcd/m<sup>2</sup>/lux.
