### RESEARCH UPDATE

U 2003-6

## INSTALLATION OF THE ULTRALINER PVC ALLOY PIPE LINER BARTON, VERMONT

**REFERENCES:** Work Plan No. 2001-R-8

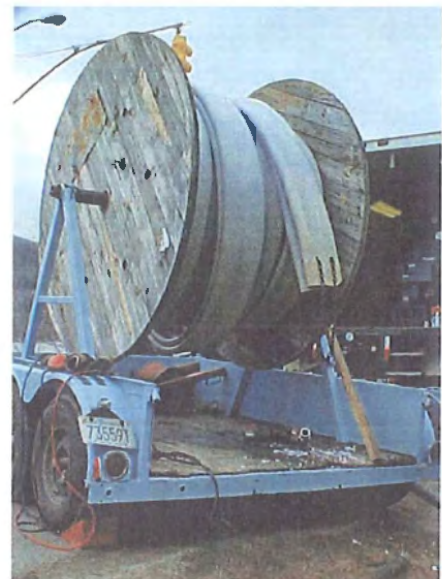
The 'steam truck' houses a 50 HP Kewanee brand boiler which, by the manufacturer's requirement, supplies low pressure steam at 10 to 15 psi for up to two hours for processing. The folded pipe liner arrived on a large wooden spool as seen in the adjacent photograph.

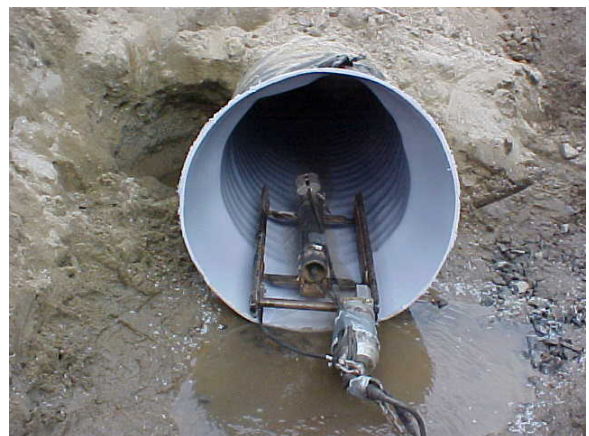
Material at the inlet and outlet are trimmed at this time. The adjacent photograph is of the 600 mm corrugated metal lining. An inspection of the culvert is performed before and after installation using a video
