RESEARCH UPDATE

U 2004-1

**INTERIM REPORT ON THE ULTRALINER PVC ALLOY PIPE LINER
BARTON, VERMONT**

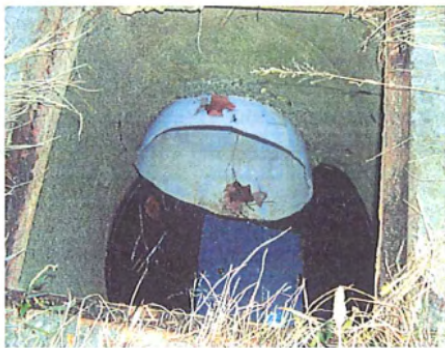
The 450mm diameter drain pipe Catch Basin had water collecting below the invert of the pipe as expected. The catch basin is in good structural and functional condition. The pipe's interior was dry and appeared to be in good condition with no signs of cracking or distress.

450mm Pipe Catch Basin (West End)
Top View with Grate removed

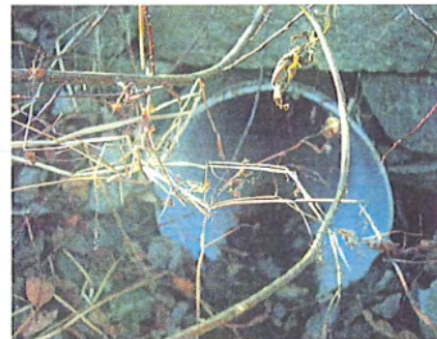
450mm Pipe Outlet - Stone Headwall (East End)
Front View

Both pipes showed water collected outside their respective outlet and inside a section of the pipe forming a pond at the foot of the embankment. This situation does not imply a hydraulic failure since the pipes are performing satisfactorily; however, water collecting at the outlets could be a concern to the future stability of the embankment. This situation will be monitored to assess the impact of the retained water on the embankment stability.

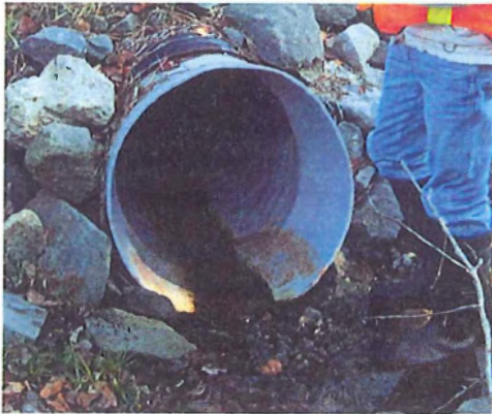
The 600mm diameter drain pipe appeared to be in good condition with no signs of cracking or distress. At the time of the inspection; water was running into the pipe freely and without obstructions.

600mm Pipe Inlet (West End)
Front View

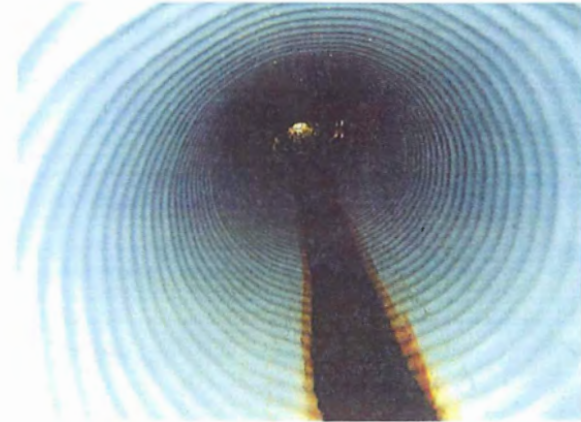
600mm Pipe Outlet - (East End). No Headwall present
Front View
