## RESEARCH UPDATE

U 2005-3

### INTERIM REPORT ON SILICOFLEX STRIP SEAL JOINT SYSTEM BERLIN, VERMONT

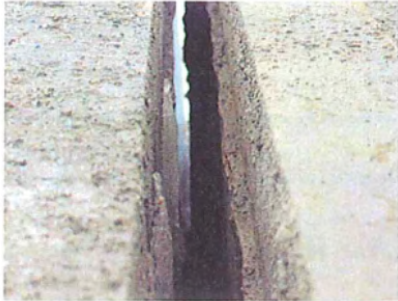
Photo -1  
Looking west

Notice there is no strip seal left

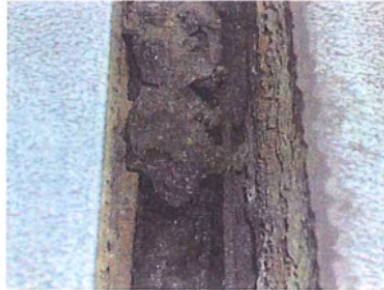
Photo -2  
Looking west

Notice the strip seal had dropped down passed original level as seen in Photo -3

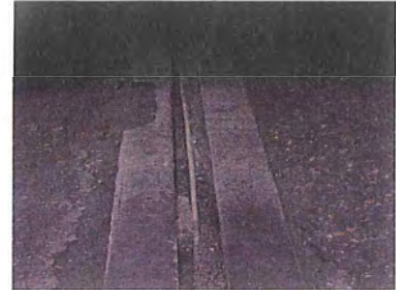
Photo -3  
Looking east

Only about 7 feet remains in place  
At its original level
