MATERIALS & RESEARCH SECTION

RESEARCH UPDATE

U2013-05

Assessment of 40" Wide Paving Skid Box

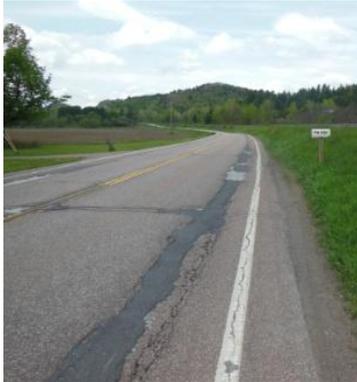
Sections of US Route 2 have a concrete base underneath the pavement layers. To accurately evaluate the repair process, four two hundred foot test sections were chosen along US Route 2 to quantify existing distresses including cracking and rutting. Preexisting site conditions are shown in Figures 2 and 3 below.

**Figure 2: Test Site 2
looking WB.**

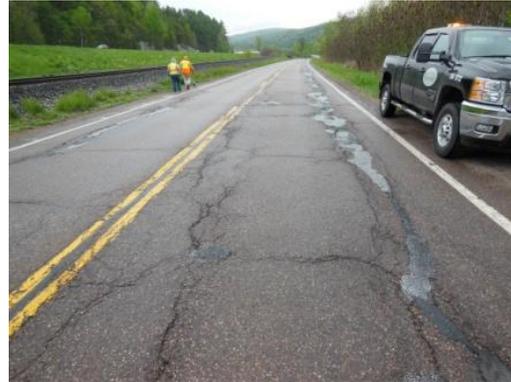
Figure 3: Test Site 3, looking EB.

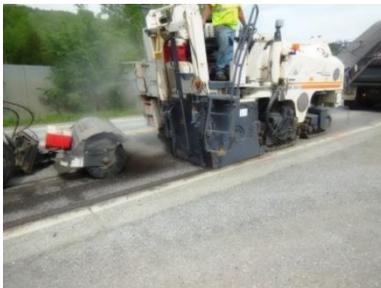
**Figure 4: Cold planing and
sweeping.**

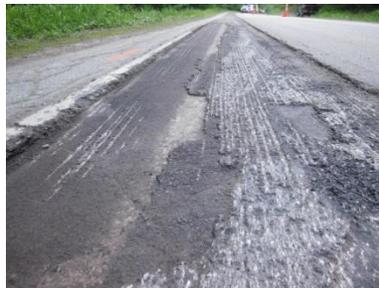
**Figure 5: After cold
planing.**

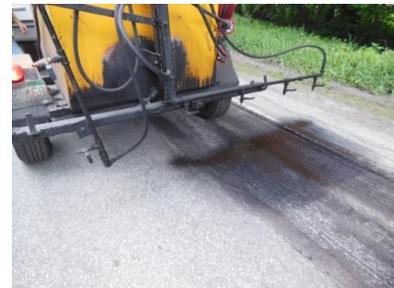
**Figure 6: Spraying
emulsion tack coat.**

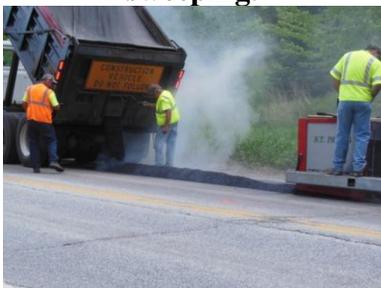
Figure 7: Paving.

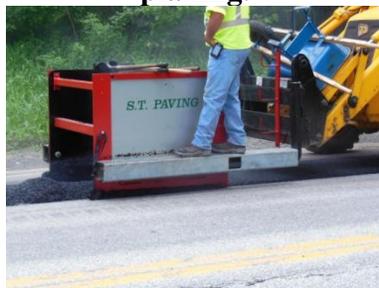
Figure 8: Paving Skid Box.

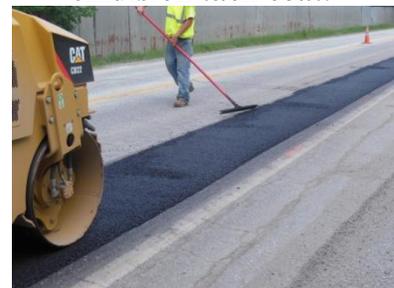
**Figure 9: Squeegee and
Compaction.**

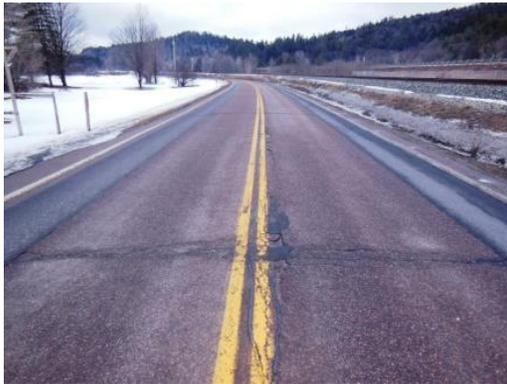
Figure 12: Test Site 2, looking WB.

The site was visited in March 2013 and July 2013 to evaluate the repair and measure rutting in each test site. Photographs and general observations were made at each visit. Test sites 2 and 3 are shown in Figures 12-15 below. Figures 12 and 13 depict each test site in March 2013 and Figures 14 and 15 show each in July 2013.
