October 10, 2014

### INVESTIGATIVE REPORT

U2014-01

#### Assessment of Extendo-Pave, a Polymer Crumb Rubber Crack Fill vs Standard Type II and Type IV Crack Fill

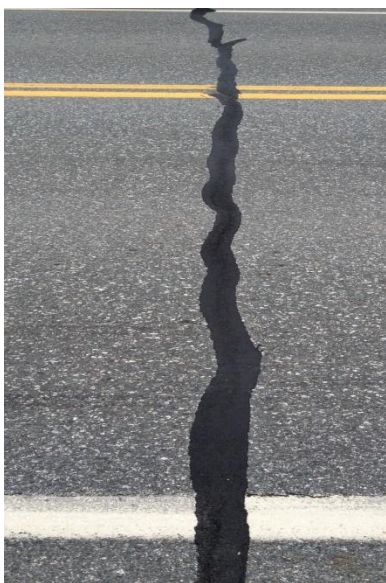
**Figure 4: Transverse crack in test site 2 in the Extendo-Pave section.**

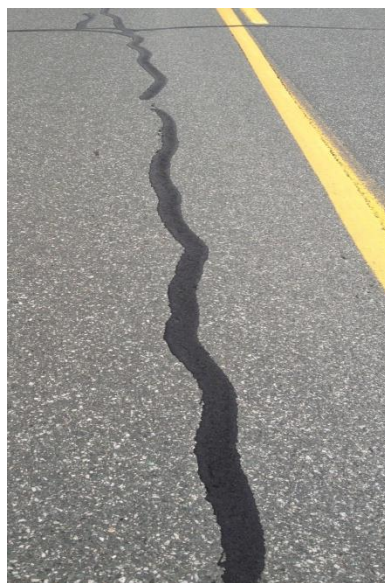
**Figure 5: Longitudinal crack in test site 3 in the Extendo-Pave section.**

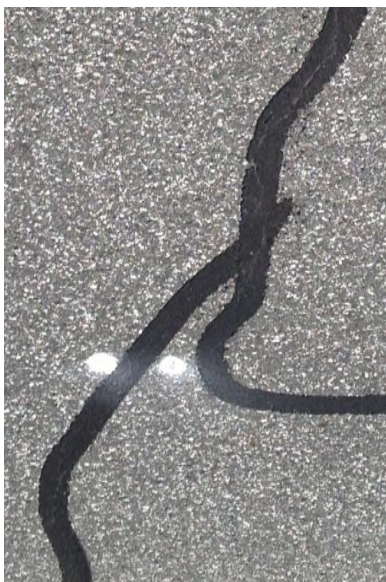
**Figure 6: Transverse crack in test site 7 in the Type II section.**

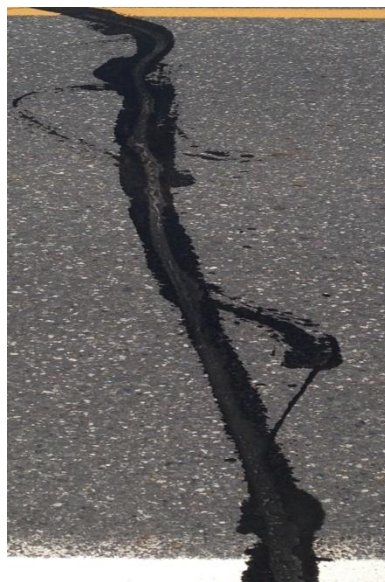
**Figure 7: Transverse crack in test site 12 in the Type IV section.**

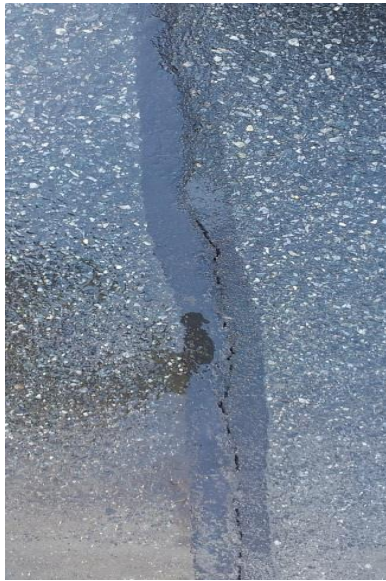
Adhesion distress (sealant peeling away from crack wall) within the transverse cracks was 9% in the Extendo-Pave section and the 8% in the Type II section. The Type IV product exhibited a much lower percentage, averaging 2%. For longitudinal cracks, the adhesion distress average

**Figure 8: Adhesion loss in transverse crack in test site 2 in Extend-Pave section.**

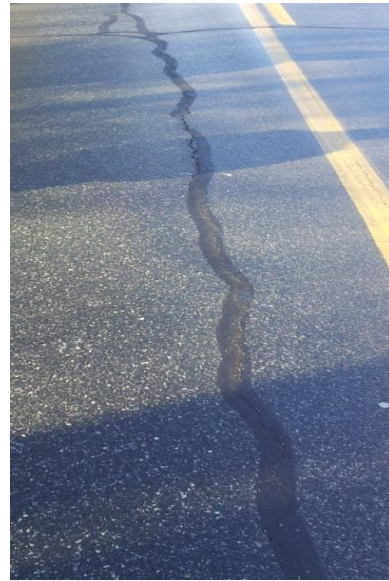
was much higher for the Extend-Pave product, averaging 34%, where the Type II averaged 2% and Type IV averaged 0%.

**Figure 9: Longitudinal crack in test site 3 in Extend-Pave section.**

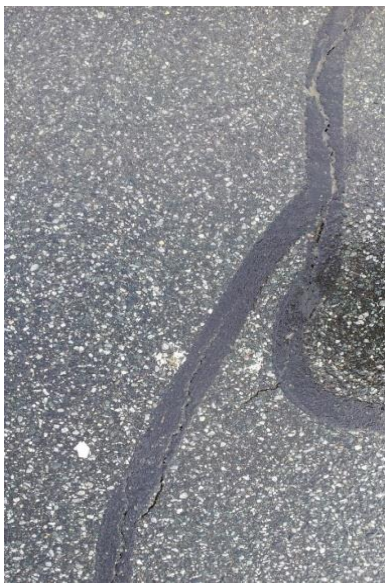
**Figure 10: Adhesion loss in transverse crack in test site 7 in the Type II section.**

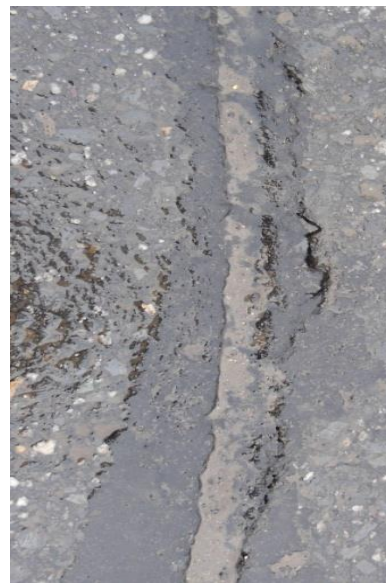
The first year winter visit was conducted on January 17<sup>th</sup>, 2014. The weather was noted to be sunny during this visit. The high temperature for the day was 32°F and the low was 27°. At this visit it was noted that no cohesion distresses (splitting or cracking of the sealant material) were noted. There was minimal spalling (weakening of the pavement around joints and cracks), averaging 1% and it was isolated to test sites 11 and 12 where the cracks were routed.

**Figure 11: Spalling distress in test site 12 in Type IV section.**

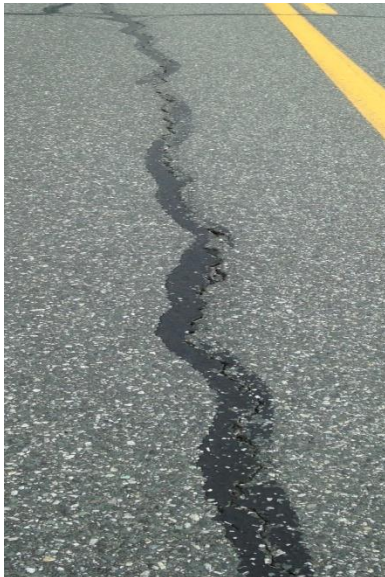
Adhesion distress significantly increased, presumably due to the below average temperatures and numerous freeze-thaw cycles in the months following the winter site visit. Within the transverse cracks, Extendo-Pave averaged 43% failure, Type II averaged 25%, and Type IV averaging 4%. For longitudinal cracking, Type II and IV fared better, averaging respectively 12% and 0%. The Extendo-Pave averaged 78% failure rate. There were four longitudinal cracks monitored in this section. Of the four, one crack was 25%, one crack was 85%, and the other two were 100% failed where the crackfill was not intact. As a note, the two transverse measurements taken in this test site had higher failure percentages than the rest of the transverse measurements. The two measurements were 96% and 90% failed.

**Figure 12: Adhesion distress in longitudinal crack in test site 3 in Extendo-Pave section.**

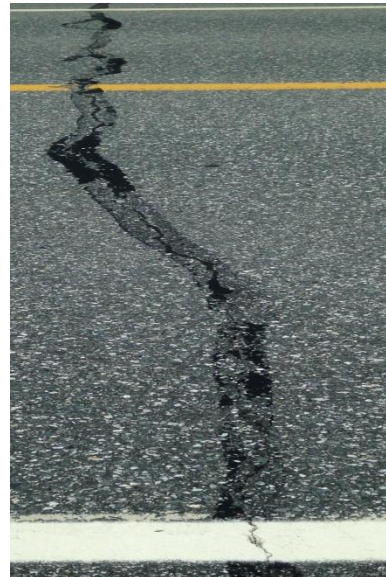
**Figure 13: Adhesion distress and wearing in transverse crack in test site 4 in Extendo-Pave section.**

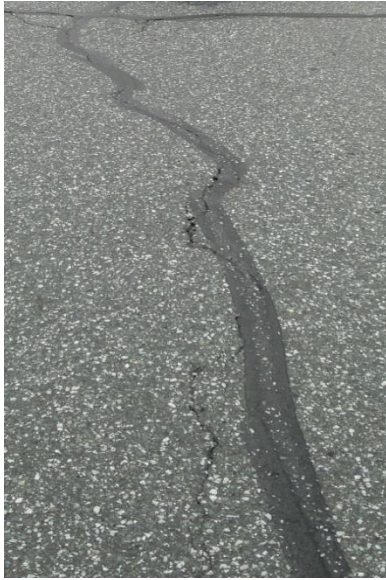
**Figure 14: Adhesion distress in longitudinal crack in test site 5 in Type II section.**

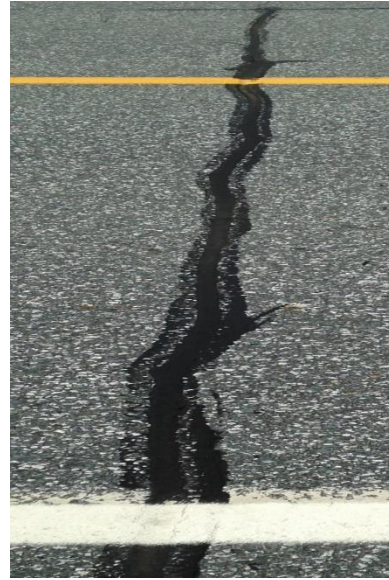
noted to be sunny during both days of this visit. The high temperature for the July 30<sup>th</sup> was 64°F and the low was 46°F. On August 1<sup>st</sup> the high was 66°F and the low was 48.9°F. Similar to the winter visit, there was no cohesion distress noted in any of the test sites and spalling was again isolated to test sites 11 and 12 and was noted to be minimal, averaging 4%.

**Figure 15: Transverse crack in test site 12 in Type IV section.**
