RESEARCH AND DEVELOPMENT SECTION

RESEARCH UPDATE

U2015-01

Assessment of the Composite Arch Bridge System (Bridge in a Backpack) First Year Findings

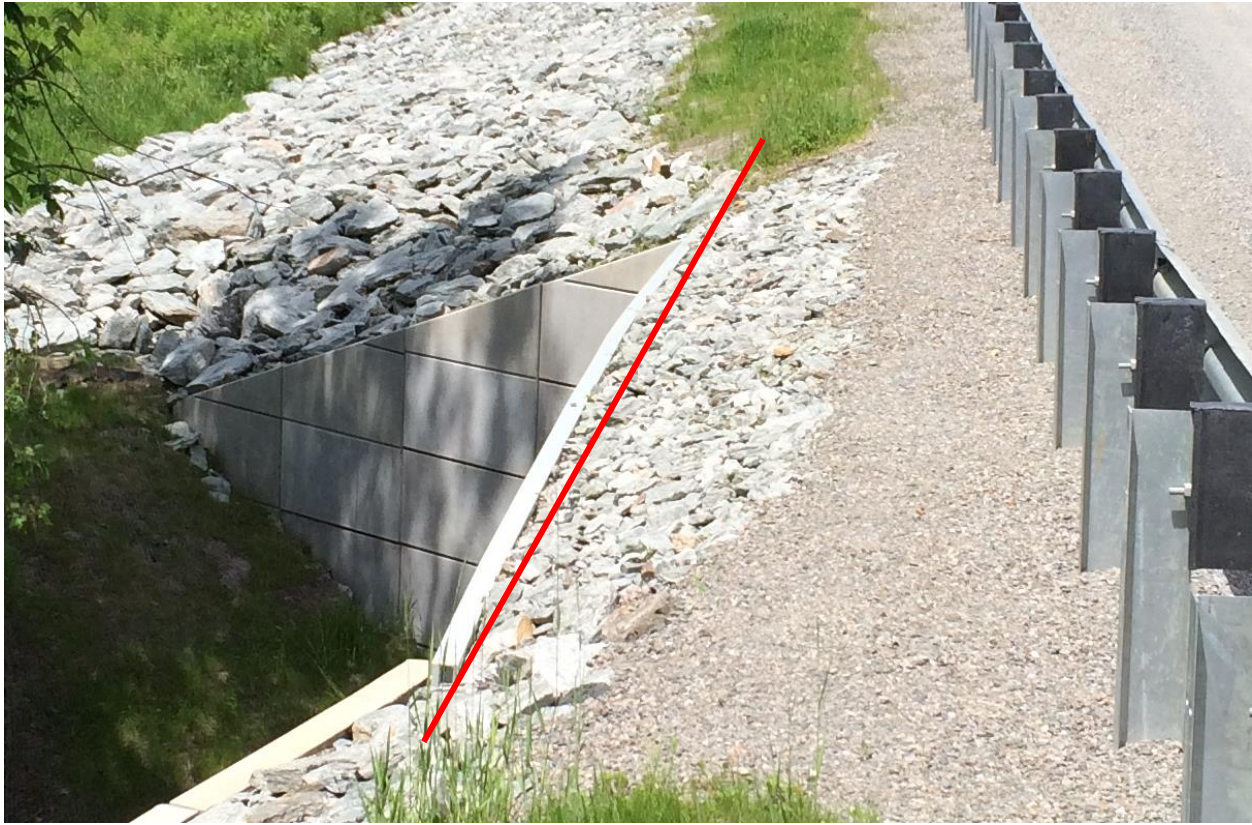
Initially, the overall appearance and basic geometry of the bridge was evaluated. Since the last site visit a year ago, the overall appearance has not changed. No points of impacts or damage were observed. The riverbed under the bridge appeared to have experienced very little change since construction. Overall, the bridge appeared to be performing as expected. One area of concern is that the headwalls seem to be bowing outward by the lateral pressures applied to them by the roadway bed. The bowing appears to be in 1-3 inch range at this point and will need to be monitored more closely in subsequent site visits. The westerly headwall is bowing throughout its entire length in a smooth curve, where the easterly headwall seems to be held back in some places, and bowing in others with a meandering curved shape (see Figure 1 and Figure 2).

Figure 1 Westerly headwall with bowing out with a smooth curved shape

There appears to be no change to the overall shape and performance of the externally FRP reinforced concrete arches. The arches are not exhibiting any negative environmental impacts. There is no impact damage to the arches from stream activity. The headwalls are showing some displacement, which may be due to setting of materials. Continued monitoring including a

method of measurement for the headwalls is appropriate. An inlet and outlet arch will be added to the dimensional checks in subsequent years. Notification of the change in condition will be provided to VTrans Structures, District and Geotechnical staff for their consideration.

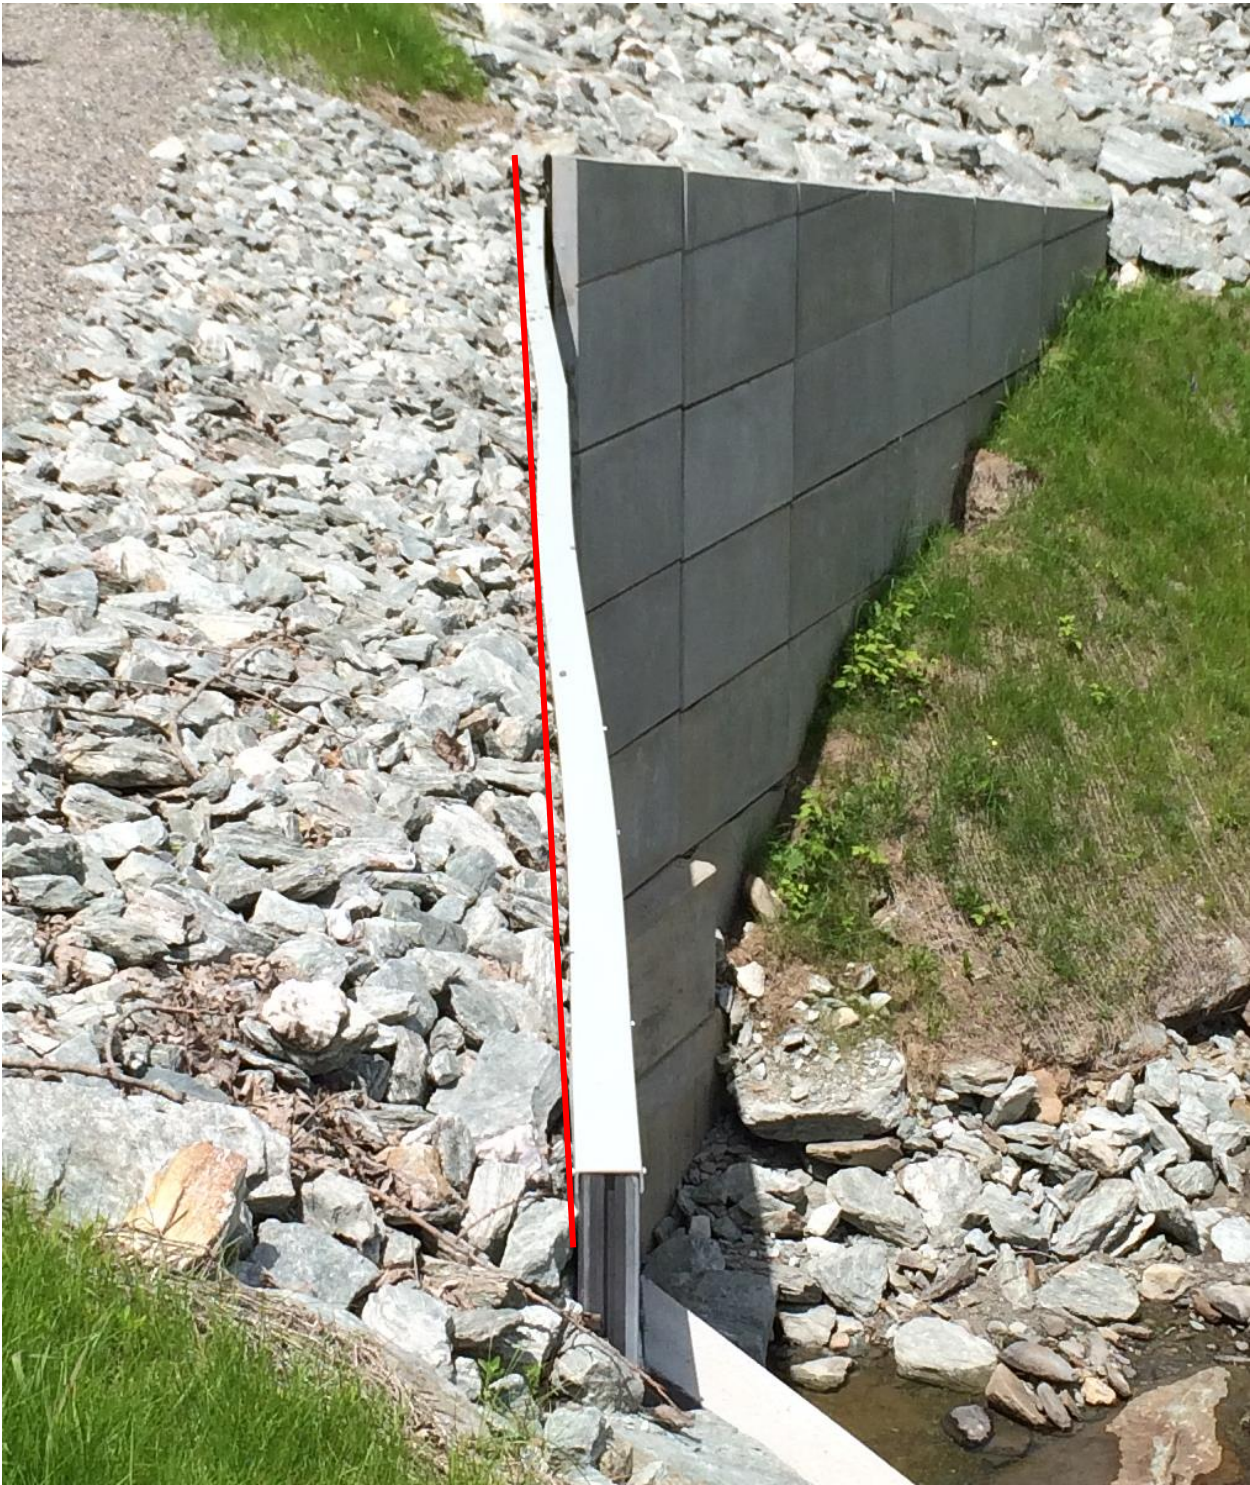
Figure 2 Easterly headwall bowing out with a meandering curved shape

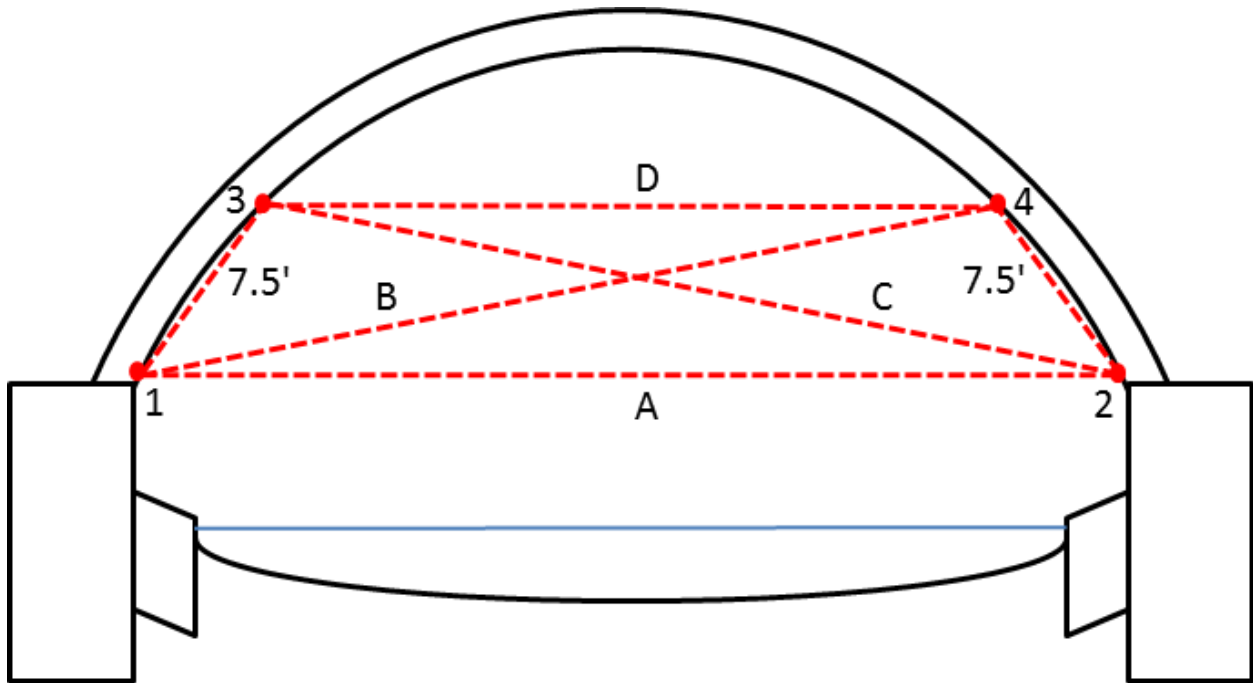
Figure 3 Measurements taken

The overall measurements (see Table 1) averaged about 3/8 inch different from the measurements taken in 2014 discounting the sign of the dimensional change. If expansion and contraction is considered the average change is 3/16 of an inch. These represented a 1.38% and 0.68 % overall difference respectively. The differences did not indicate any significant change is occurring. One of the diagonal measurements displayed a contraction on all three arches of approximately 3/4 of inch, which is well within the capacity of the arches to redistribute loads without harm.

The data collected over the last year suggests that there is contraction occurring in the horizontal line 'A' for arch 6 of about 1/4 inch, and an expansion of about a 1/4 inch for arch 4 and 3/8 inch for arch 5. All arches showed expansion along the diagonal line 'B' from 5/8 inch on arch 4 down to an 1/8 inch on arch 6. All arches showed contraction along the diagonal line C from 3/4 inch on arch 4 to 7/8 inch on arch 6. Arch 4 showed some expansion by 1/8 inch along

horizontal line 'D' where arches 5 and 6 showed contraction by 3/8 inch. These measurements suggest that the arches are deflecting slightly in a southerly direction.
