Asphalt Treated Permeable Base, I-89 Georgia, Vermont

Report 2005-1 September 2005

State of Vermont Agency of Transportation Materials and Research Section

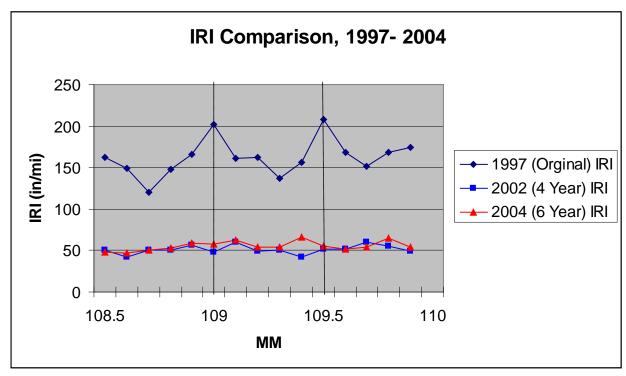
Figure 4- IRI comparison data

Roughness was measured using a Dynatest 5051 Mark II Road Surface Profiler. Roughness measurements were taken every tenth of a mile. As discussed earlier the IRI values were very comparable throughout the control and experimental areas prior to construction. The control areas averaged 162 in/mi (average of both sections), ranging from a low of 120 in/mi to a high of 208 in/mi. The experimental area (MM 109.00 to 109.50) was very comparable with an average of 164 in/mi and a range of 137 to 202 in/mi over its half mile length. However the values measured varied greatly over this 1.5 mile section. This is illustrated in the graph in Figure 4.

At the 4 year inspection, the roughness values exhibited a consistent pattern in both the control and experimental areas. This pattern is shown in Figure 4 and Table 6. The IRI values in the control sections averaged 52 in/mi with a low of 41 and a high of 60 in/mi, with the experimental area exhibiting similar values and averaging 50 in/mi with the same sample range of 41 to 60 in/mi.

Figure 4 also shows the six year (2004) data for roughness in the experimental and two control areas. While the graph indicates that, on the average, the 2004 and 2002 readings are comparable, this can be misleading. Table 6 shows that, most all of the recorded roughness values decreased from the 2002 survey. This includes all values recorded in the travel lane and 10 of 15 values recorded in the passing lane.
