Town: 215 - STOCKBRIDGE

IDENTIFICATION	
(1) State Names	50 - Vermont
(8) Structure Number	101419003514191
(5) Inventory Route	1
(2) Highway Agency District	4 - District 4
(3) County Code	27 - WINDSOR

Team Lead: Justin White, Inspection Date: 09/09/2024

Superstructure

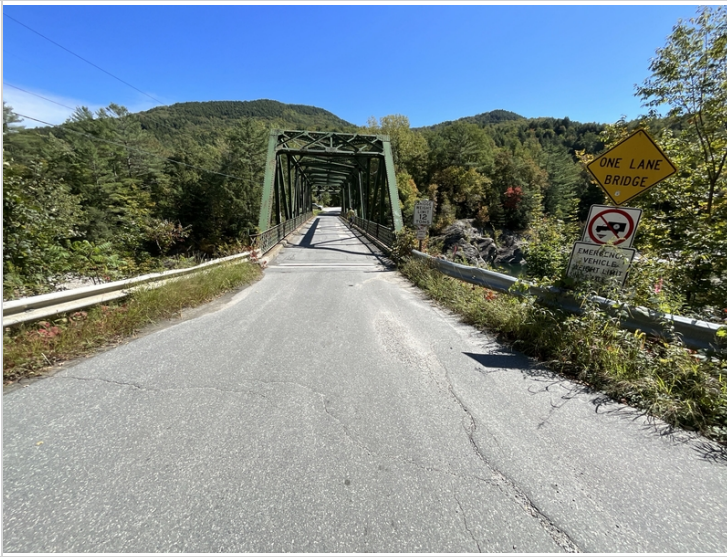
Abutment 2 approach

Scattered minor bending along the abutment 2 approach rail. The upstream rails have minor freckled rust throughout. The upstream abutment 1 rail is in good condition.

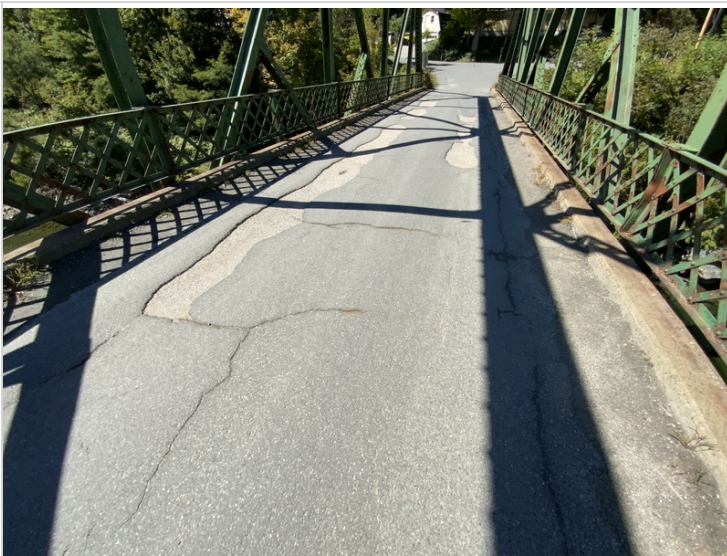
Wearing surface

Deep tire wear depressions and wide map cracking throughout. Small spalled areas (of the first layer) are scattered along the tire wear depressions in the abutment 2 half.

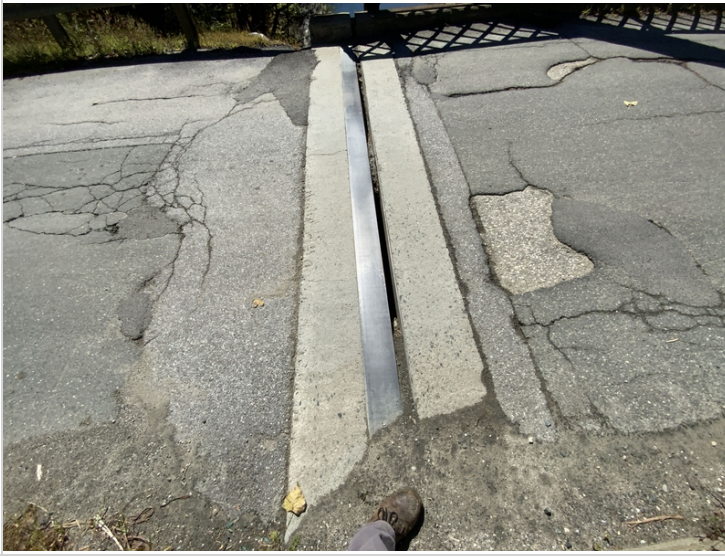
Abutment 1 joint

The replaced compression joints have both had the compressions seals fall out allowing runoff and debris to fall on the abutment and beam ends below.

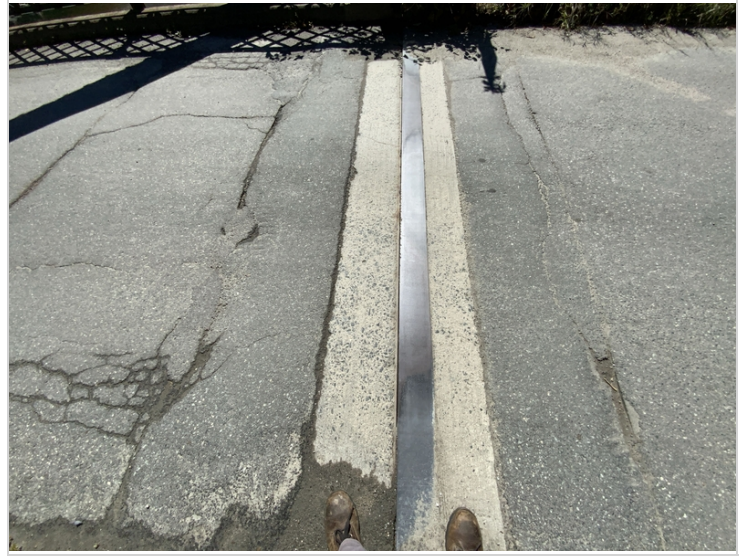
Abutment 2 joint

See stringer notes. The abutment 2 end of the structure was found to have visible transverse movement at the joint when loaded as vehicles passed over it.

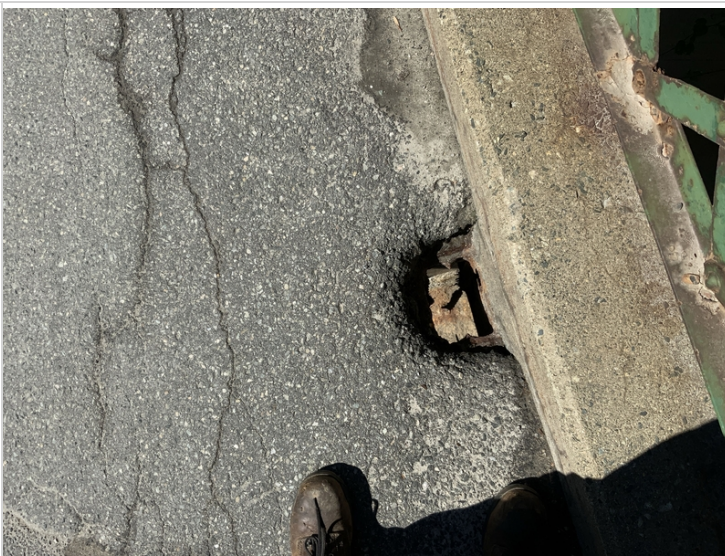
Drain opening

All of the deck drains have rotted out with insignificant or no section remaining and is the root cause to the deterioration in the fascia stringers.

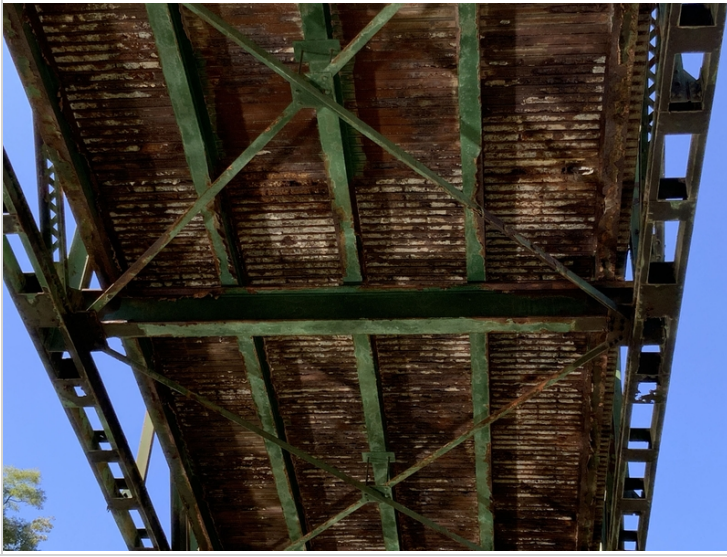
Deck

Much of the lower corrugation of the steel form work is rotted out revealing the concrete. The exposed concrete has moderate spalling with scaling throughout and some scattered small voided spalls exposing deteriorated longitudinal reinforcing. Deep voided spalls surround the openings of the failed deck drains and in some cases have spread to reveal the (interior) top flange of the exterior stringers.

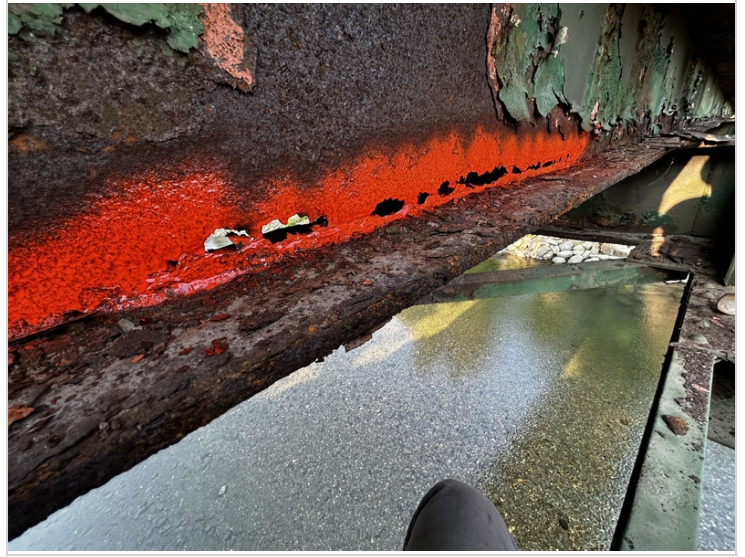
Downstream fascia stringer node 3 end

The stringer flanges have paint peel with rust scale, pitting, and minor to moderate section loss throughout. The exterior (fascia) stringers have more wide spread rust scale and section loss. Areas at the abutment ends and below the deck drain locations have moderate to heavy section loss with some small perforations in the flanges and lower areas of the webs. Heavy section loss in the downstream fascia stringer near the node 3 end (below the deck drain opening) has developed into a 2' long x 1" +/- high lineal perforation in the lower area of the web. The upstream fascia stringers at the abutment ends have had secondary beams added along their interior to compensate for their advanced section loss. Stringer 2 at abutment 2 has now started to crush with buckling in the lower area of the web extending out beyond the beam's floorbeam bearing seat. The downstream fascia stringer's abutment 2 end has advanced section loss in the lower flange and is no longer attached to the bearing/floorbeam. Typical remaining section in the abutment 2 stringer ends of the lower area of the webs and flanges is 1/8" - 1/16".

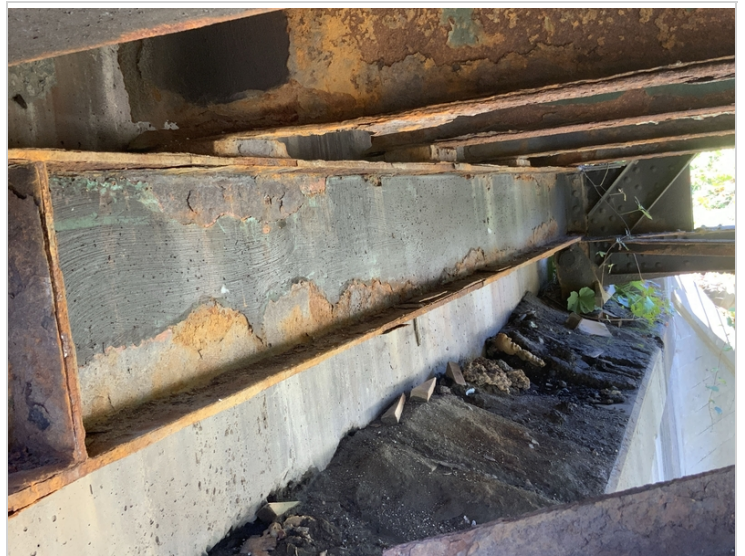
Stringer 2 abutment 2

This structure should be considered for replacement as deterioration continues develop throughout. Significant deterioration of the abutment 2 stringers was found with crushing of beam 2 and failed flange connection of beam 5 due to section loss. General remaining section along the lower flanges and adjoining areas of the webs of the abutment 2 stringers was found to be 18"- 1/16". These failures and section loss has contributed to the now visible lateral movement in the supported deck end when loaded. It is recommended that this structure be closed until repairs or replacement can occur.

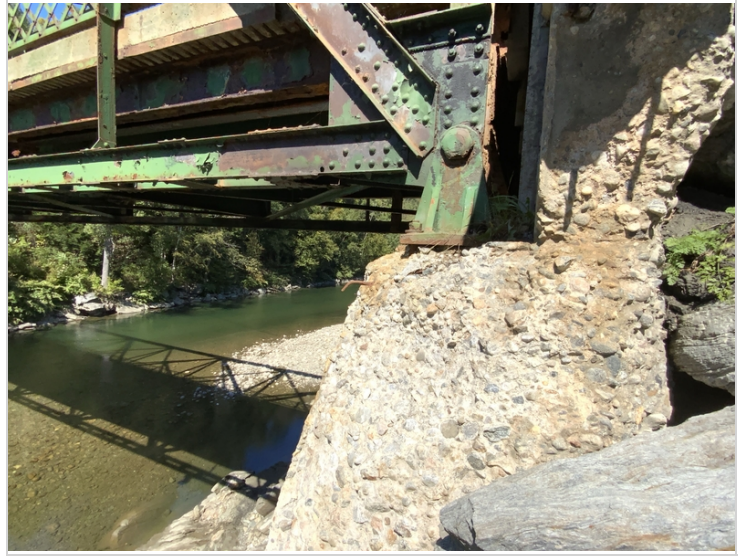
Abutment 1 upstream bearing

Areas of rust scale with minor section loss and deep pitting throughout.

Areas of minor abrasion throughout the abutment walls and some minor spalling along the base of abutment 2. Deep voided spalling throughout the bridge seats with scaling, exposed rebar, and heavy debris build up that extends up to the bearings causing some minor undermining of the upstream pedestal bearings.

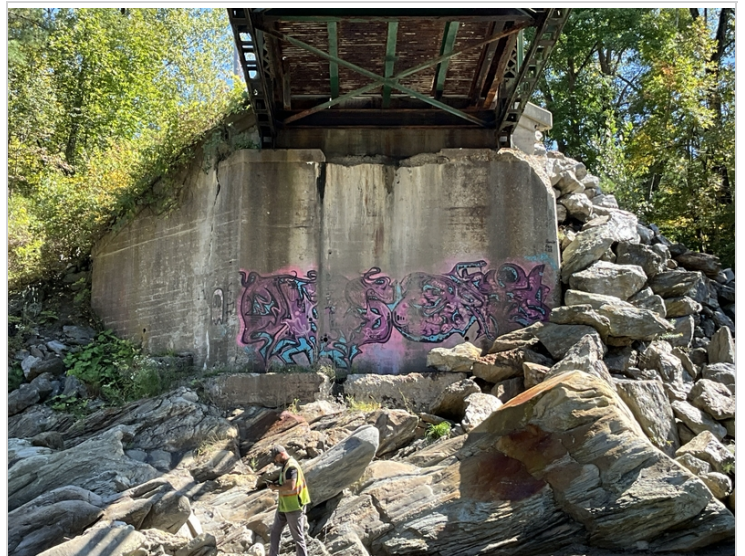
Abutment 1

Map cracking throughout with light staining and minor saturation. The abutment 1 wall has small voided spalls in the ends with exposed reinforcing.

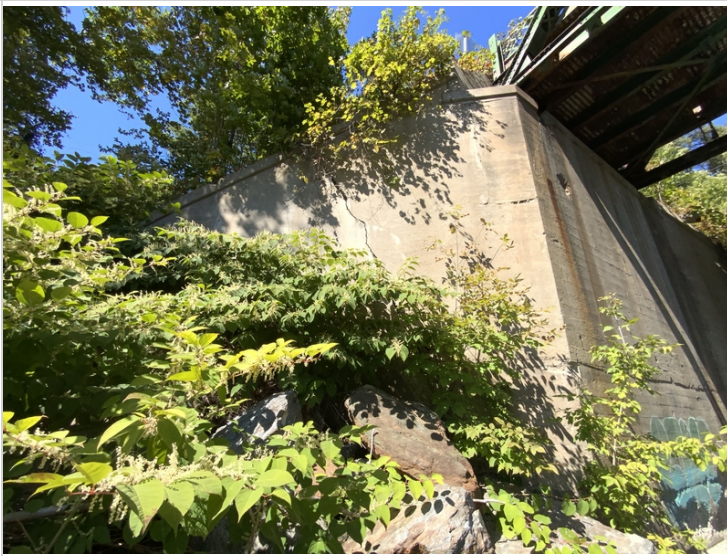
Wingwall 3

Full height vertical sustained settlement cracks with scattered small spalls and minor separation in the upstream abutment 2 wing and downstream abutment 1 wing. The downstream abutment 2 wing has areas of minor spalling and abrasion along its base. The upstream wall of abutment 1 failed during Irene and has had large ledge rip rap put in its place.
