Town: 30 - BRISTOL

IDENTIFICATION	
(1) State Names	50 - Vermont
(8) Structure Number	100103002001031
(5) Inventory Route	1
(2) Highway Agency District	5 - District 5
(3) County Code	1 - ADDISON

INSPECTIONS *			
(90) Inspection Date	08/01/2024		
(91) Frequency	24		
(92) Critical Feature Inspection	Done	Freq. (Mon)	Date
A: Fracture Critical Detail	No		
B: Underwater Inspection	No		
C: Other Special Inspection			
* The inspection date and frequency information in this box contains the current NBI date and frequency information. Please refer to the report header for the date this inspection was conducted.

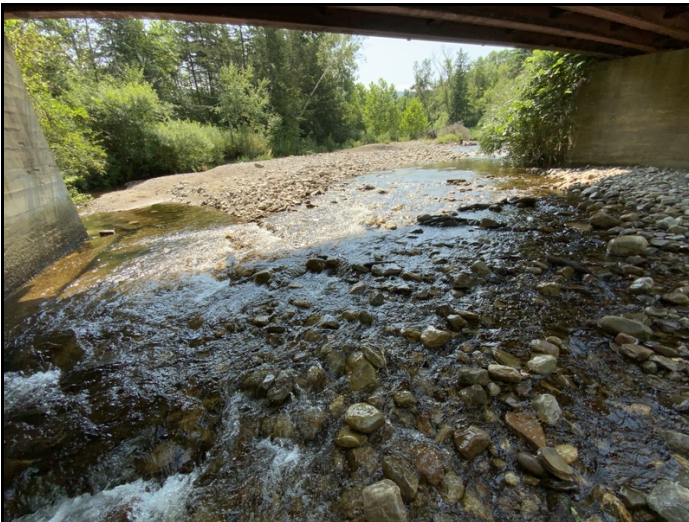
Channel

Heavy aggradation along upstream stream bed over the years has forced the channel along the upstream abutment 2 embankment and runs into/along abutment 1. This has caused localized scour exposing the abutment 1 footing and small voids were found below the base of footing in the downstream end. Heavy erosion along same side and protection has washed away over years.

A channel realignment project with anti scour protection installed along abutment 1 should be considered.

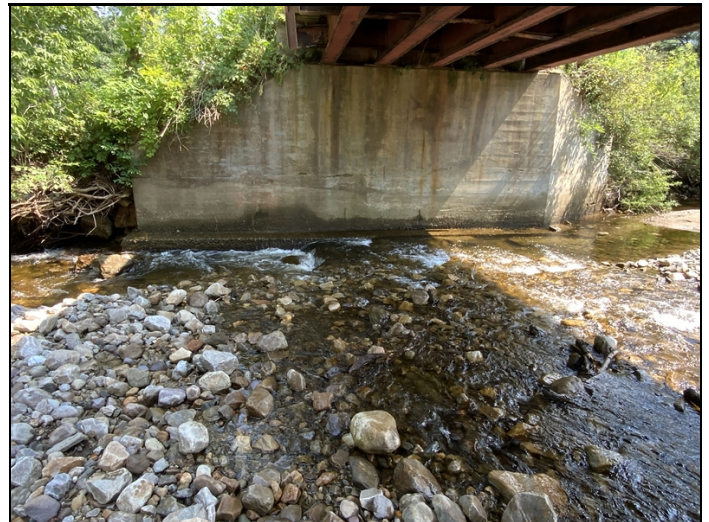
Abutment 1

Precast segmented blocks are generally in good condition along abutment 2. The abutment 1 members have areas of minor scaling in scattered locations, the upstream exposed end has minor spalling with heavy scaling.

The exposed abutment 1 footing has minor abrasion throughout.

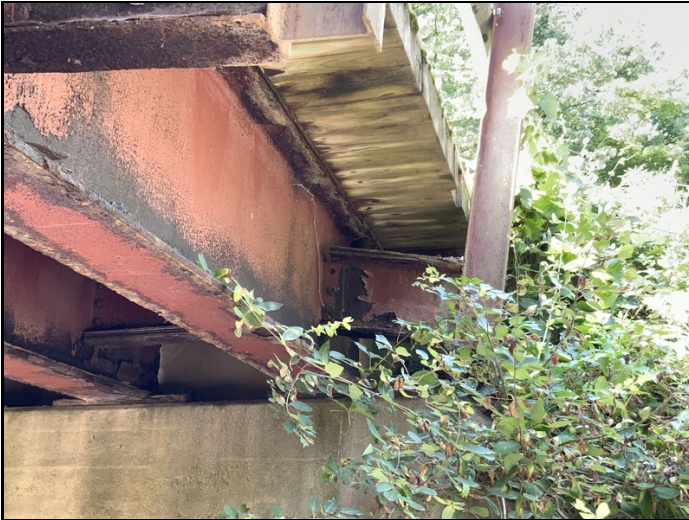
The abutment 2 downstream end post has moderate displacement due to a past impact causing failed bolt connections in the stub beam bracket.

Downstream abutment 2 guardrail end post

Repairs should be considered.

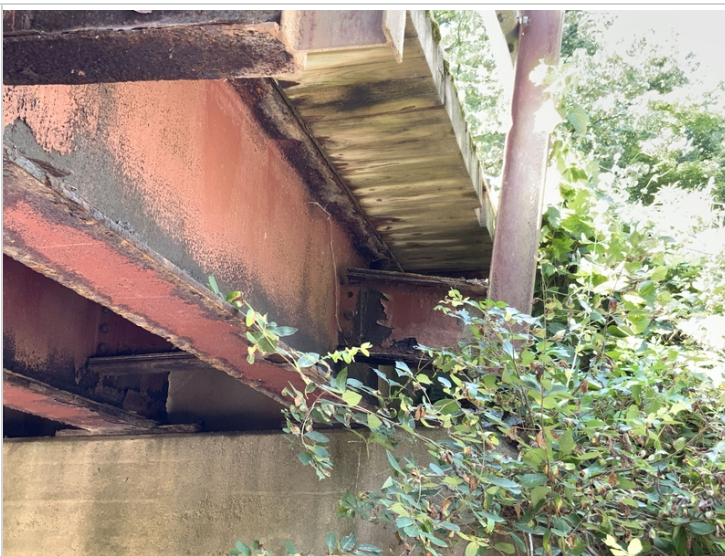
Scrape marks with minor rust staining throughout. The connecting stub beams along the fascias have heavy rust scale with moderate section loss throughout. The abutment 2 downstream end post has moderate displacement due to a past impact causing failed bolt connections in the stub beam bracket.

Scrape marks with some small areas of minor rust staining initiated. The downstream abutment 2 end has some flattening of the rail as well.

Downstream abutment 2 guardrail end post

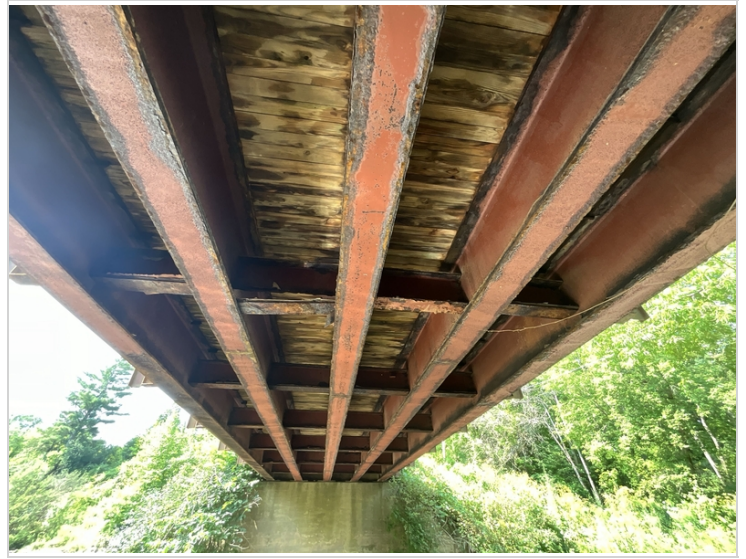
Span

Heavy rust scale build up along the flanges and lower area of the webs with minor to moderate section loss.
