FIELD PERFORMANCE OF GALVANIZED REINFORCING STEEL

INTERIM REPORT 81-5 NOVEMBER 1981

VERMONT ROUTE 12 SPRING STREET BRIDGE MONTPELIER VERMONT

STATE OF VERMONT AGENCY OF TRANSPORTATION MATERIALS & RESEARCH DIVISION

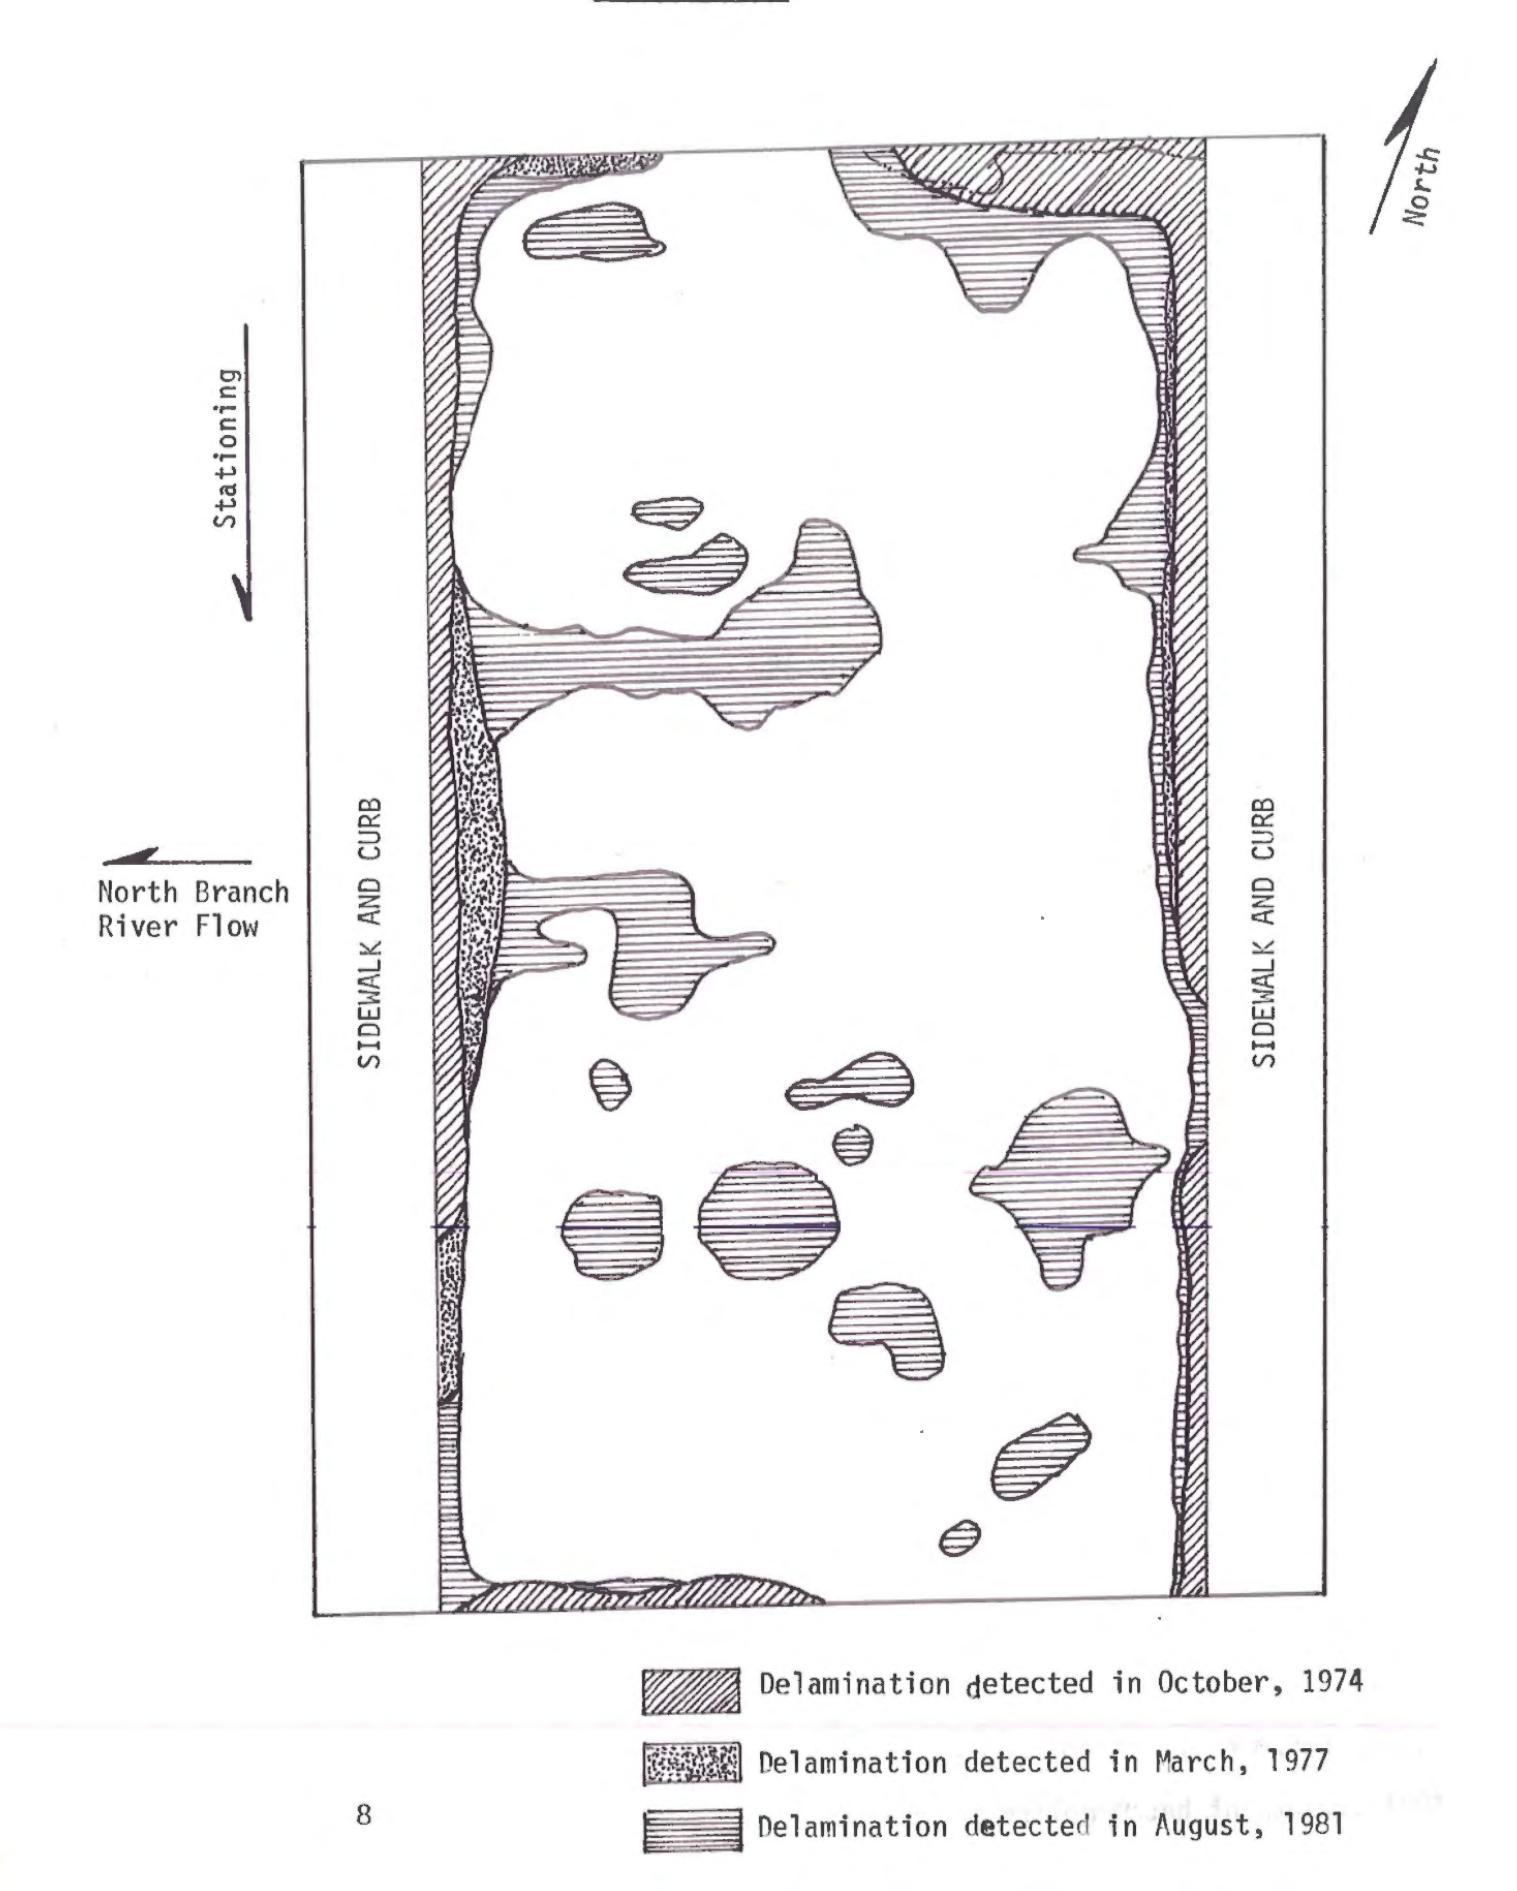
DELAMINATION

Delamination between the two courses of concrete has been on the increase since 1973 when it was calculated at 9% of the deck surface area. The initial delamination was confined mainly to the deck perimeter along the curb lines. By 1977, the area had expanded to 12% of the deck surface and a 1981 survey revealed a sharp increase to 32%.

The latest increase consisted of extensions to previously detected areas and the development of 12 additional isolated areas.

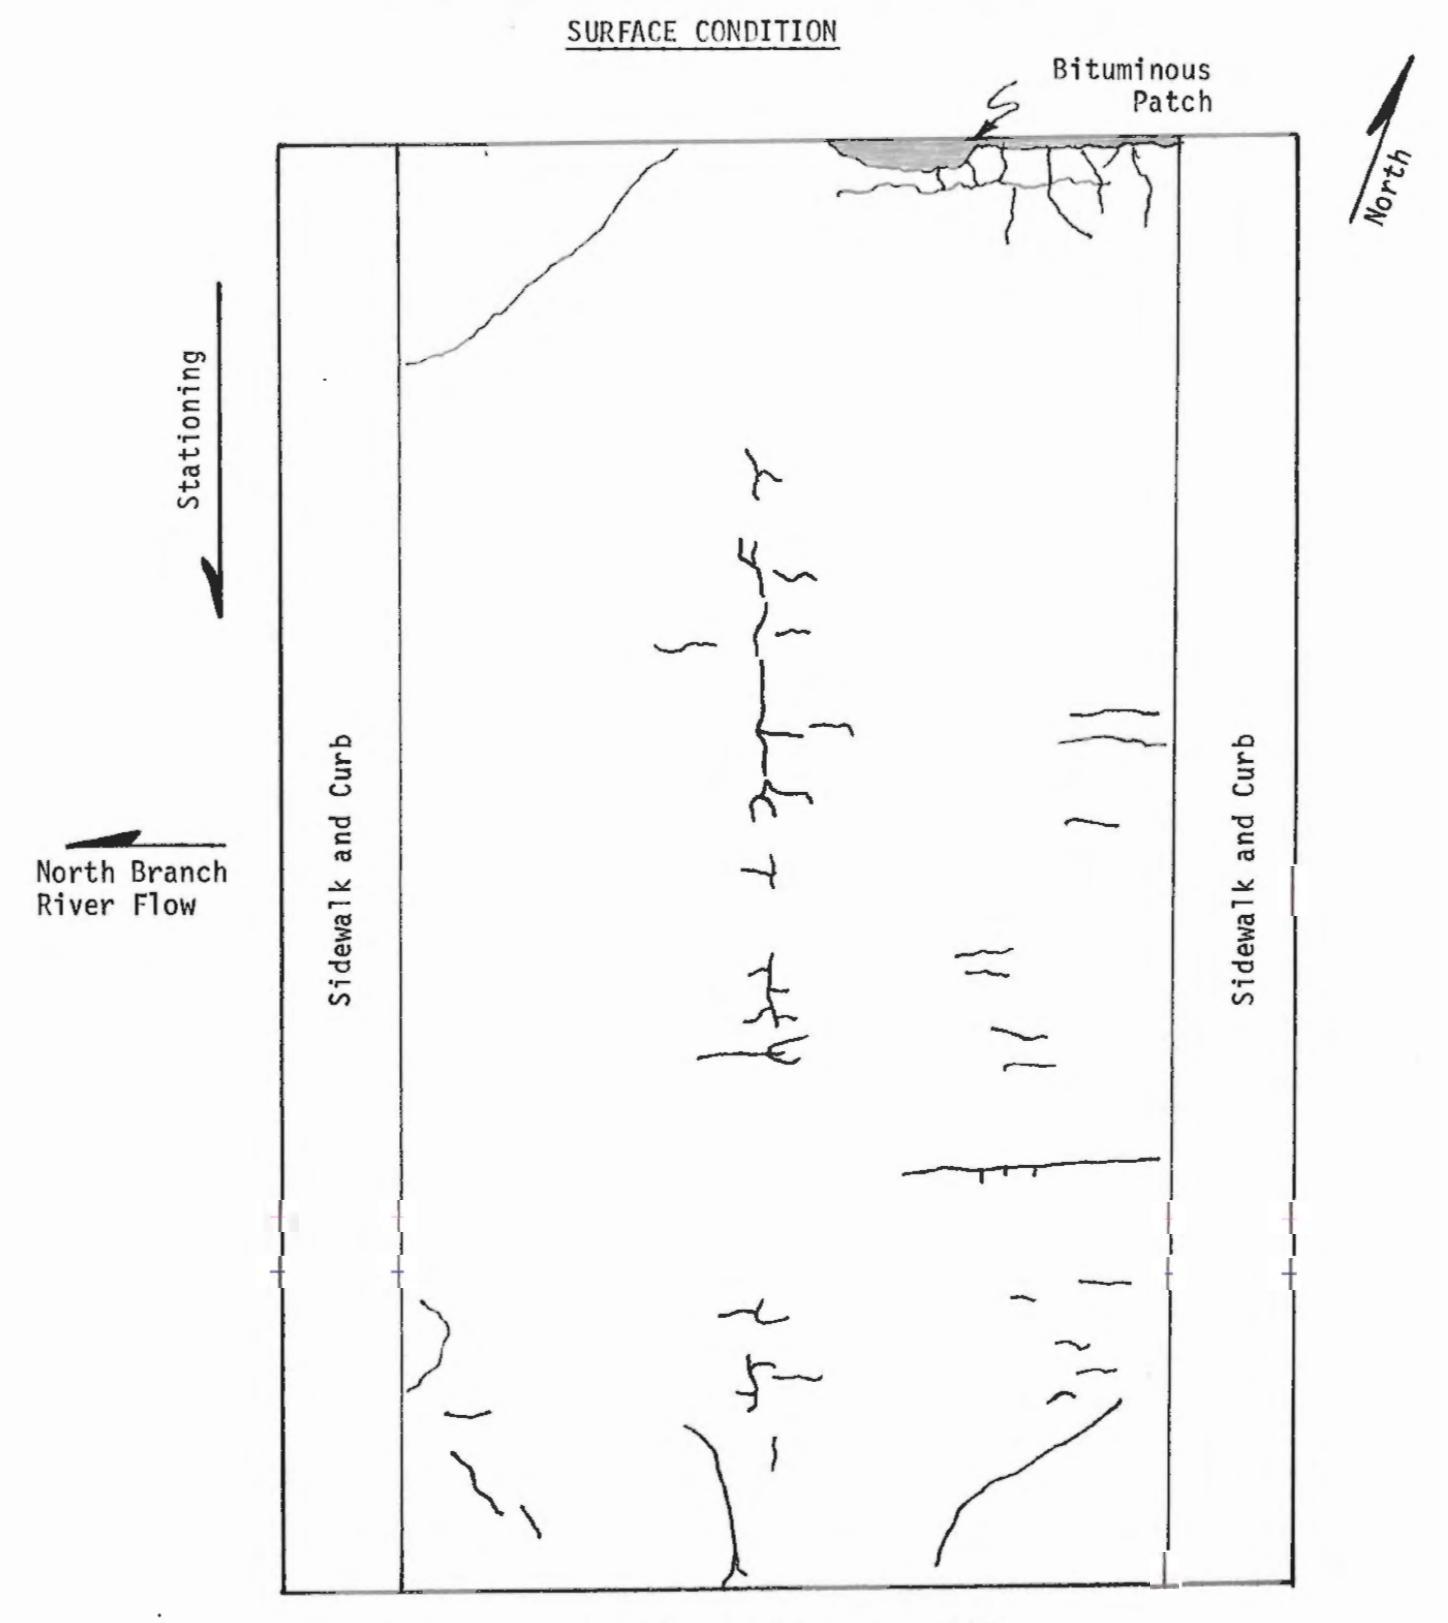
Cracking As Of August, 1981

There is 225 lineal feet of visual cracking on the deck surface, randomly spaced over the entire deck. Forty percent of the cracking is transverse varying from 1 foot long to 15 feet long. Longitudinal cracks make up 36% of the cracks and range from 1 to 6 feet in length. The remaining 24% are miscellaneous. See illustration of cracking on Attachment 4, page 10.

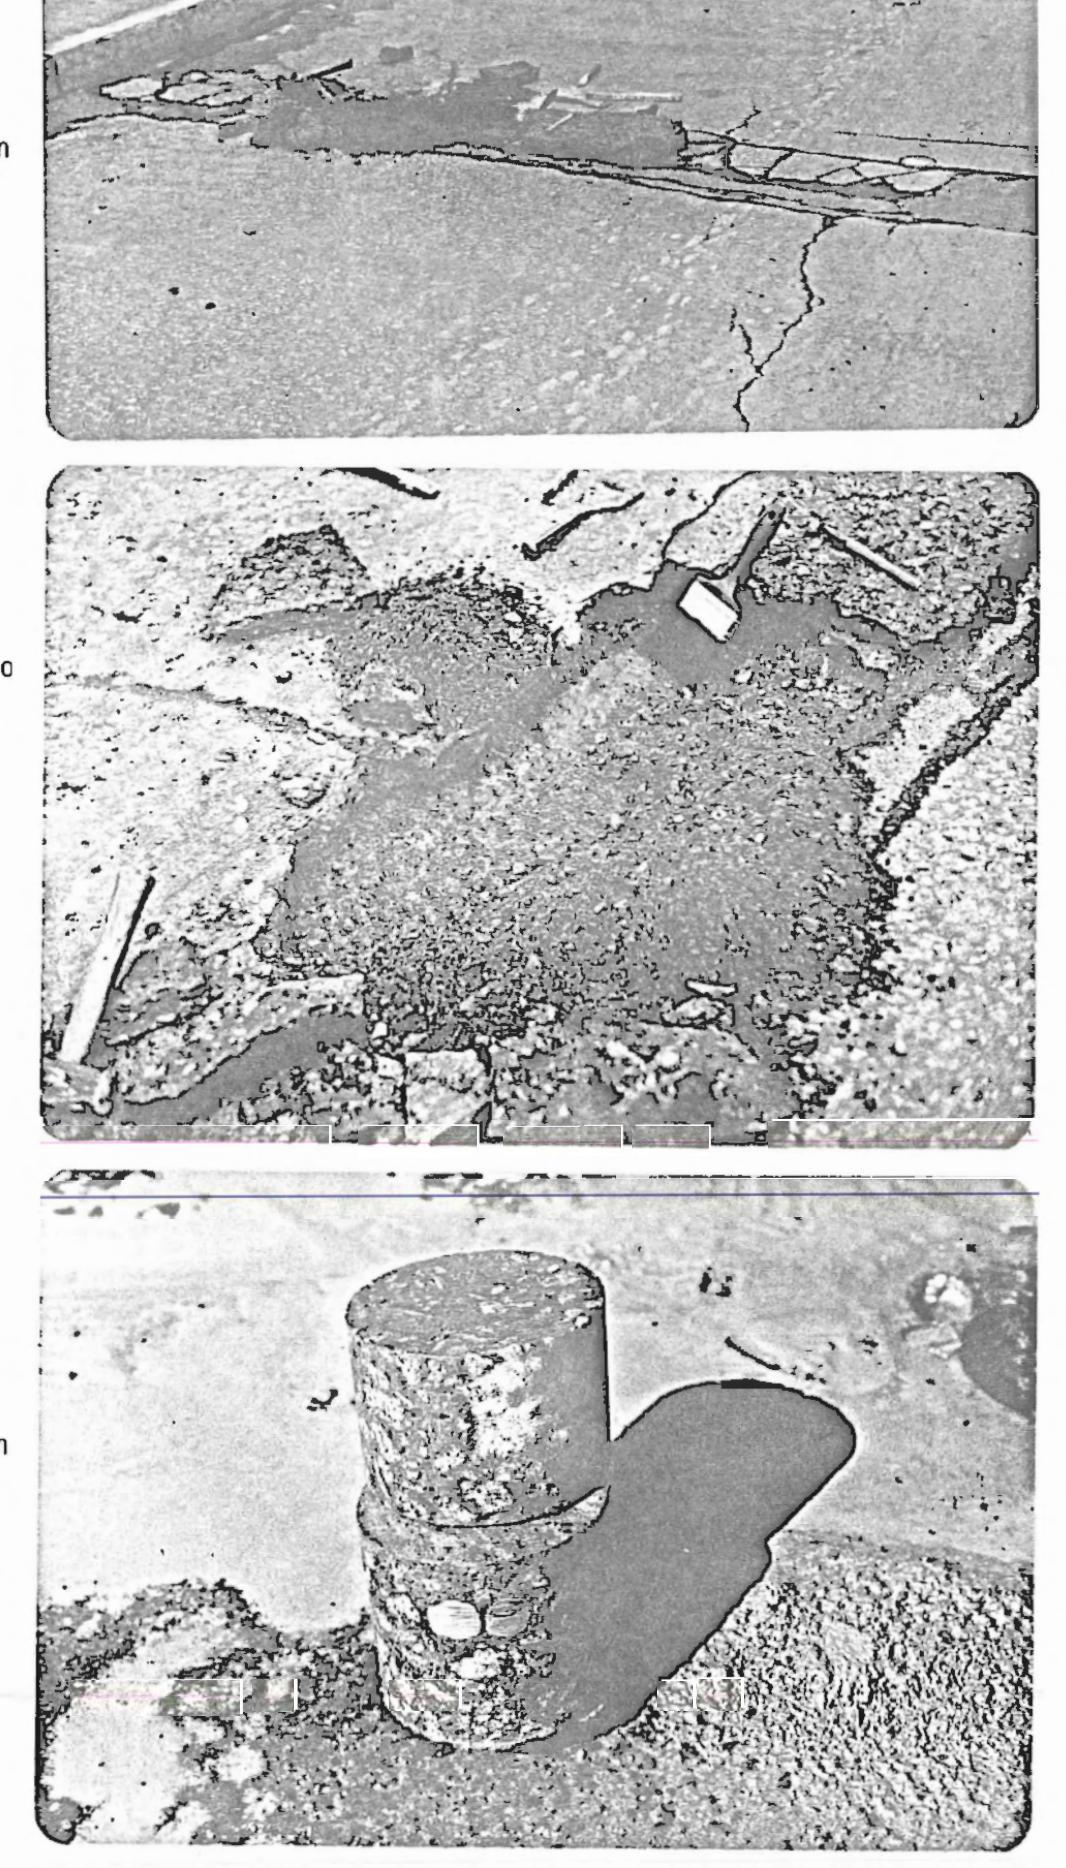
Concrete deterioration adjacent to northerly approach slab.

Lack of bond between courses. No visible signs of corrosion on galvanized rebar.
