Comparison of Pavement Marking Systems Waterford-Lyndon, Vermont

> Initial Report 1998-2 April, 1998

Reporting on Work Plan 96-R-4

State of Vermont Agency of Transportation Materials and Research Section

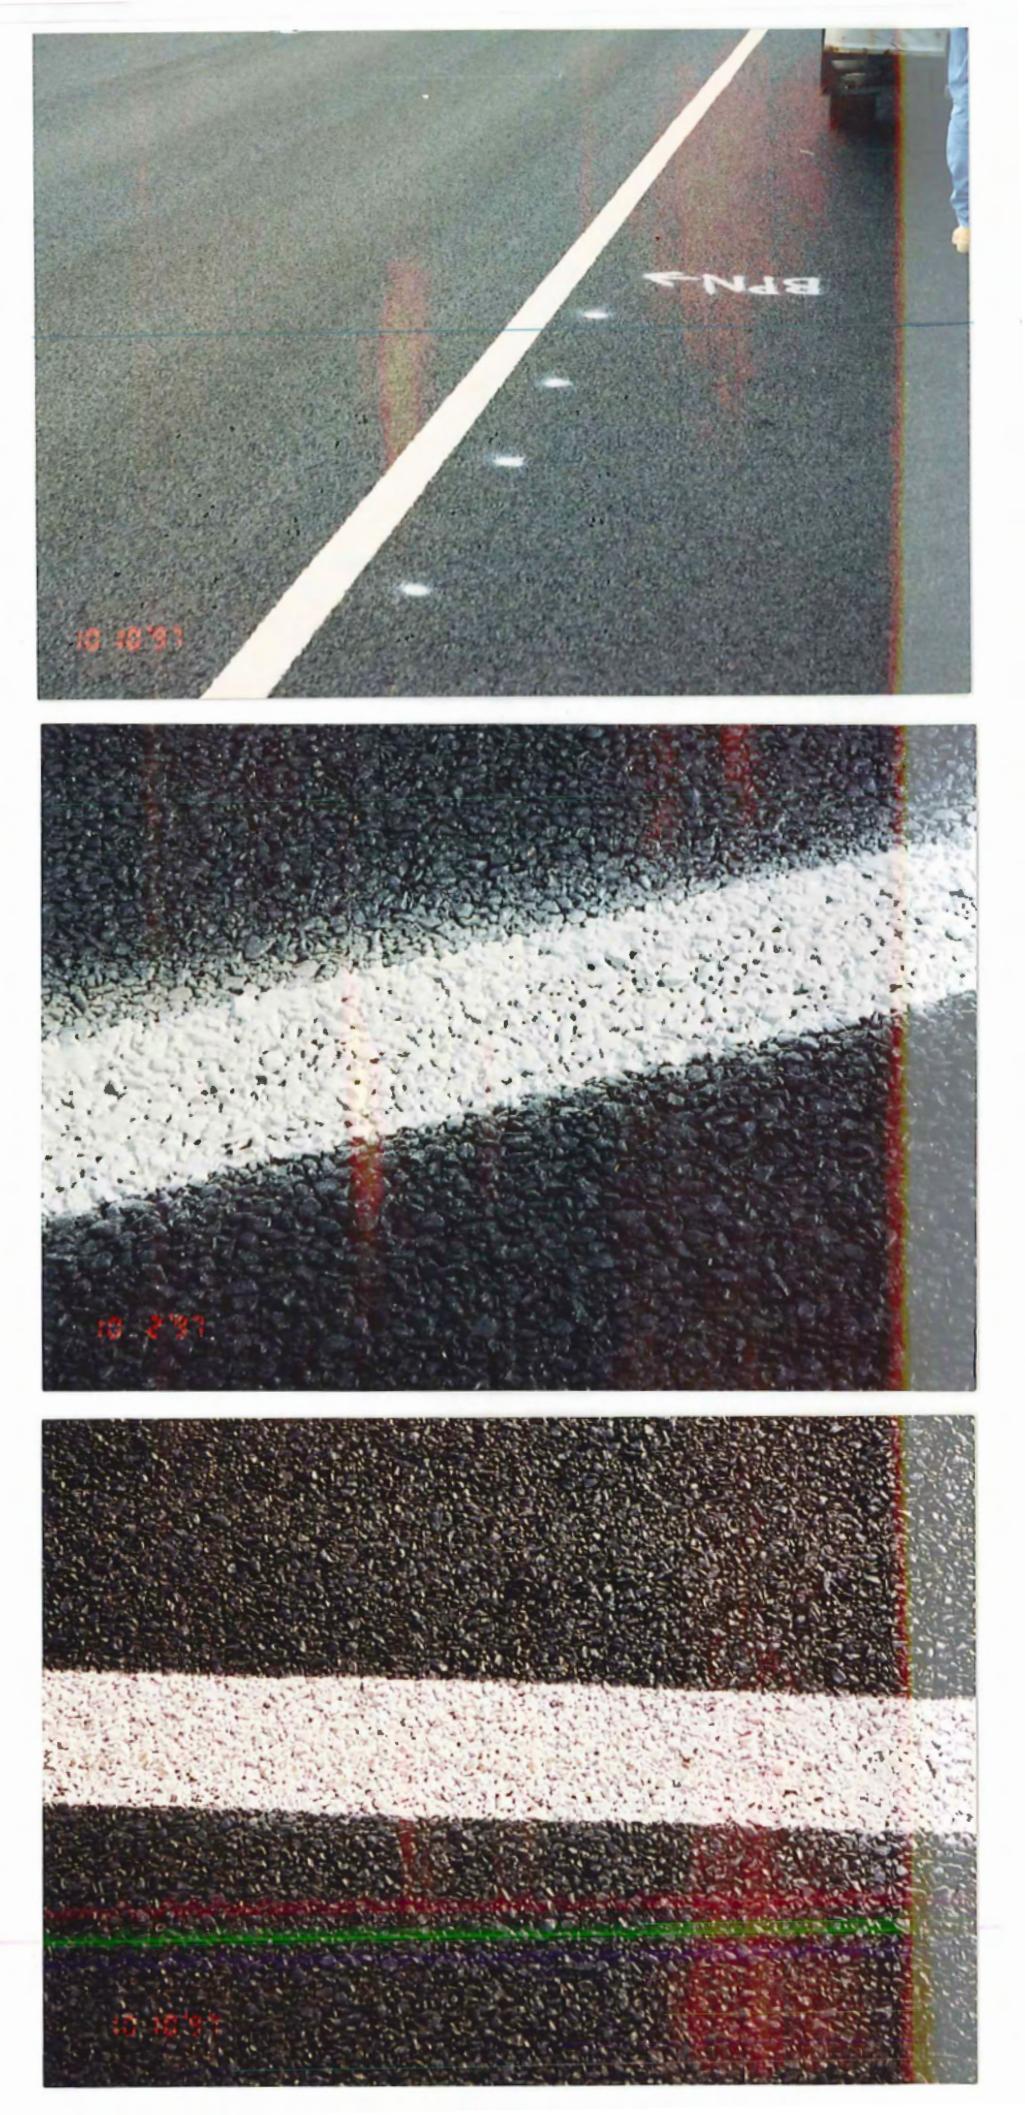
Thermoplastic edge line, Photo taken 11-2-97, MM 130.50

Epoxy edge line, Photo taken 11-2-97, MM 133.50

Waterborne edge line, Photo taken 11-2-97, MM 134.00

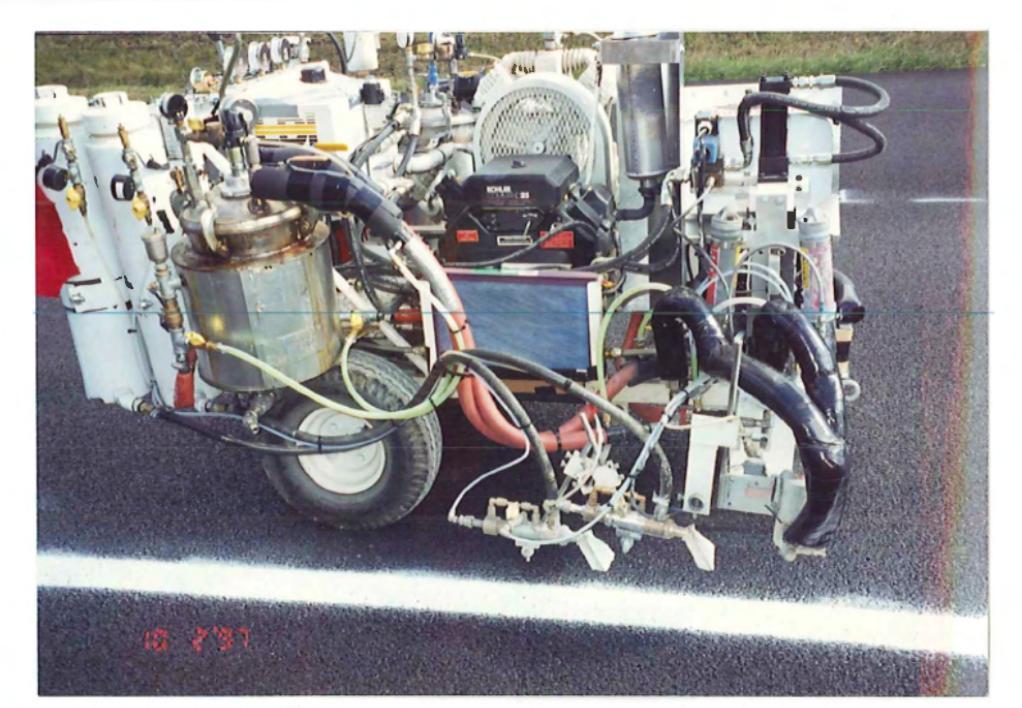
Epoxy applicator

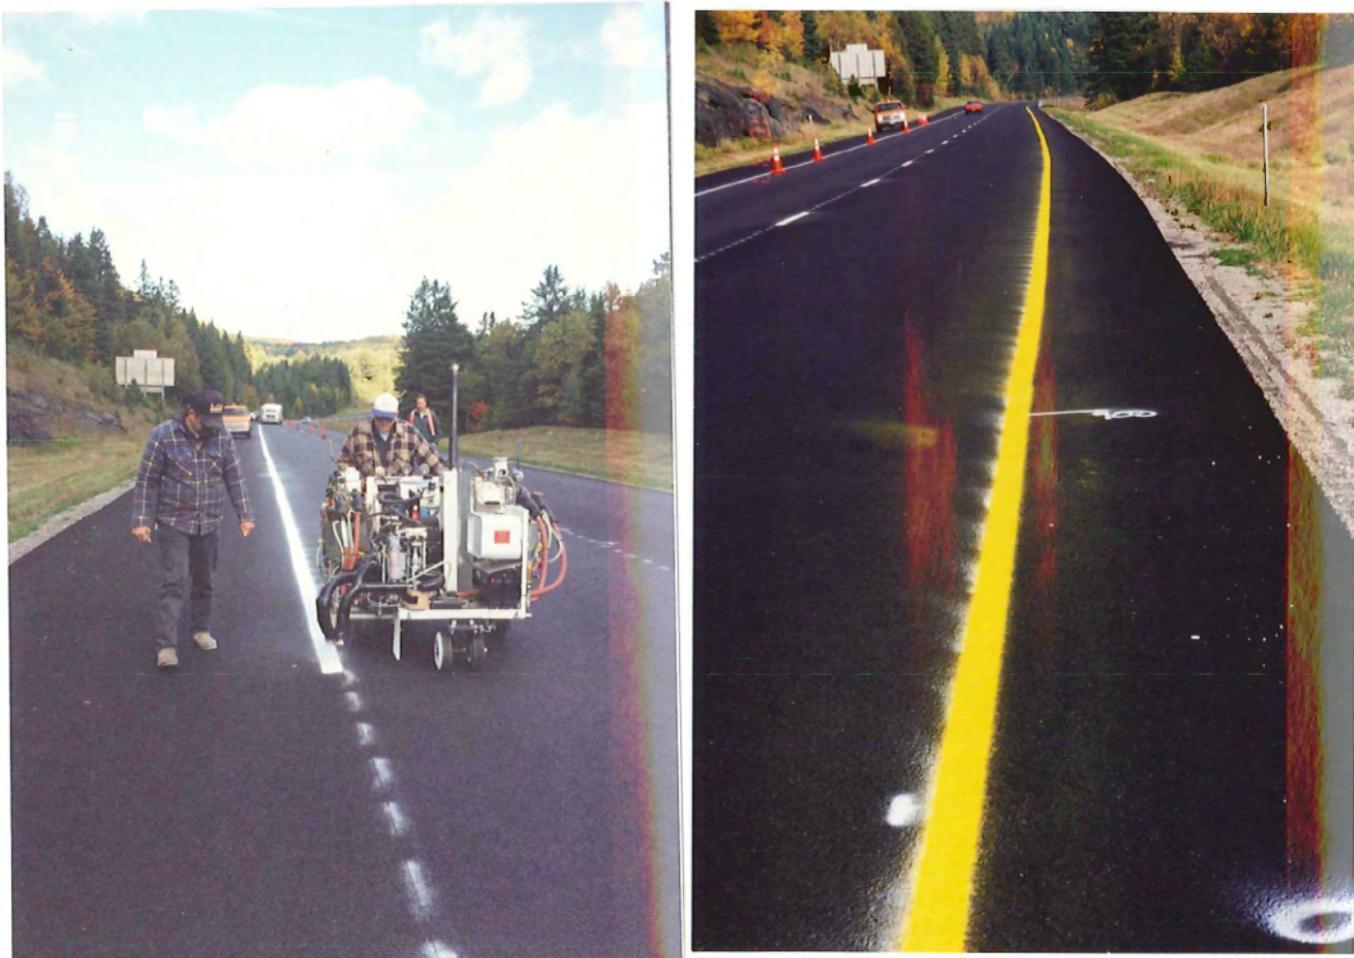
The epoxy crew had trouble keeping the cart aligned with the stencil so that the initial $1500 \pm$ feet of edge line is badly misaligned. The LDI crew stated that the cart they were using was primarily for working on test decks, and therefore had not been installed with a pointer. In addition to the alignment problem, there was heavy over-spray resulting in blurry edges. The cause of the over spray was probably attributable to excessive application pressure and/or the high temperature of the material, causing the epoxy spray to bounce off the pavement.

Applying epoxy 10-2-97

Epoxy barrier line Note heavy over spray
