Asphalt Treated Permeable Base, I-89 Georgia, Vermont

> Report 2005-1 September 2005

State of Vermont Agency of Transportation Materials and Research Section

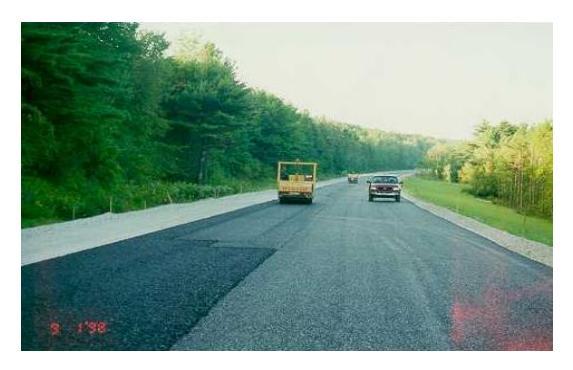
Figure 1 Application of ATPB

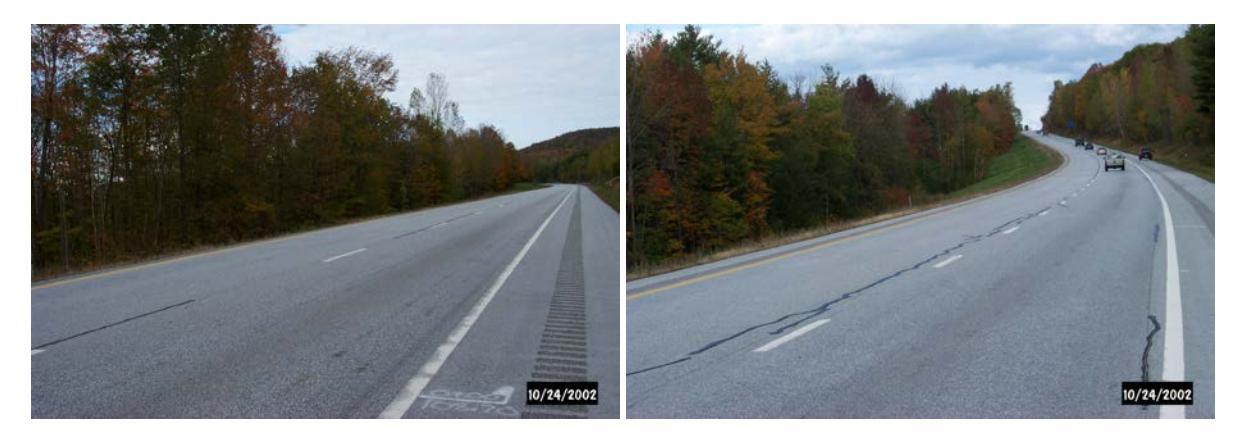
Very little cracking was evident in the first two control test sites, with only centerline/paving joint cracking noted. Cracks were not significantly evident in the shoulders as well. Limited longitudinal cracking appeared in the third test site (MM109.10, the first in the experimental area); with more significant longitudinal cracking in the second and third ATPB sites as well as the final control site. This can be identified as an 88-foot long crack located 1 to 1.5 feet from the centerline paving joint in test site 109.25. Few other types of cracks were noted within the test area. All of these cracks had also been sealed as part of the statewide crack seal project, and appear to be related to the center and right edge paving joints (Se Figures 2 and 3).

Figure 2 - Typical Control Site (MM 108.70)

Figure 3- ATPB Site (MM 109.25) (note paving joints and sealed crack locations)

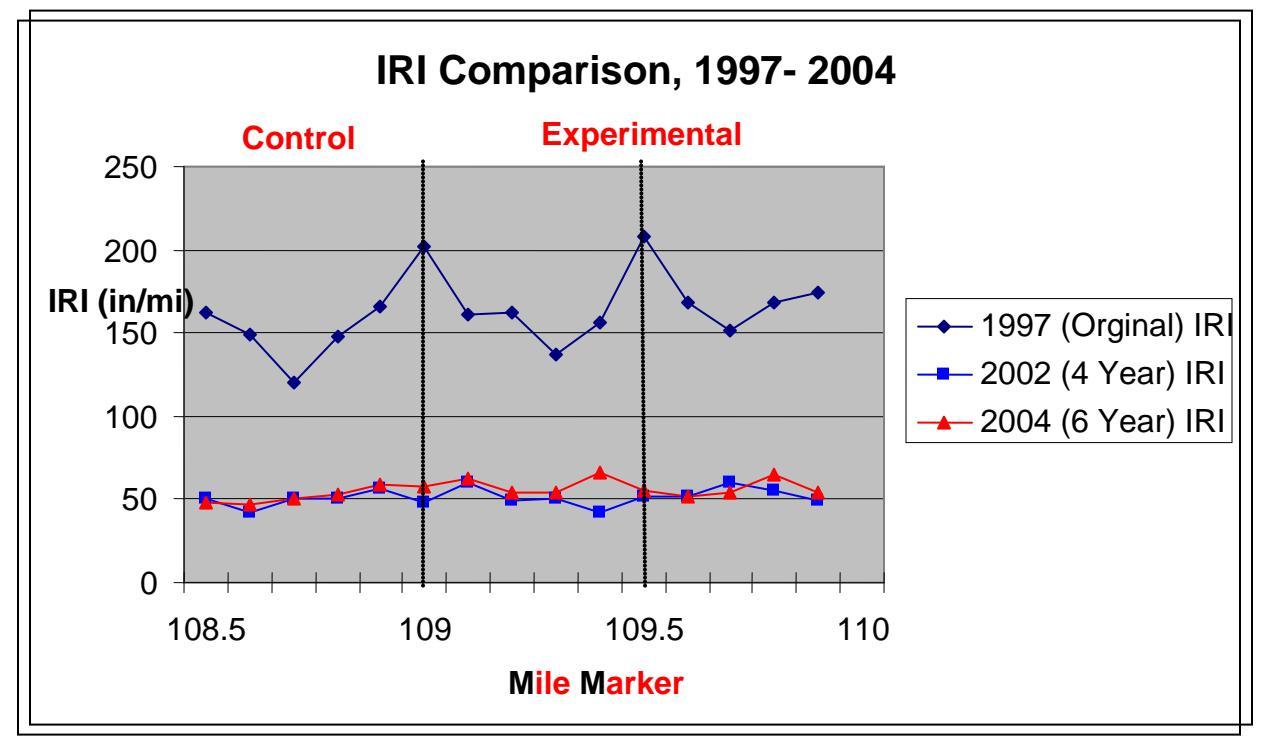
At the 4 year inspection, the roughness values exhibited a consistent pattern in both the control and experimental areas. This pattern is shown in Figure 4 and Table 6. The IRI values in the control sections averaged 52 in/mi with a low of 41 and a high of 60 in/mi, with the experimental area exhibiting similar values and averaging 50 in/mi with the same sample range of 41 to 60 in/mi.

Figure 4 also shows the six year (2004) data for roughness in the experimental and two control areas. While the graph indicates that, on the average, the 2004 and 2002 readings are comparable, this can be misleading. Table 6 shows that, most all of the recorded roughness values decreased from the 2002 survey. This includes all values recorded in the travel lane and 10 of 15 values recorded in the passing lane.

Figure 4- IRI comparison data

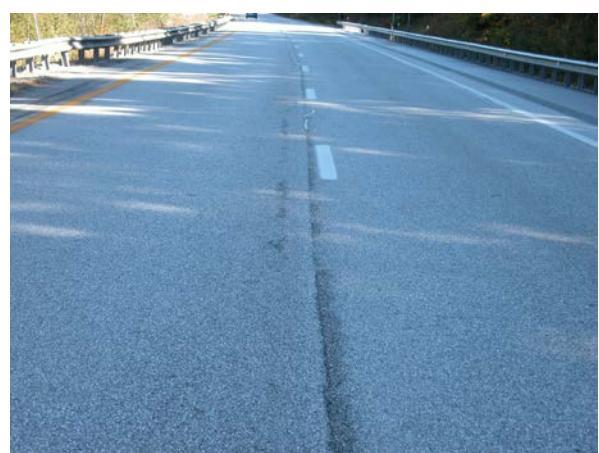
As of 2004, the data indicates a number of trends. Of primary concern is the crack counts results, which infer that increased cracking of the ATPB over the standard control section could be expected as the projects ages. One area of note is at MM 109.10, where pavement distress, though not yet a crack, was evident near the centerline paving joint. This is shown in both Figures 5 and 6. Areas like these were not present in the control areas north and south of the experimental location.

Figure 5 - Overview of Cracking in ATPB

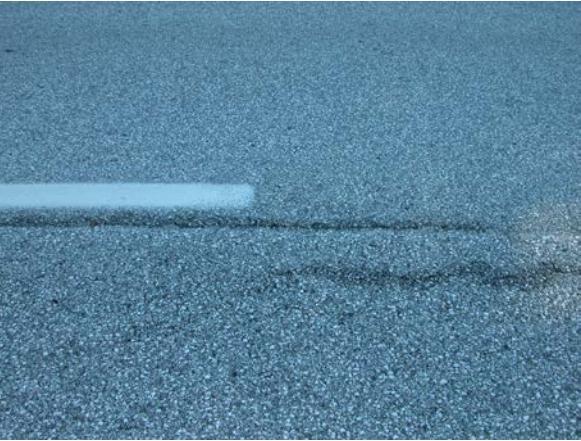
Figure 6 - Distress in Test Site at MM 109.10
