RESEARCH UPDATE

U 1998-2

SILICOFLEX STRIP SEAL JOINT SYSTEM

Reference Initial Report U95-10, Update U97-3

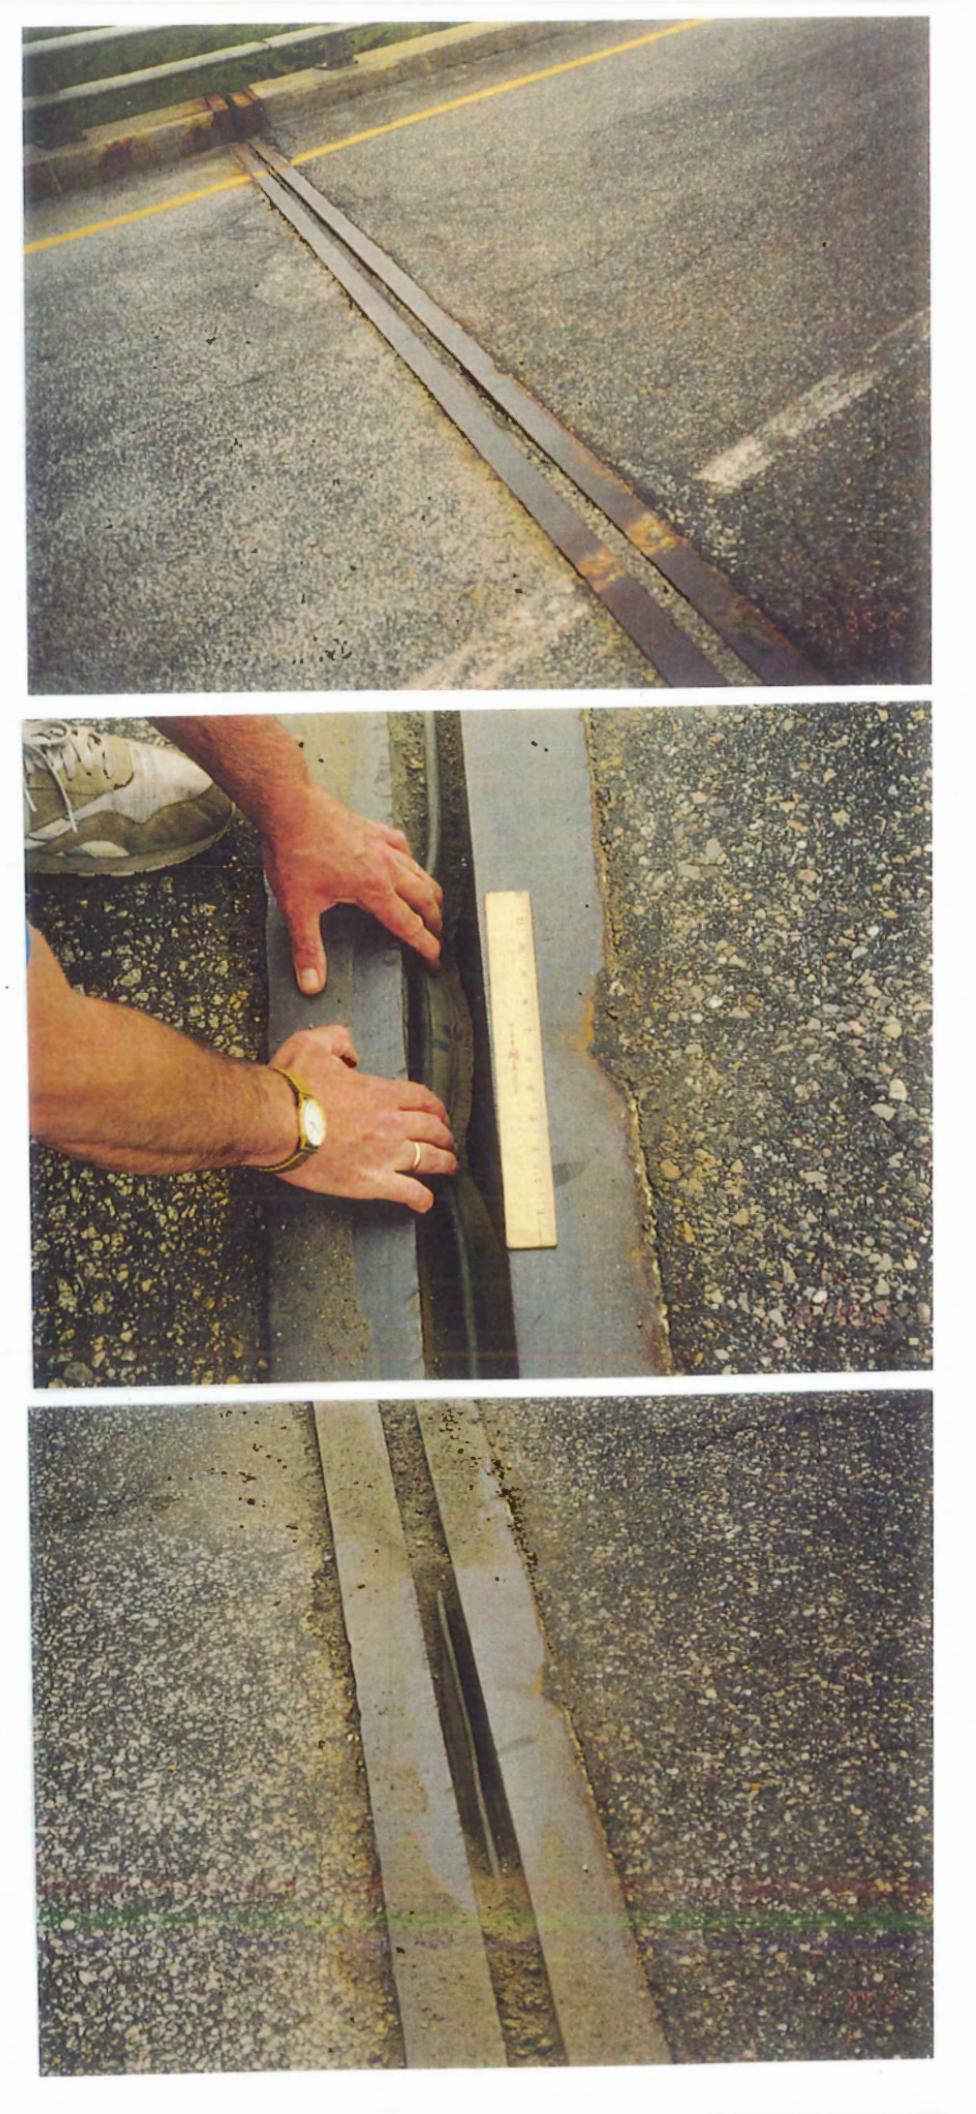
At another location in the travel lane a fourteen inch bond failure was discovered. This break was so long that the V joint has buckled and become so misshaped that it no longer is in contact with the angle plate. The result is an opening of three inches by 1/2 inch where water can freely drain down onto the girder ends. Towards the downspout end another five inch bond loss was found.

Similar conditions were discovered during this inspection as were found last year. Accumulation of sand and debris in the recesses of the joint seal, aggravated by rust on the steel angle plates, are the direct cause of the failures. The inevitable rust on the uncoated steel has spread underneath the adhesive and weakened the bond. Loading from vehicles crossing the debris laden joint has put pressure on the weakened adhesive and caused it pull away from the angle steel.

Silicoflex Strip Seal Joint Bridge # 1 Berlin State Highway View towards downspout before cleaning

Strip seal deformed from bond failure

14 " bond failure
