RESEARCH UPDATE

U 2000-7

PAVEPREP CRACK REDUCTION INTERLAYER

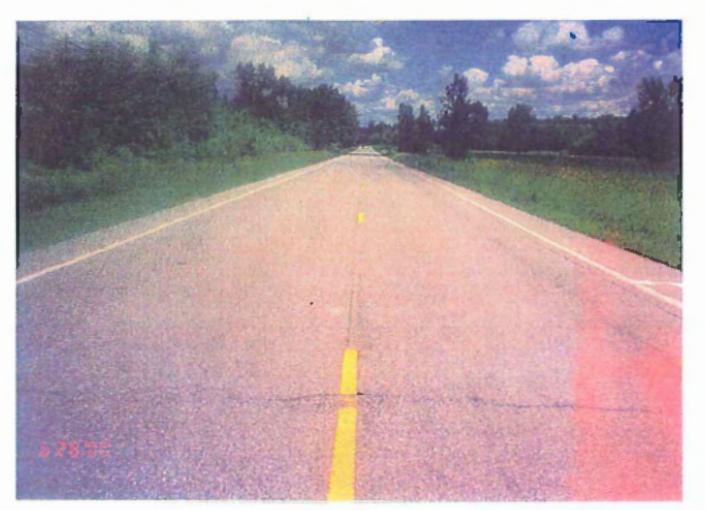
Highgate US Route 7 @MM 3.60

In Highgate, reflective cracking has developed both north and south of the test area, but the test site shows no signs of reflective cracking where the previous, transverse shoulder-to-shoulder crack existed, or along the centerline.

In Lowell, one site continues to perform as intended, while the other is beginning to show signs of failure. Although both these sites were part of the same resurfacing project, the site at MM 6.13 has a lower traffic volume than MM 3.26, possibly contributing to the performance difference. The Highgate site has a concrete road base and low traffic volume, factors that may be associated with its good performance.

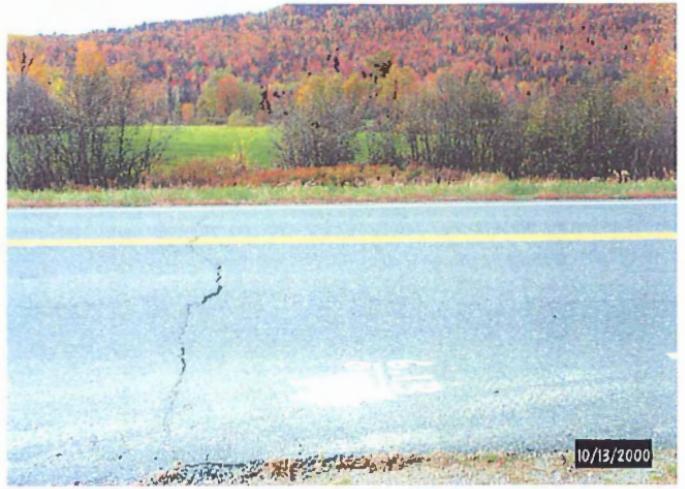
Lowell-Westfield VT Route 100 @MM6.13

In Lowell-Westfield, the test site at MM 3.26 has developed a crack 2.8 meters in length beginning at the eastbound shoulder going toward the centerline. The crack continues but diverges toward the south, away from the interlayer. Several other cracks have developed on both sides of the test site. No cracking was evident at the MM 6.13 test site in Lowell, but evidence of reflective cracking exists north and south of the test site.

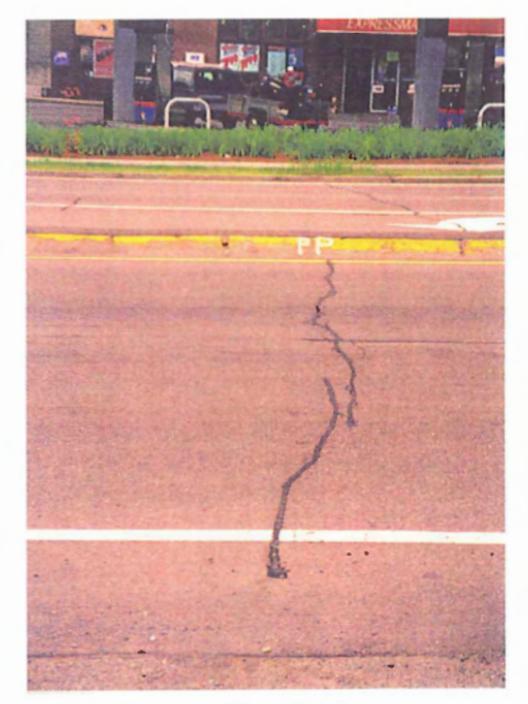
Hartford US Route 5 @ MM 3.13

On the Hartford project, the interlayer detached itself from the road surface the day following its placement. The loss of bond was thought to be attributed to the rough textured pavement surface and the condition was further aggravated by rain showers that followed the installation. The following week a new 7.3 m strip was placed near the previous strip location. Emulsified asphalt was applied on the milled surface just before the PavePrep installation. One lane was paved within five to ten minutes of application. The fabric was picked up by the shoes on the paver's automatic grading and slope equipment. This problem was corrected by lifting up each pad as it passed over the PavePrep.

In Hartford, two independent transverse cracks have developed along the alignment in which the PavePrep was installed. One crack measuring 2.8 meters in length, begins at the shoulder edge and goes toward centerline, while the other measuring 7 meters in length, begins at the median and goes toward the centerline. The crack is across the entire lane with the two cracks overlapping slightly at the center. The placement of crack sealant at this test site has continued to arrest the further crack development. Since the cracks were routed prior to sealing, the developed crack width prior to routing is unknown.

After six years of service, two of the five applications developed reflective cracks, and in one of these applications, failure occurred along the entire length of the test site. Although the results are inconclusive at this time, the Hartford failure may be attributed to a high traffic volume and the milled surface on which the material was placed. Although not required, the manufacturer recommends the material be exposed to traffic prior to paving. The Hartford site was paved shortly after installation, possibly contributing to its failure.

Performance monitoring will continue for the life of these projects, with emphasis on reflective cracking quantification. An attempt will be made to saw cut a portion of the Hartford test site to identify the probable cause of failure.
