RESEARCH UPDATE

U 2000-8

GLASPHALT PAVEMENT PERFORMANCE HARTLAND, VT ROUTE 12

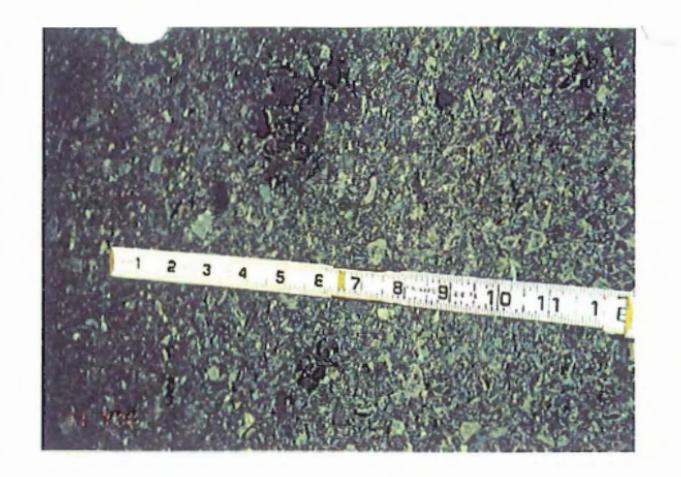
During eight years of performance, under close examination, the glasphalt overlay has exhibited some popout of the glass aggregate (Figure 1). Although the distress is not severe, small voids in the surface treatment are visible. The presence of glass is still very noticeable and well intact, particularly in the shoulder area where less wear has occurred (Figure 2).

Figure 1. Glass aggregate popped out (between 7" – 7 ½" mark on rule). (Photo taken November, 2000 at test site #2)

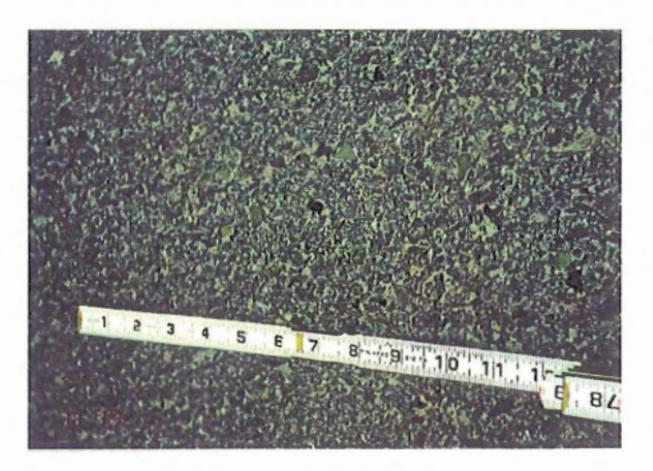
Figure 2. Green and brown glass aggregate remains visible. (Photo taken November, 2000 at test site #2)

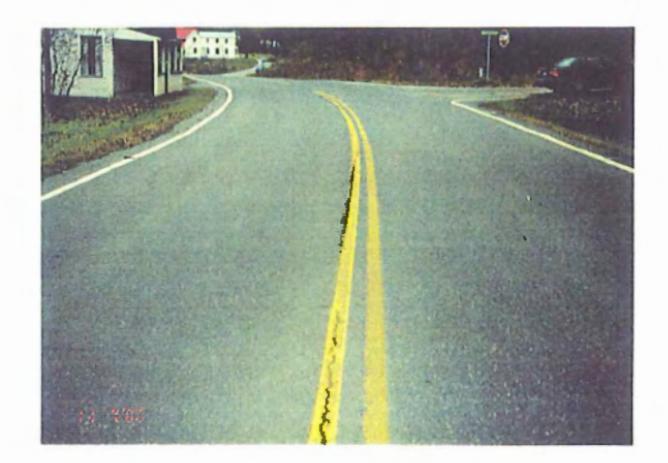
Overall, the glasphalt pavement is performing well. The addition of glass as an aggregate increases the tendency for asphalt stripping. However, with the addition of an anti-strip agent, as was the case here, the problem seems to be minimal (Figure 3).

Figure 3. Glasphalt (left lane) / Standard Bituminous Pavement (right lane). (Photo taken November, 2000 at test site #2)
