RESEARCH UPDATE

U 2002-2

QUIK-GARD[®] GUARDRAIL DELINEATORS (Final Report)

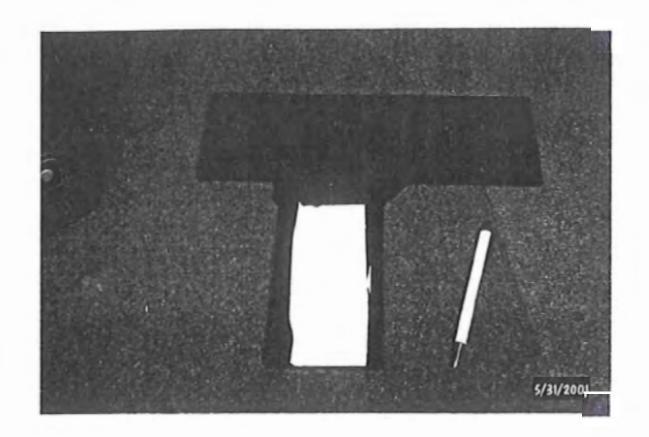
The regional manufacturer's representative from PSS, Inc. was on-site to install the product in accordance to the manufacturer's recommendations. At the time of installation overcast skies prevailed with an ambient air temperature of 50°F. Each spacer block was wiped clean with a cloth prior to the delineator's attachment to the steel spacer blocks and was affixed with a 6"x2" piece of F-68, butyl adhesive tape manufactured by the Plymouth Rubber Company of Canton, Massachusetts.

Figure 3. Detail of adhesive tape.

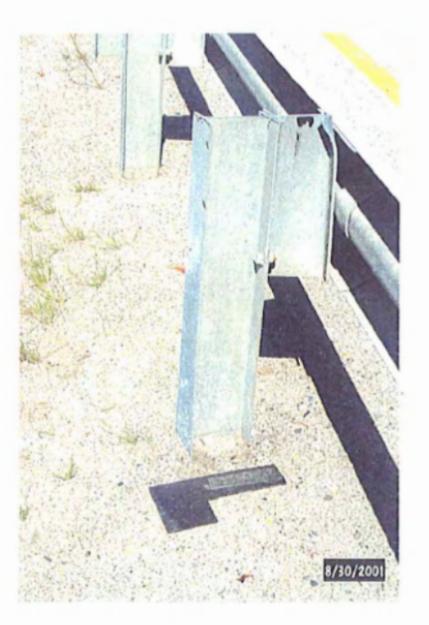
After one month in place, one of the delineators on the right-hand side of the ramp had fallen off the steel spacer block. During an inspection in August 2001, it was discovered that two additional delineators had come off (one on each the right-hand and left-hand side), and in mid-December another became detached. The failure associated with these delineators is likely associated to the adhesive and method of attachment. Each of the delineators was recovered at the base of the guardrail post they were attached to with the adhesive primarily affixed to the delineator, as seen in Figure 4.

Figure 4. Detached delineator after three months.

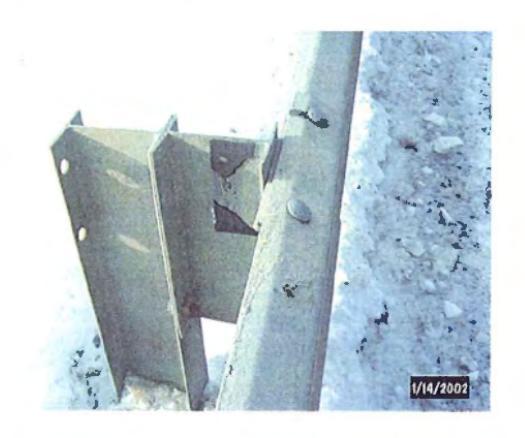
Figure 5. Failure at adhesive.

The early failure during the summer and fall months was most likely associated with the adhesive's performance in warm climates. In the summer of 2001, Vermont experienced a warmer than average season, including several days with temperatures above 80°F. The adhesive's bond with the metal guardrail weakened causing the delineator to drop-off the spacer block.

In 2002, Plastic Safety Systems, Inc., modified their installation procedures recommending that on metal spacer blocks the delineators be attached by tapping a lag screw through the marker into the block and eliminated the sole use of butyl adhesive. According to the manufacturer, some states such as Georgia, Tennessee, New Mexico, and Illinois have approved the product for use in their state. Vermont's experience indicates a limited use for this product, although clearly visible, the product's design doesn't appear to withstand normal maintenance activities required in a snow belt region and may be suitable for only short-term applications.

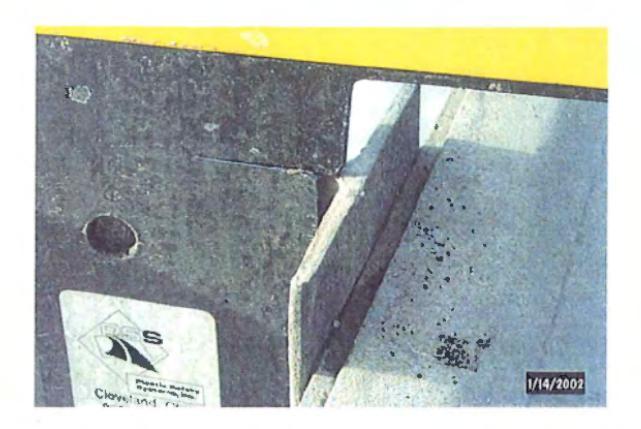
On January 2002, an inspection revealed the loss of several more delineators on both the right and left side of the ramp. Some of these were found a few feet from the guardrail, some directly below the post, and some not at all due to the snow coverage. Similar to the ones lost in the summer and fall months, the failure of some of the markers was likely associated with the adhesive, but in these cases, the adhesive was either partially or fully attached to the steel guardrail spacer block as shown in Figure 5. Other delineators failed due to shear force, causing some to break completely or partially along the top edge of the spacer block as shown in Figures 6 - 8.

Figure 6. Partial shear failure at top of spacer block.

leaving a majority of the adhesive on the metal spacer block. In others, the high-density polyethylene markers experienced a shear failure, likely associated with routine snow plowing activities such as contact between the plow equipment and the delineators or the force of the plowed snow against the markers. Vermont's 2001-2002 winter maintenance season experienced a less than normal snowfall and as a result, the snow banks did not require "winging" back as it would in a typical year.

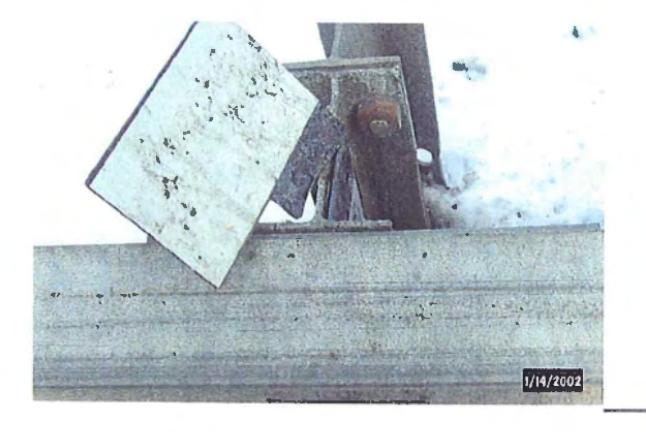
Figure 7. Nearly complete shear failure at top of spacer block.

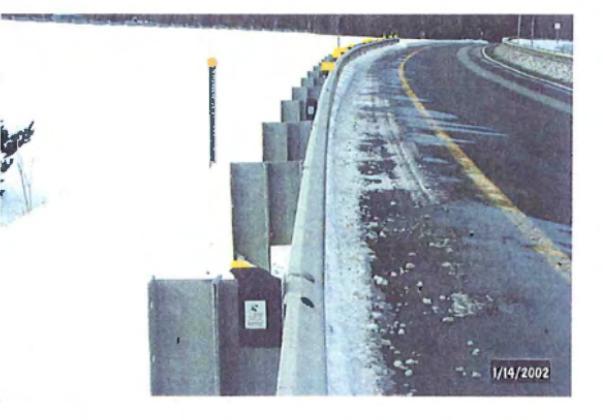
Figure 8. Shear failure above the spacer block.

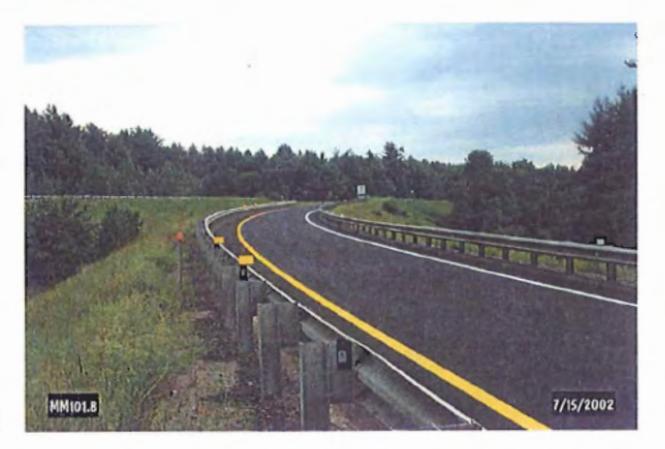
After 8 ½ months, only 40 markers remained affixed to the guardrail, 20 on both the right-hand and left-hand side of the ramp, resulting in a 57% loss. A final inspection in July 2002 revealed only 25 of the original 70 delineators were still attached to the steel guardrail spacer block.

After 13 months of service, only 36% of the Quik-Gard[®] guardrail delineators remained intact along the northbound entrance ramp to Interstate I-89 at Exit 7 in Berlin, Vermont. A combination of failures, occurring under various climatic conditions was likely attributed to the large loss seen in Figure 9, as well as routine maintenance activities during the winter season.

Figure 9. Northbound Ramp at Exit 7, I-89 (13 months after installation).
