INITIAL RESULTS OF VERMONT FIELD TRIALS OF WATERPROOFING MEMBRANES

R. I. FRASCOIA

VERMONT DEPARTMENT OF HIGHWAYS

FOR PRESENTATION AT THE FIFTY-THIRD ANNUAL MEETING HIGHWAY RESEARCH BOARD

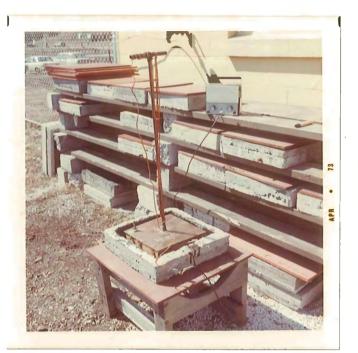
Laboratory and field applied membrane coatings are periodically checked for decreases in electrical resistance

Whenever possible, small samples of new membrane products are applied in the field to check the materials' tendency to pinhole or bubble and to obtain electrical resistance readings. Resistance tests on an impervious material should produce readings in excess of 500,000 ohms per square foot.

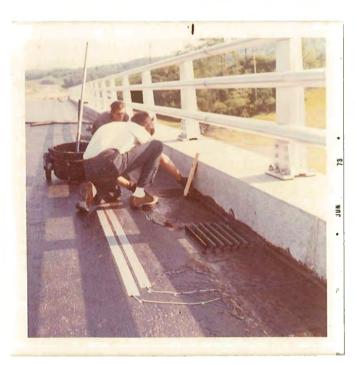
Copper foil strips placed beneath a membrane to detect the passage of moisture

Inspection during application has included the logging of pinholes, bubbles, or blisters, placement of moisture sensing copper foil strips beneath the membranes, electrical resistance testing and the application of each membrane system on 18 inch square concrete test slabs for future observation and testing.

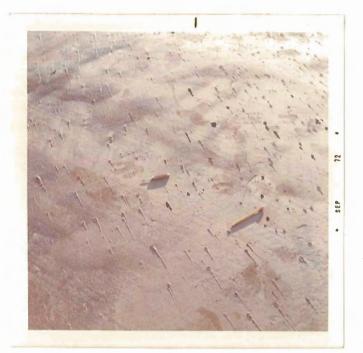
Air bubbles and craters in a cured polyurethane membrane. The type and number of holes and bubbles often varied with each application

In nearly all cases, applications of liquid applied materials were plagued by pinholes, air bubbles or blisters due to outgassing of air/or moisture vapor from the concrete. The condition is caused primarily by increases in air temperature or a reduction in the barometric pressure. The pinholes or craters do not always remain open to the concrete; however, this often depends upon conditions such as the weather which cannot be controlled or duplicated. Although close visual inspection or testing with hydrochloric acid may not reveal exposed concrete, electrical resistance tests will often indicate that a system is not impervious. It should be recognized that even if pinholes or craters are not initially open to the concrete, they are potential weak points due to the lack of cover and may act as funnels if the pinholes later open up. This could happen due to shrinkage of the coating from additional curing or aging.

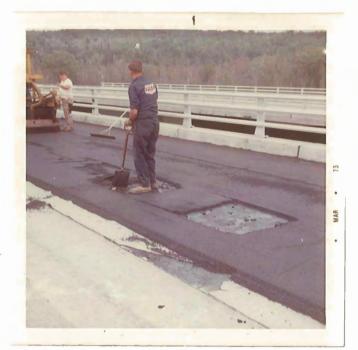
Lack of bond between roofing sheet and polyurethane caused blockage of the paver screed

(1) A two component modified polyurethane elastomer. The system includes a solvent thinned prime coat, 40 mil finish coat, and a roofing sheet protective overlay. Lack of bond between the roofing sheet and the polyurethane resulted in pavement application problems on the first of two decks. Quicker installation of the roofing sheet on the second deck prevented a recurrence of the problem; although, fishmouths occurred at periodic intervals along the edges of The polyurethane appeared to effectively seal the concrete along the the sheet. critical curb areas. Poor bond was noted between the prime and finish coats in one area. Pinholes and bubbles were noted in areas not covered with roofing sheets. Electrical resistance readings in such areas varied from an average of 60,000 ohms on one deck to over 2 million ohms per square foot on the second deck. Readings on the membrane with roofing sheet were generally satisfactory on both decks ranging between 1 million and 7 million ohms. Bubbles formed in coatings immersed in water for a 10 month period. Further use of the material is suspended until long term evaluations can be obtained.

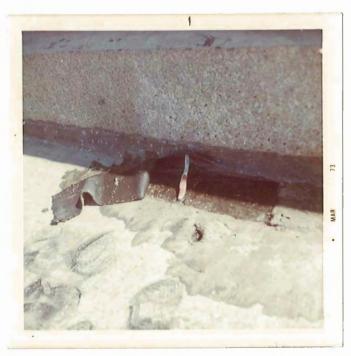
Water detected beneath top course of rubberized asphalt and rubber sheet along the base of the granite curb

(1) A hot-applied rubberized asphalt compound. The system includes a prime coat and rubber sheet used to reinforce the system along the curbs and over cracks or joints. The rubberized asphalt was applied by squeegee at the rate of one pound per square foot for an average thickness of 3/16 inch. Air bubbles were noted in the membrane on all applications, with visible areas of concrete often detected when individual bubbles were broken open for inspection. Generally, the material bonded well to the concrete; although, exceptions were noted. Water was able to enter the system and travel along the curbs beneath the membrane and rubber sheet on two of the four decks treated. Electrical resistance readings on the membrane were low, averaging 51,600 ohms per square foot. Softening of the membrane caused by the heat of the bituminous mix made the compaction of the first course of pavement difficult. Migration of the first course of pavement and membrane due to construction traffic necessitated the removal of the pavement from one deck. Lateral migration of the finish pavement has occurred on a bridge deck banked 15/16 inches per foot. The material should not be considered for use on bridges with excessive superelevation or grades over approximately 3%. Further use is suspended until long term evaluations can be obtained.

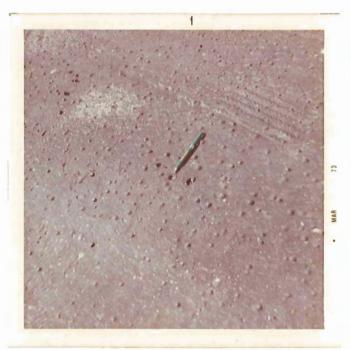
Visual checks of air bubbles in a hot applied rubberized asphalt disclosed that most were open to the concrete
