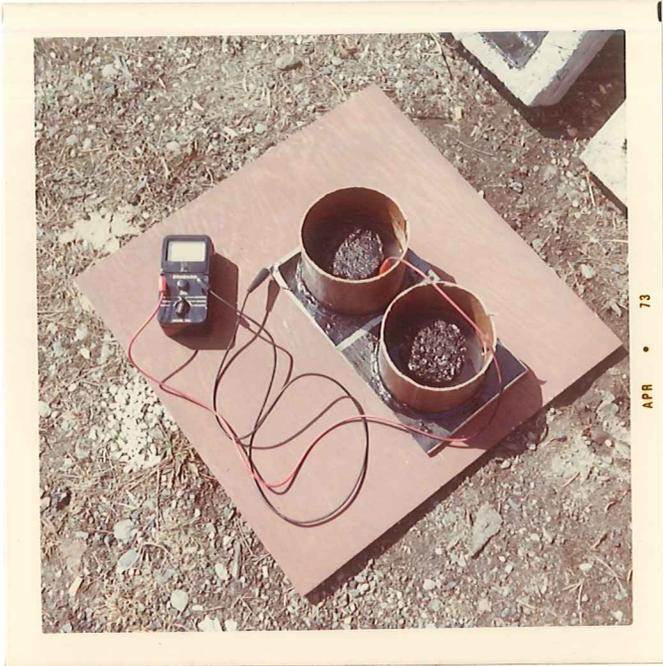
Puncture resistance of preformed sheet membranes being checked with an electrical resistance test

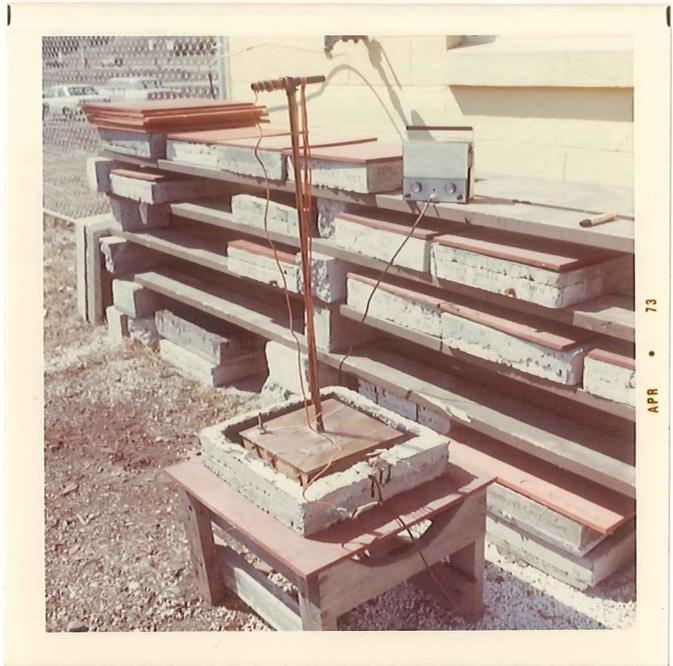
Laboratory and field applied membrane coatings are periodically checked for decreases in electrical resistance

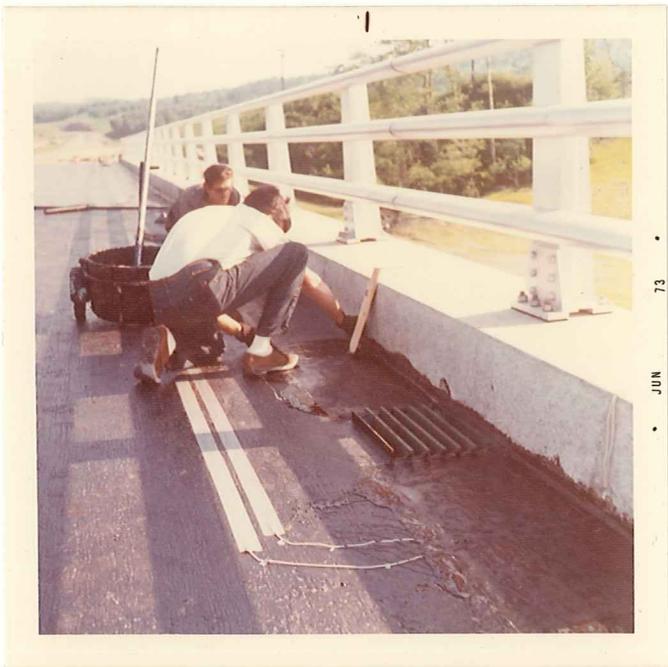
Copper foil strips placed beneath a membrane to detect the passage of moisture

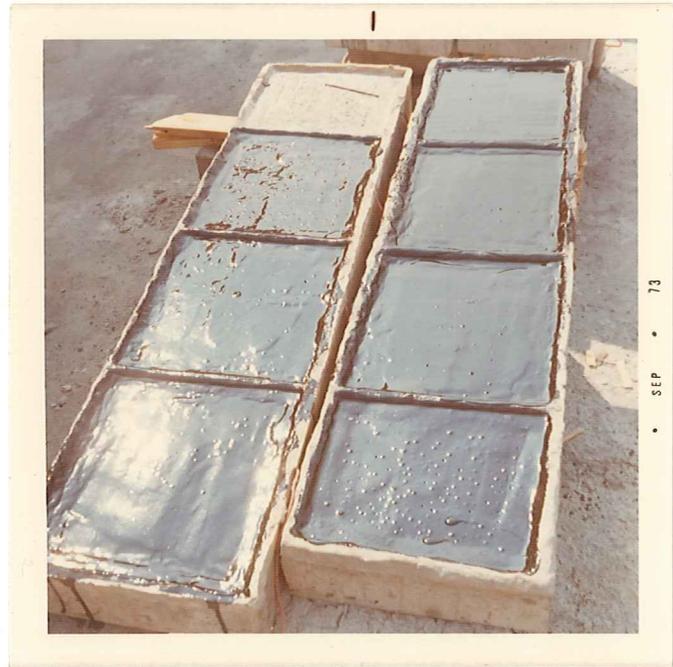
Two of eight concrete test slabs treated with liquid membrane products to study the relationship between pinholes and chloride intrusion

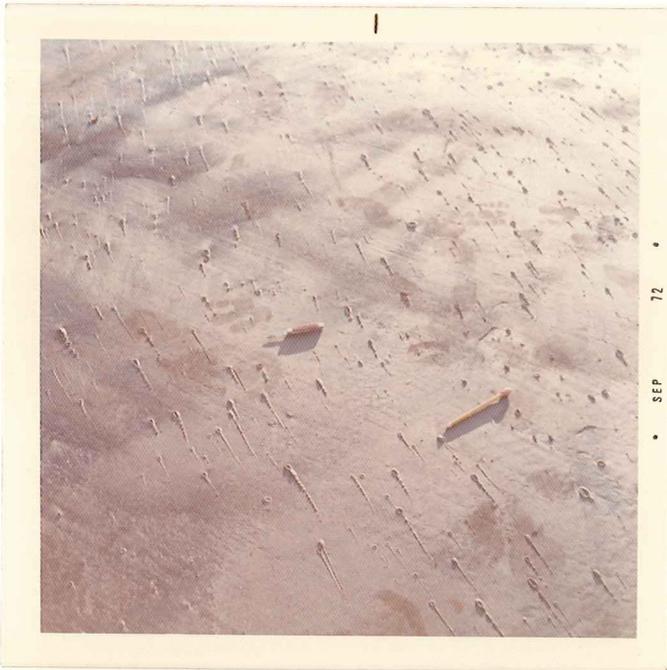
Air bubbles and craters in a cured polyurethane membrane. The type and number of holes and bubbles often varied with each application

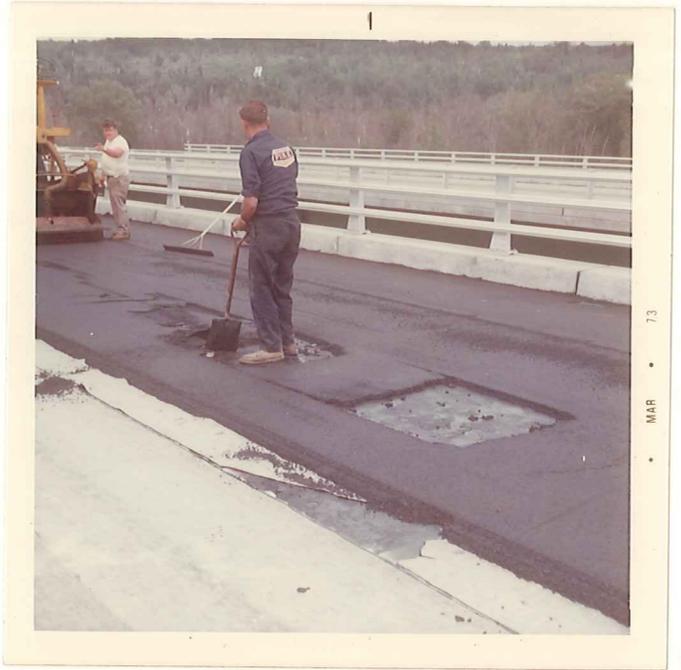
Lack of bond between roofing sheet and polyurethane caused blockage of the paver screed

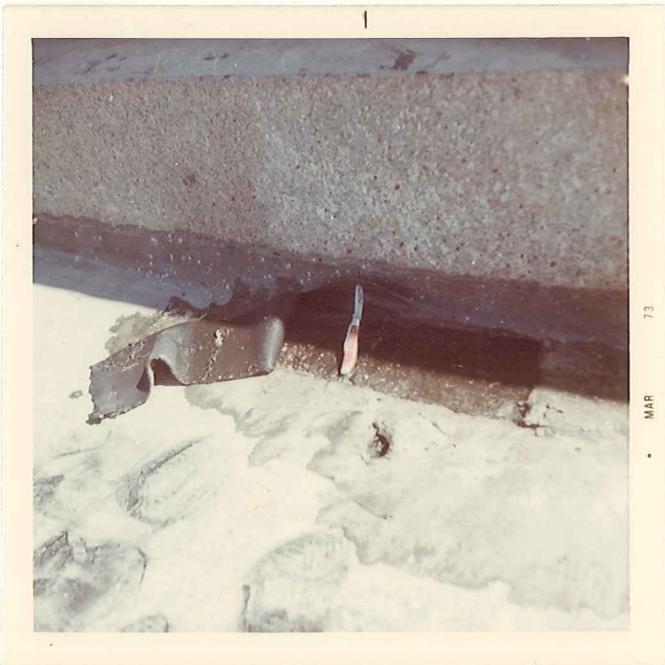
Water detected beneath top course of rubberized asphalt and rubber sheet along the base of the granite curb

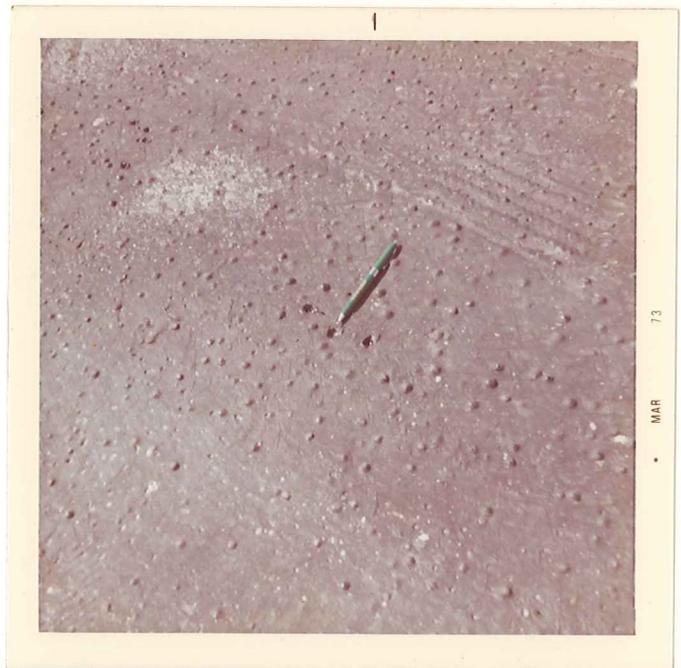
Visual checks of air bubbles in a hot applied rubberized asphalt disclosed that most were open to the concrete
