EXPERIMENTAL BRIDGE DECK MEMBRANE

APPLICATIONS IN VERMONT

REPORT 78-5

Project - Ryegate-Barnet I 91-2 (27) Stg. II

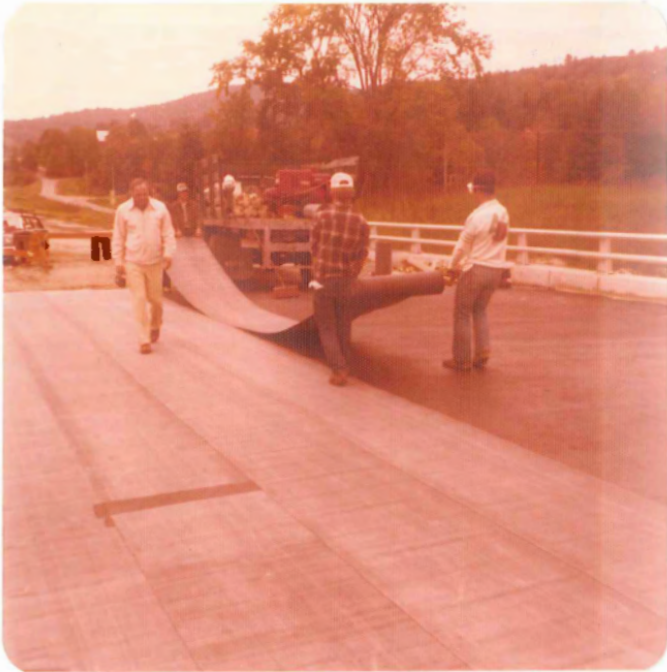
Placing Tri-Ply Membrane

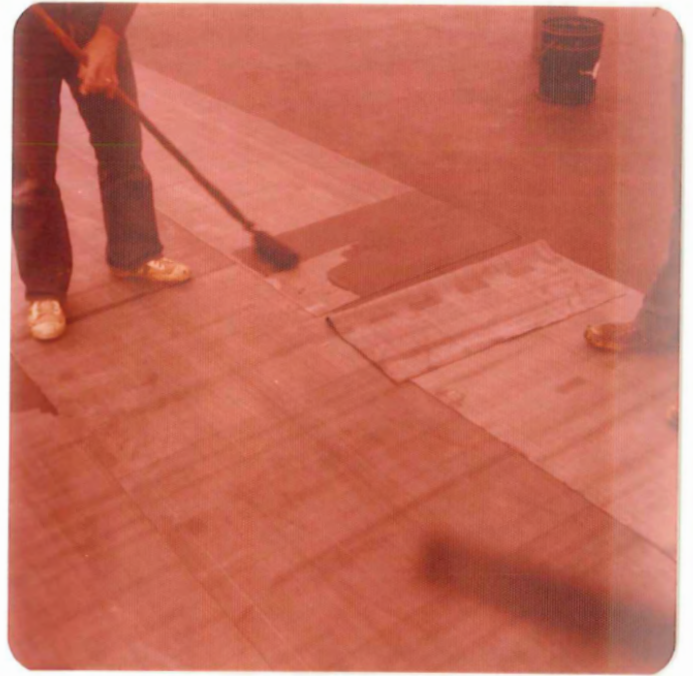
Priming Membrane at end laps

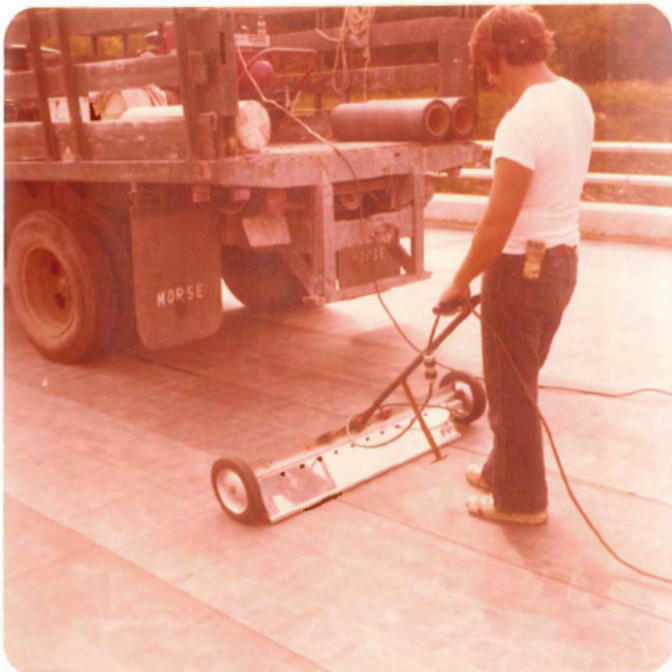
Heating Membrane to create
adhesion to concrete

12:45	67°	55°	Air bubbles noted beneath membrane where overlapped at butt joints.
2:00	57°	52°	Began heating membrane using a 44" by 12" 220 volt double probe heater run off a 5000 watt generator.

<u>Time</u>	<u>Air Temp.</u>	<u>% Humid.</u>	
2:25	70°	52°	Heating at a rate of 7 feet per min. Rate of 2 feet per minute resulted in greater adhesion to the concrete but caused some smoke to come from the membrane.
4:05	65°	58°	Heating complete on 1/3 of deck.
5:35	65°	71°	Completed heating remainder of deck in 1 1/2 hrs. by speeding up rate of movement.
6:00	59°	72°	Finished applying Bituthene mastic along edge of membrane at curb line and 5 gallons of RS-1 emulsion over membrane.

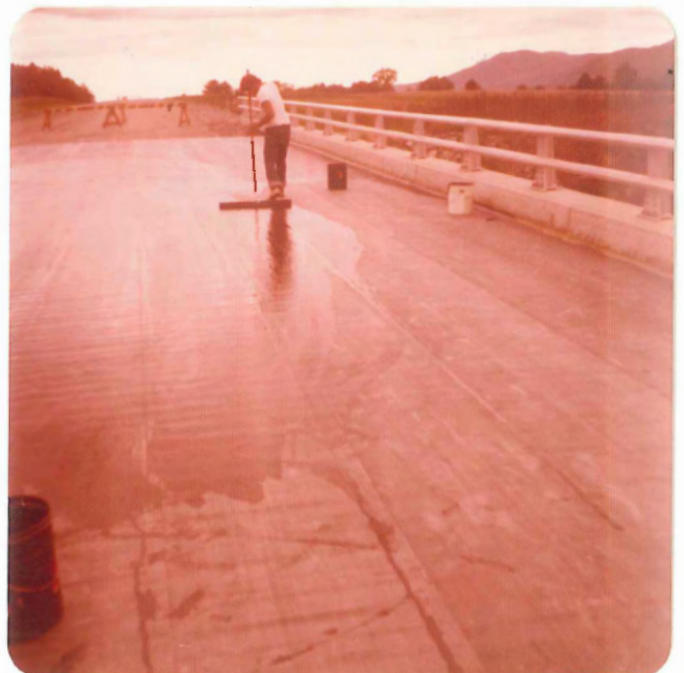
Applying RS-1 emulsion over
membrane

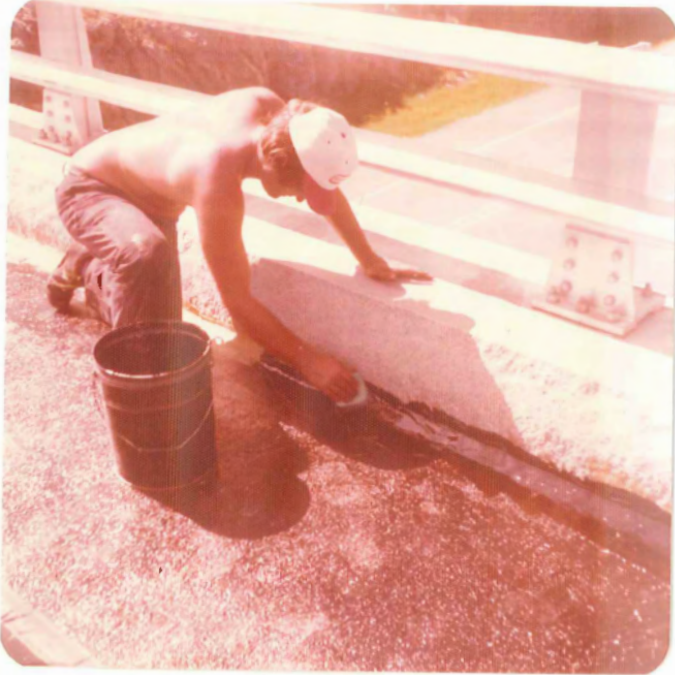
Placing Polyurethane Sealant
along curb line

<u>Time</u>	<u>Air Temp.</u>	<u>% Humid.</u>	
12:10	93°	54°	Application complete. Applying Duraflex M one-component polyurethane over edge of membrane at curb face. Membrane was cut over approach slab joint at northerly end of deck in order to allow proper compaction of pavement over the unsupported area.

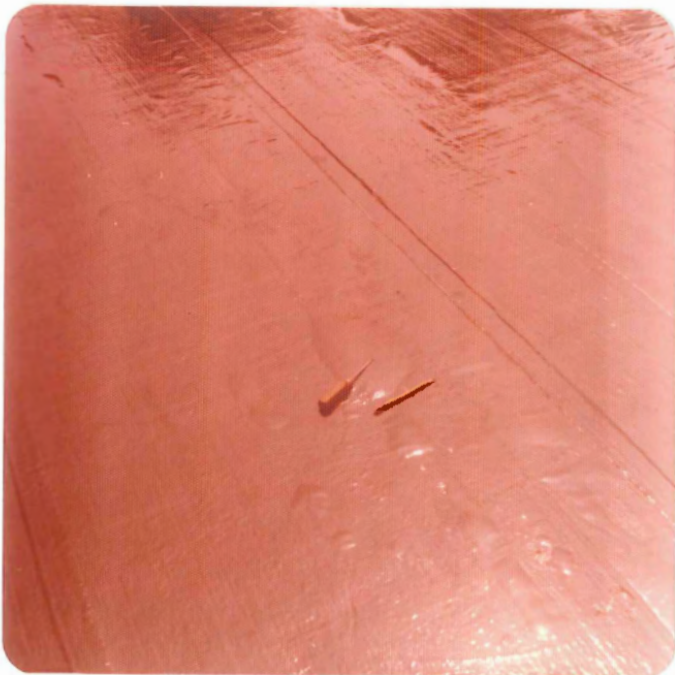
Air blister concentrations resulting
from compaction of the No. 10 membrane

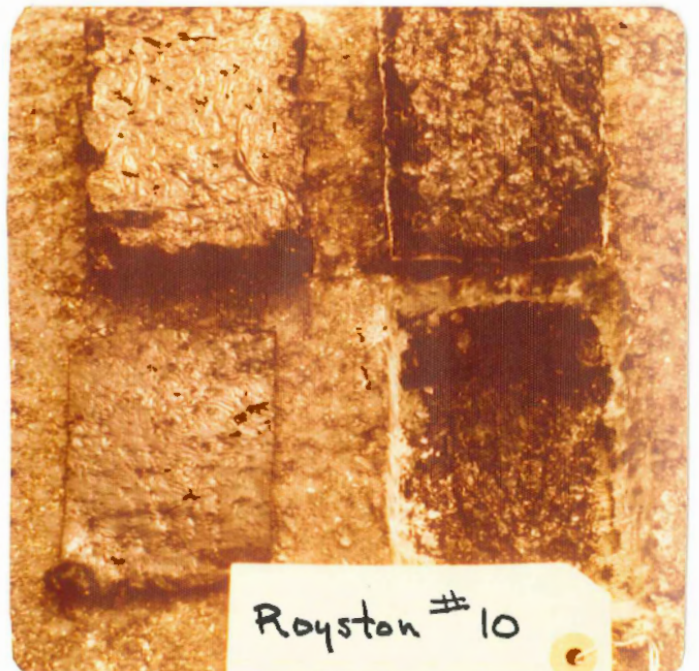
Removal of compacted pavement
revealed no damage to the membrane
