EXPERIMENTAL USE OF AN
ASPHALT RUBBER SURFACE TREATMENT
INITIAL REPORT 79-6

Category III Work Plan 79-R-6

SPRINGFIELD-WEATHERSFIELD IR-F 91-1(4)

STATE OF VERMONT
AGENCY OF TRANSPORTATION
MATERIALS & RESEARCH DIVISION

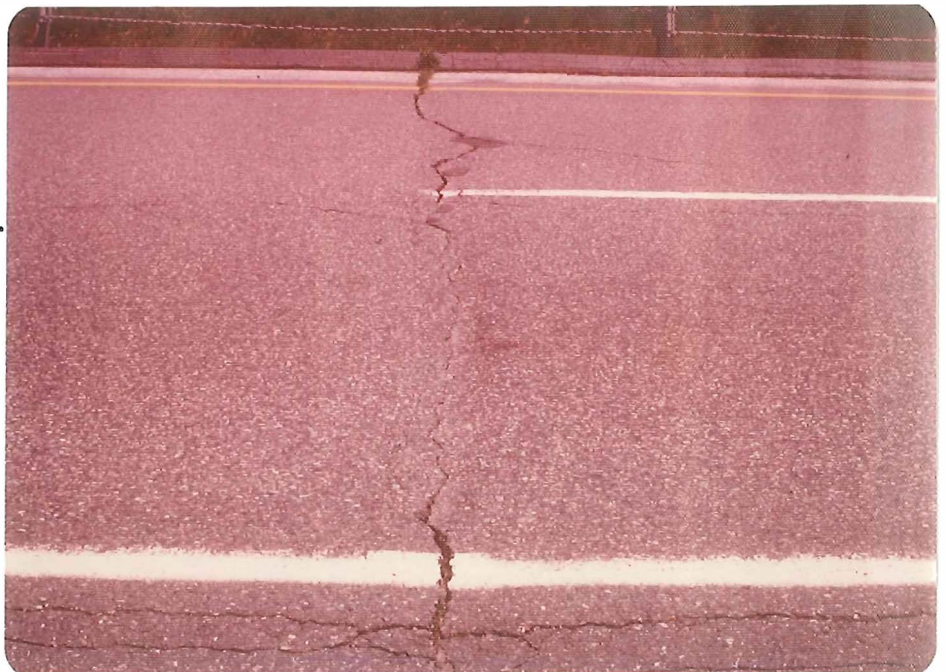
Pavement distress on SB experimental area. Note how traffic has sealed and depressed the pavement surface over the crack in the travel lane.

Pavement condition surveys made at five locations on the southbound lane revealed an average of 176 lineal feet of cracks per 100 lineal feet of 24 foot wide roadway. The type of cracks consisted of 49 percent longitudinal, 46 percent transverse, and 5 percent miscellaneous. However, it should be noted that miscellaneous cracks less than 18 inches in length were not included in the survey. The longitudinal cracks were generally located in the left wheel path of the travel lane varying from 1/8 to 1/2 inch in width with most in the 1/4 inch range. The transverse cracks were most severe averaging 5/8 inch in the passing lane by up to 2 measurable inches in depth and 1/4 inch wide in the travel lane.

The transverse cracks also exhibited a surface depression of up to 3/8 inch in depth by 1 1/2 inches in width at each edge of the wider cracks. Such depressions made the existence of the cracks apparent to the traveling public. It should also be noted that all crack width measurements were recorded in June during periods of relatively high ambient temperatures, therefore, such widths would increase significantly during colder weather.

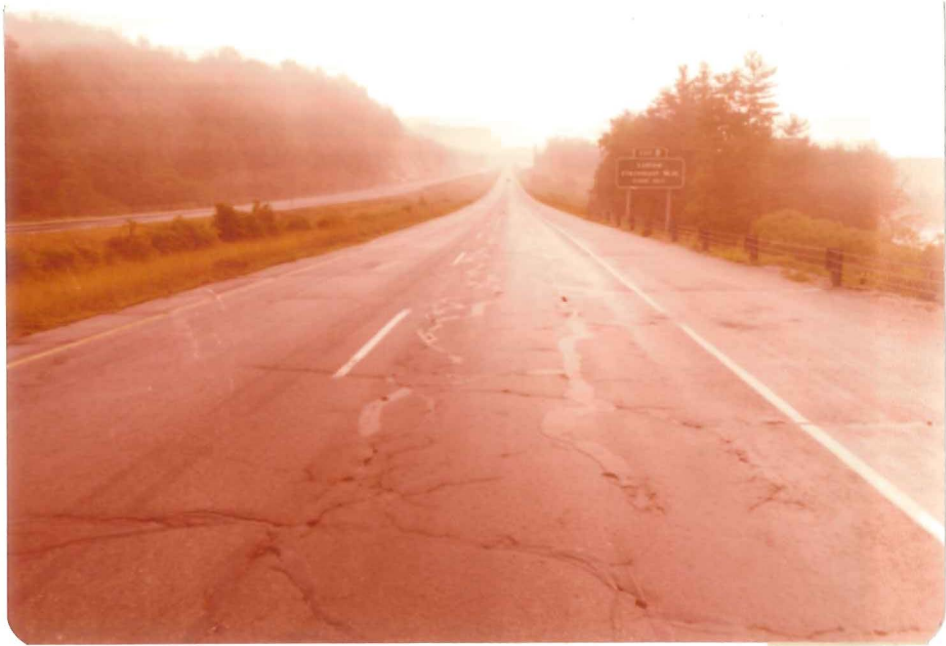
Severe pavement distress on crack filled NB control area.

Pavement condition surveys made at five locations on the northbound or control lane revealed greater pavement deterioration than that noted on the southbound lane. Cracking averaged 244 lineal feet per 100 lineal feet of

roadway with 48 percent longitudinal, 38 percent transverse, and 14 percent miscellaneous. Here again the transverse cracks were the most severe particularly in the passing lane where some were open to a depth of four inches.

The longitudinal cracks averaged $1/2$ inch in width and were generally located in either the left or both wheel paths of the travel lane. Such cracks together with numerous short adjacent longitudinal cracks (which were not included in the crack count) and occasional raveling gave the impression that a portion of the pavement failure was the result of inadequate base or subgrade support. Wheel path rutting averaged $5/8$ inch in the travel lane and $3/8$ inch in the passing lane.

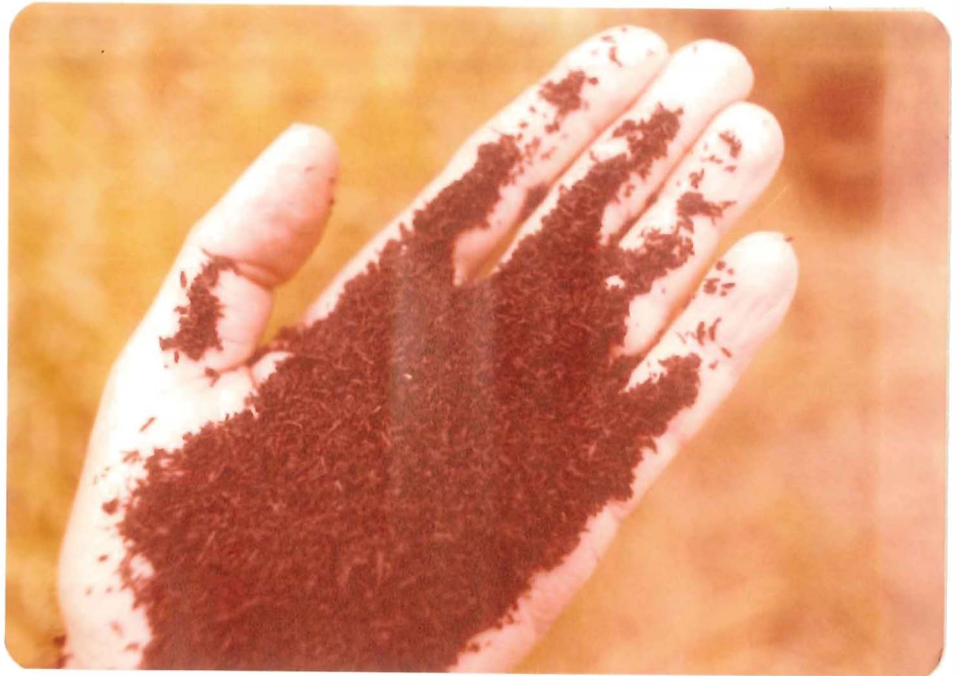
Crumb rubber
particle size

The same general procedure was followed each day. It began at approximately 4:00 A.M. with the transfer of 2500 to 2700 gallons of AC 10 asphalt from the tanker to the Sahuaro distributor. As the asphalt was taken on, the distributor's on board diesel heater was fired to bring the 260^o- 280^o F asphalt up to the desired 385^o F temperature. At the same time the pump was activated to circulate the material and prevent spot overheating. When the proper temperature was achieved, the burner was turned off and the vulcanized crumb rubber was manually added to each truck by means of a hopper and conveyor belt system. The amount of rubber added per load varied from 36 to 38 percent by weight of asphalt or an average of 26 percent of the total blend.

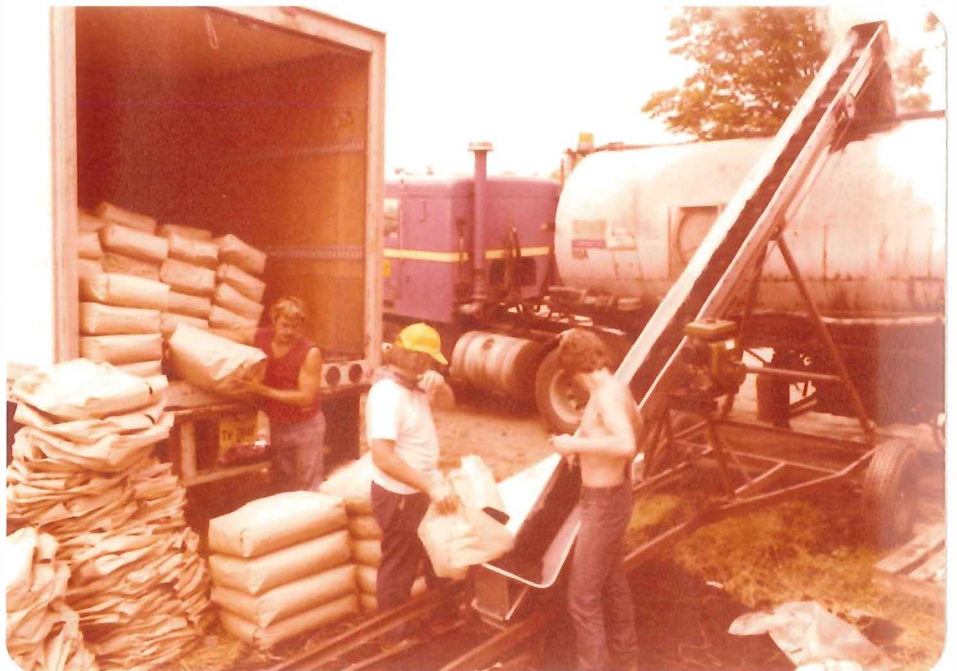
Introducing crumb
rubber by means
of a conveyor
system

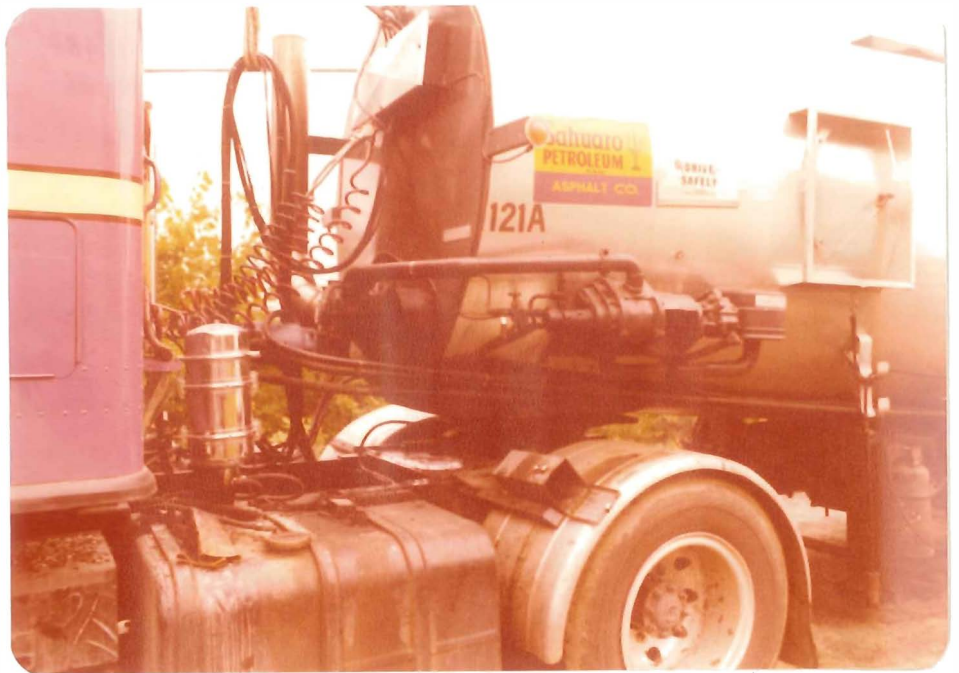
Mixing and heating
units on Bear Cat
Distributors.

It should be noted that the Bear Cat distributor trucks used by Sahuaro include a special equipment package required to mix and spray the viscous asphalt rubber material. The equipment includes a 5 cylinder 125 HP diesel engine used to power a mixing auger and heavy duty pump rather than the normal means of using a power take off from the truck engine. The special equipment by Bear Cat Manufacturing is a patented package made exclusively for Sahuaro.

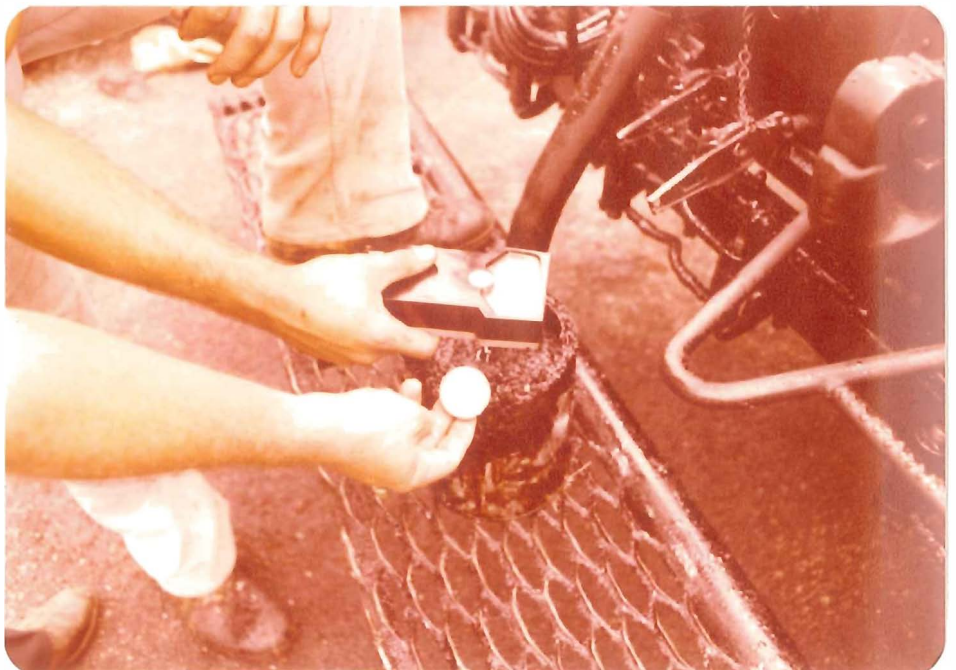
Measuring asphalt
rubber viscosity
following reaction
period.

As the rubber particles were being added, a chemical and physical reaction began between the asphalt and rubber causing the latter material to begin swelling to approximately twice its original volume. The rubber particles are also reported to become much softer and more elastic following the reaction with the asphalt. The testing carried out at Sahuaro's Laboratories indicated the asphalt rubber reaction would be complete approximately 100 minutes after one half of the rubber had been added to the distributor load. After sufficient time had elapsed, a sample of the asphalt rubber blend was drawn from the distributor and tested with a portable viscosimeter to insure that the material had reached a viscosity of 12,000 to 14,000 centipoises which would indicate the reaction was complete. After the reaction had been confirmed, the viscosity of the asphalt rubber mixture was reduced for spraying and for better wetting of the cover material by the addition of a diluent (AMSCO 140 solvent) at an average rate of 4.6 percent by volume of the hot asphalt rubber mixture. After additional recirculation, the mixture was resampled and checked to determine if the viscosity had been reduced to the desired 8,000 to 10,000 centipoise range. If satisfactory, the distributor was moved onto the project and the application begun. In most cases the mixing process ran smoothly on the 26 loads required to complete the project. The exception was an occasional load which required additional mixing time or rubber to reach the desired viscosity range or additional solvent to reduce the viscosity of the mixture.

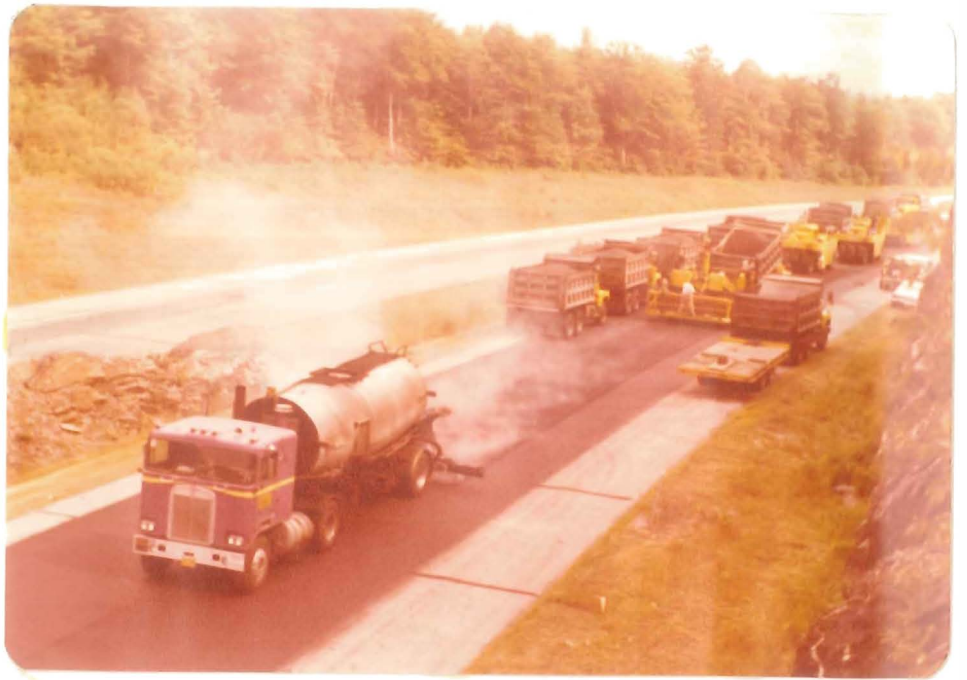
Application
train underway

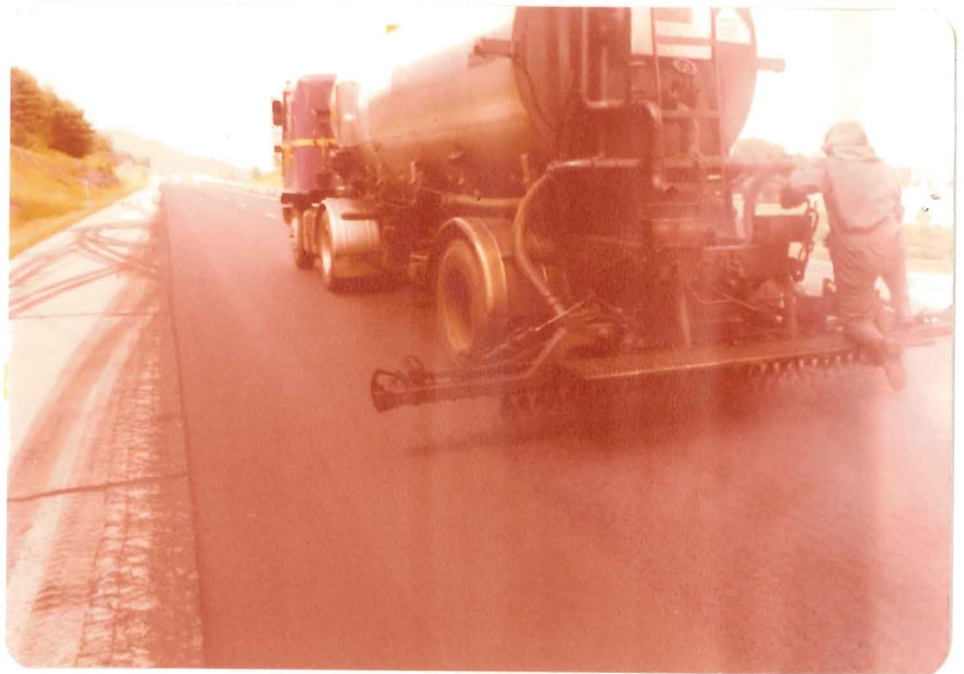
Spraybar
application

The distributor truck operator was responsible for obtaining the desired 0.60 gallon per square yard application rate on the road surface. On board monitoring equipment used to control the application rate included a gallon per minute meter which indicated the quantity of material being pumped off or circulated through the lines and a bitumeter or foot per minute gauge. Between shots while waiting for cover stone or when otherwise delayed, the operator could check the application rate obtained using onboard scales which constantly meter the reduction in load weight or by noting the location of the vernier float gauge on the side of the tank. With experience, the operator could also estimate the rate of application quite closely by noting the visual appearance of the asphalt rubber material fan beneath the spray bar jets.

The quality of the application was at least partially dependent upon the boot man stationed on the rear of the distributor. His duties included signaling the driver when to start and stop plus freeing any plugged jets which would otherwise result in skips in the coverage.

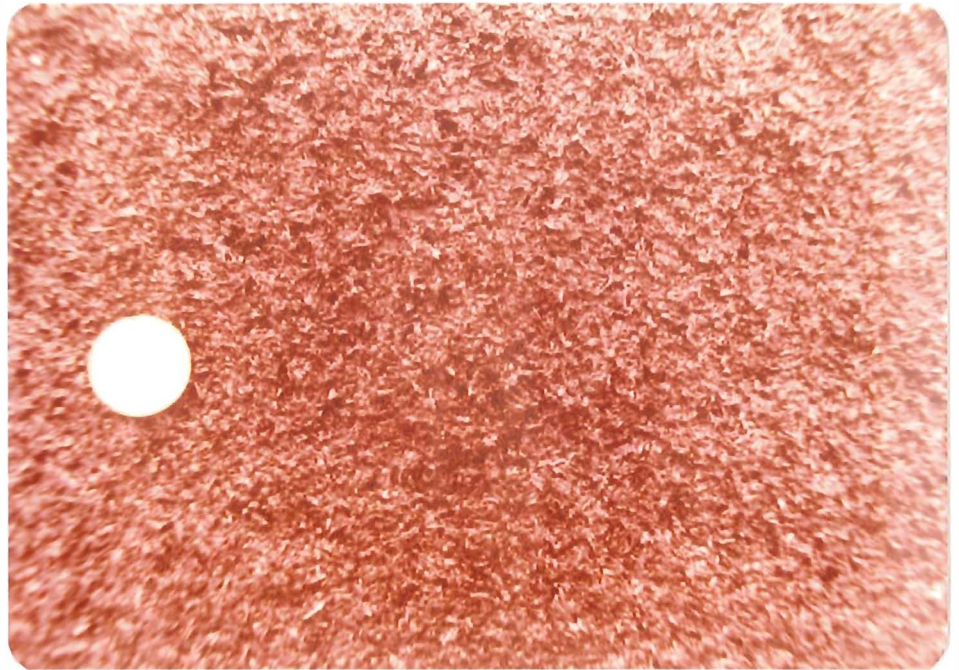
Texture of asphalt
rubber in place

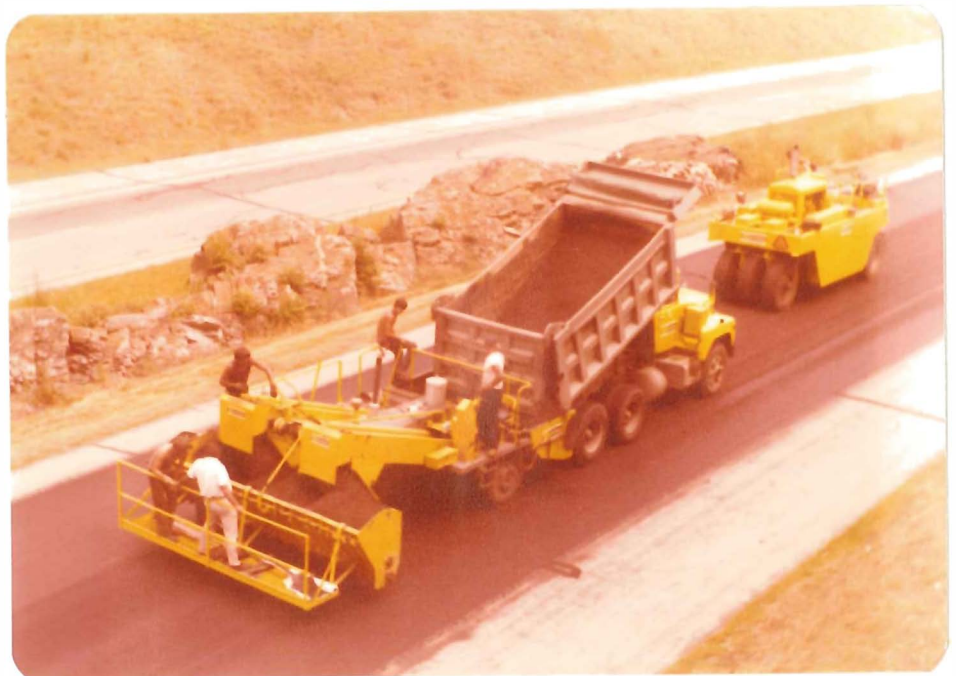
Cover stone
application and
roller operation

The application of cover stone was made with a self propelled Flarrity spreader box which closely followed the asphalt rubber application. The stone consisted of a crushed gravel which was preheated to a temperature of 180 °F - 240 °F and coated with an average of 0.4 percent asphalt at Whitcomb's Cold River, New Hampshire hot mix plant. A 3/8 inch maximum size stone was used on 8.4 miles of the treatment and 1/2 inch maximum size was used on the remaining one mile segment. The application rate varied until the operator and crew became familiar with the equipment and the amount of chips required. Occasional checks made on consecutive truck loads disclosed an average of 42 pounds of stone applied per square yard. Of that total, approximately 18 pounds or 43 percent was excess material which was removed during the vacuum brooming process. Although the application often appeared to be heavier than required, any significant reductions in the stone application rate always resulted in a bleed through and pick up of both asphalt rubber and stone by the tires on the equipment.

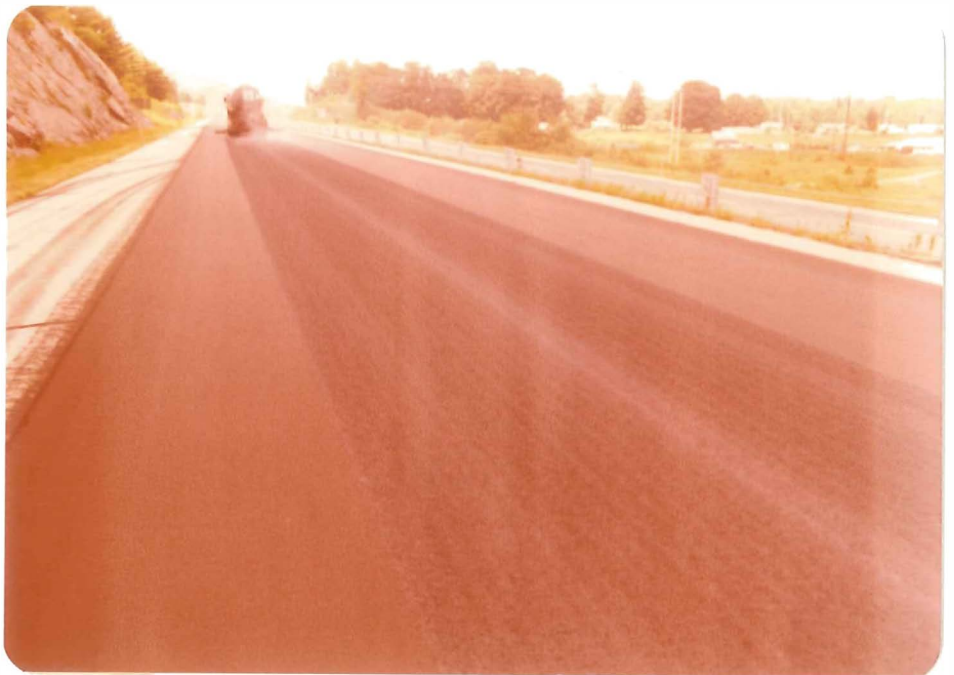
Streaks or ridges
in the asphalt
rubber application

sprayed on the pavement surface. The higher viscosities may have been caused by several factors including lower temperature or insufficient solvent resulting from evaporation following delays in the application. It is also possible that the condition was simply the result of too light an application rate. Few of the ridges remained visible following the application of the cover stone. Other imperfections included occasional voids caused by plugged jets and ridges along some of the longitudinal and butt joints.

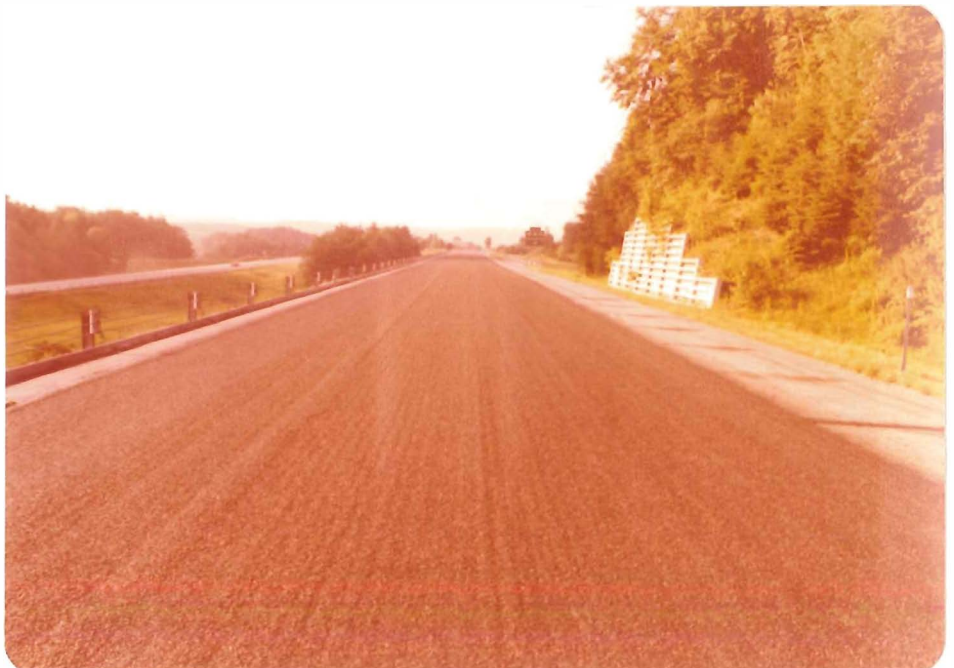
Streaks or ridges
in the cover stone

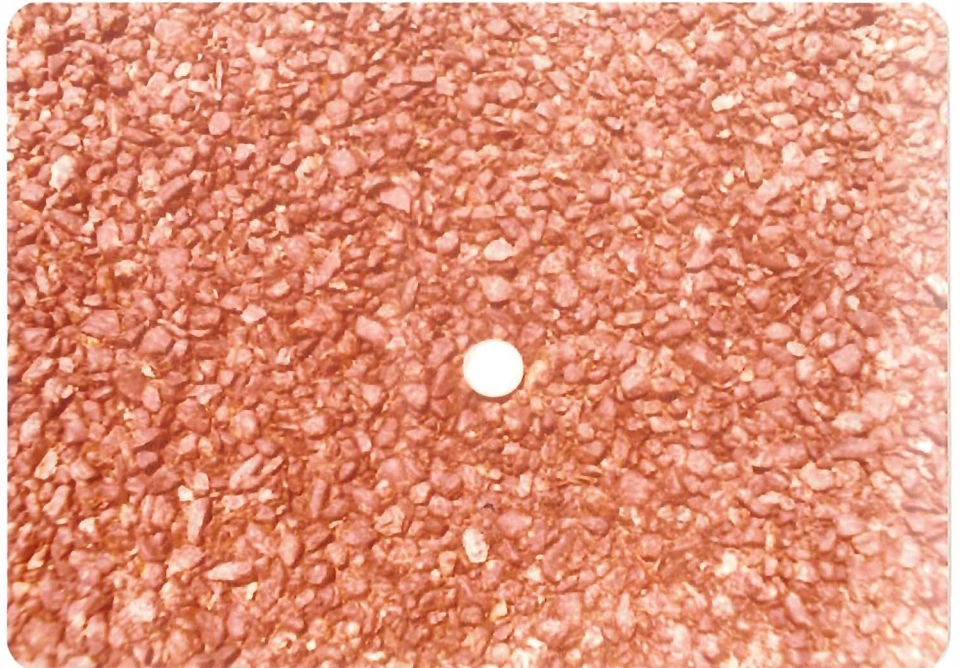
Typical surface
with 3/8 inch
cover stone .

The initial and long term retention of the cover stone is greatly effected by the depth of embedment in the asphalt rubber. The ideal condition would result in 50 percent embedment of the individual chips. Close inspection revealed a wide variation in the level of embedment depending on whether the asphalt rubber retained a single layer of stone or a combination of small and large stone. When the latter condition was noted, it often appeared that the smaller chips would be absorbed in the liquid, but in turn would prevent adequate embedment of the larger overlying stone. There were no significant visual differences in embedment between the areas treated with the 3/8 inch and 1/2 inch sized aggregate. Due to the absence of any flushing, the normal four to six pound per square yard application of blotting sand was not used.

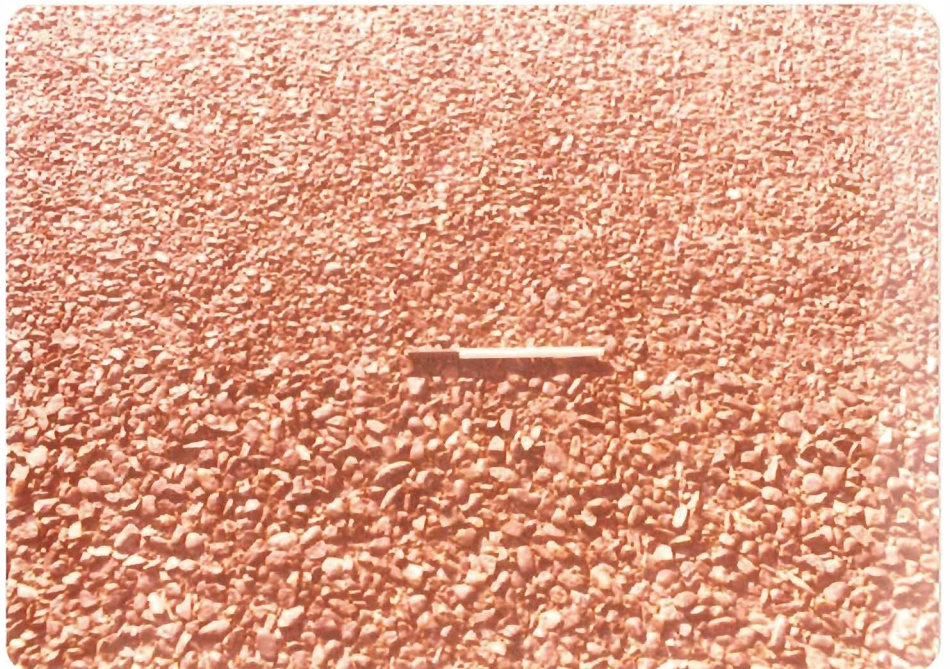
Abutting areas of
3/8 and 1/2 inch
cover stone.

The stone was applied over the full width of the asphalt rubber application and then the loose stone was power broomed off the edge of each strip prior to applying adjoining longitudinal passes of material. Coverage with the next pass of asphalt rubber included a lap of 3-6 inches onto the preceeding strip. Although necessary to insure complete coverage, the procedure often resulted in the formation of a longitudinal ridge or bump where the double application of asphalt rubber tended to retain a greater thickness of cover stone.

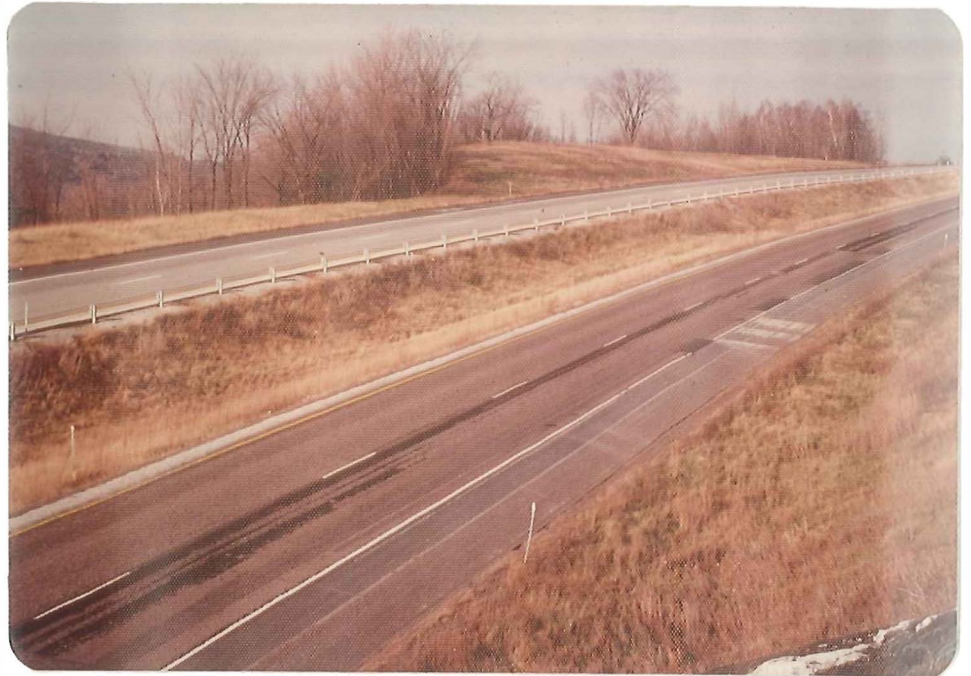
Loss of cover
stone photographed
on Dec. 11, 1979.

An inspection on December 11 revealed a nearly complete loss of stone over an area one to two feet wide adjacent to the centerline for 90 percent of the project length. Numerous other short bare strips were noted in the travel lane and a single strip was visible in the passing lane. The short strips occurred mainly in the areas where the distributor was approaching the end of a run. With the exception of the stone loss adjacent to the centerline, there were no bare spots within the areas where the spray application first started up. Up to 40 percent of the stone had been displaced at locations other than those which appeared bare. The remaining stones appeared well embedded when force was used to remove them and the coating on such stones appeared tacky and very much alive.

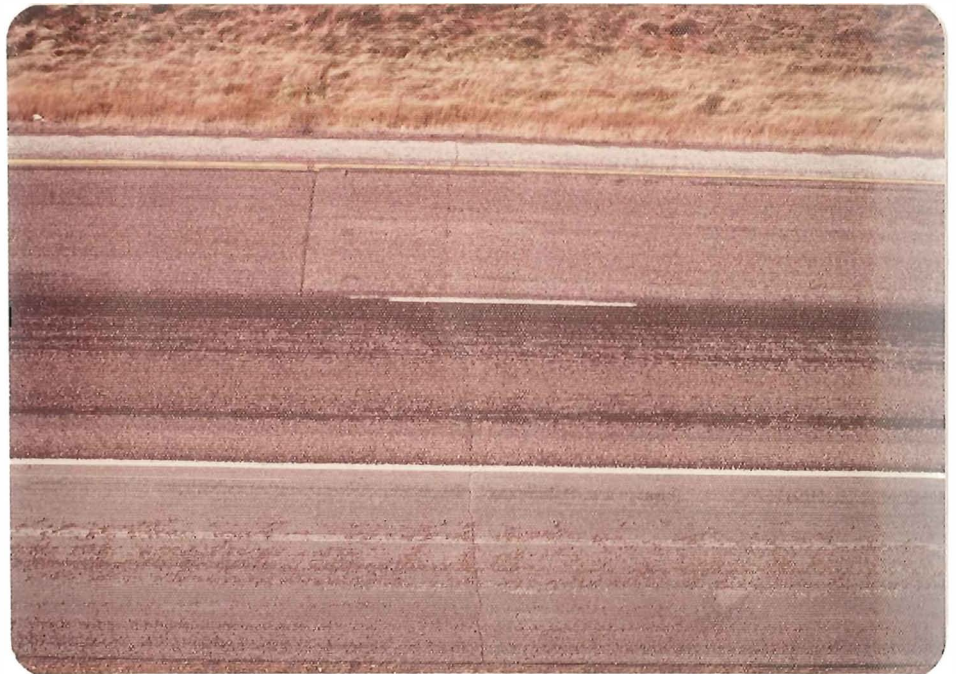
Note loss of cover
stone and transverse
cracks visible through
the surface treatment.

Three months of post construction observations have disclosed that the asphalt rubber surface treatment was not capable of preventing further deterioration of the pavement within the test area. Since stripping has occurred from the bottom up in the pavement placed over the SRI, it is likely that the areas which failed were in some stage of initial deterioration prior to the asphalt rubber application. It is also assumed that further deterioration will occur at other similar locations within the test section.
