EXPERIMENTAL USE OF HOT RECYCLED ASPHALT PAVEMENT IN VERMONT

INITIAL REPORT 82-3 FEBRUARY 1982

Reporting On Category III Work Plan 81-B&R-11

ESSEX-JERICHO-UNDERHILL FR 030-1 (11)

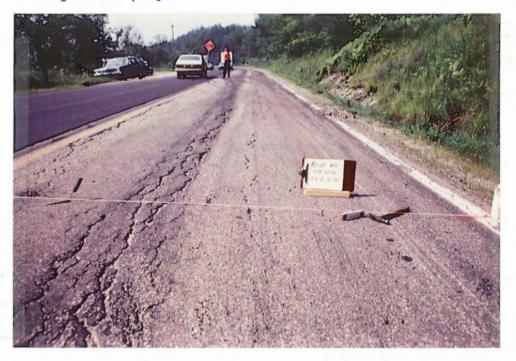
The cracks ranged from 1/8 inch to 1 1/2 inch in width with an average width of 1/4 inch. It should be noted that all crack width measurements were recorded in June during periods of relatively high ambient temperatures, therefore, such widths would increase significantly during colder weather. There were very few signs of surface raveling on the project.

The condition of the riding surface was fairly consistent over the length of the project with the exception of a few localized areas which were severely cracked and rutted. The latter failures all appeared to be base related. The roadway had been given a Pavement Serviceability Rating of 2.3 out of a possible maximum value of 5.0. Sufficiency ratings for structural condition including pavement condition, ranged from 19 to 29

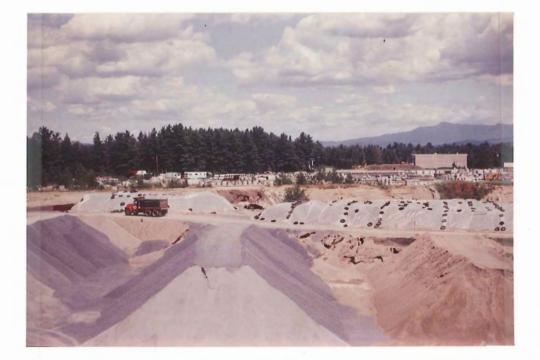
Figure 3 · Virgin Aggregate Stockpiles In Foreground Pavement Millings Covered With Plastic At Center

The cold planing method of reclaiming the pavement in thin lifts produced a very uniform gradation with less than 10 percent of the material exceeding a maximum size of $1\frac{1}{2}$ inches. An estimated 11,000 tons of material was stockpiled at the batch plant site. All material was covered with plastic sheeting which in turn was held in place with used tires. The treatment was successful in preventing moisture intrusion as evidenced by recorded moisture contents averaging 1/2 to 1 percent. The pavement millings did not fuse together to any serious degree while stockpiled up to 12 feet in height with ambient temperatures ranging up to $95^{0}F$.

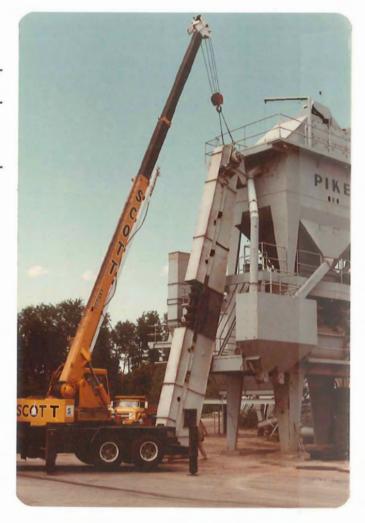
Figure 4 Installation of Elevator

Modification of the conventional plant was required to allow the introduction of the reclaimed pavement millings at the proper point within the production process. The method selected was the use of an HMT 24 Flow-boy Asphalt Transport body combined with an elevator conveyor system which transported the material to a hopper bin mounted on the plant. The plants automated controls introduced the material directly into the weight hopper as required.

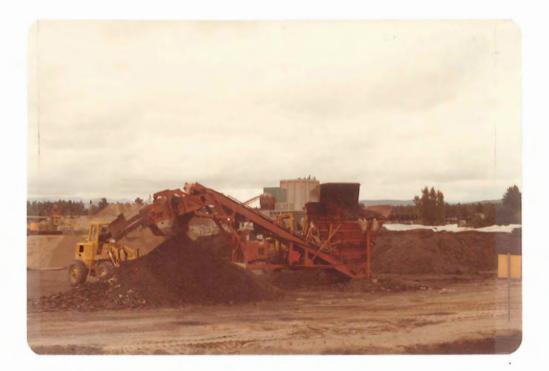
Figure 5 Removing Oversized Material by Screening

During the initial production stage, the millings were transported directly from the stockpile to the Flow-boy by bucket loader without any prior screening. This resulted in occasional clogging of the 5 1/2 inch x 6 1/2 inch grizzly screen mounted on the top of the Flow-boy or in the elevator conveyor system. To eliminate the problem, the millings were pre-screened through a conventional vibratory screening plant where materials over 1 1/2 inches in size were separated. The resulting gradation can be seen in Table 2 on page 16. The 5 to 10 percent oversized material was broken down further by manipulation of the loaders' buckets with the result that less than 5 percent of the millings were discarded.

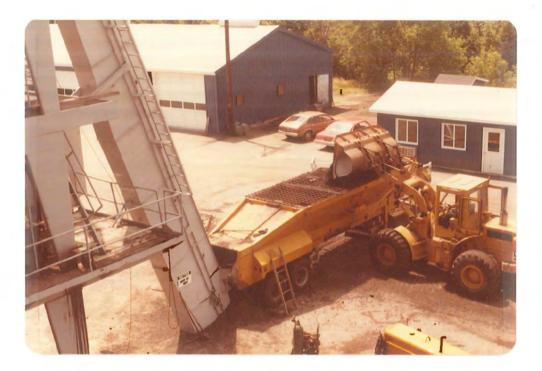
Figure 6 Feeding Reclaimed Material to Weight Hopper

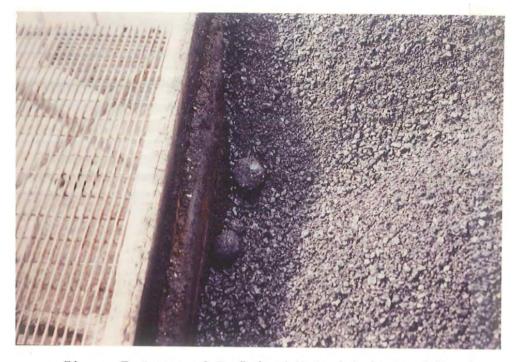
Figure 7 Lumps of Reclaimed Material in New Mix

The plant charging sequence consisted of the virgin coarse aggregate followed by the pavement millings with the virgin fine aggregate last. Initially, inspection of the mix in the trucks revealed occasional lumps of the pavement millings which had not broken down completely during the mixing process. Although there was concern that the lumps might cause problems when placed in a thin overlay, none were ever noted on the project which suggests the heat of the mix was sufficient to break down the particles over the longer period of exposure. After the contractor began screening the millings as a standard procedure, fewer lumps were noted although they were never completely eliminated from all of the mix produced.

Occasional lumps of pavement millings were observed in the trucks following batching but were never noted on the project which suggests the heat of the mix was sufficient to break down the particles over the longer period of exposure.

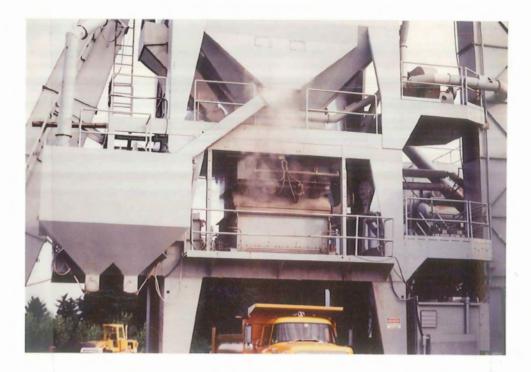
Figure 8 Normal Emissions At Pug Mill During Dry Mix Oycle

Visual emissions were kept to a minimum on the project and therefore air quality tests were not performed during the production of the recycled mix. As a rule, emissions were limited to the area of the pug mill and were similar to that occurring with the production of a virgin mix. Exceptions did occur when rain showers increased the moisture content of the pavement millings along the face of the stockpile. This resulted in venting of steam and some accompanying dust when the millings were mixed with the hot virgin aggregate. Less dust was produced in transporting the pavement millings from the stockpile to the point of use than that which occurred transporting the virgin aggregate.

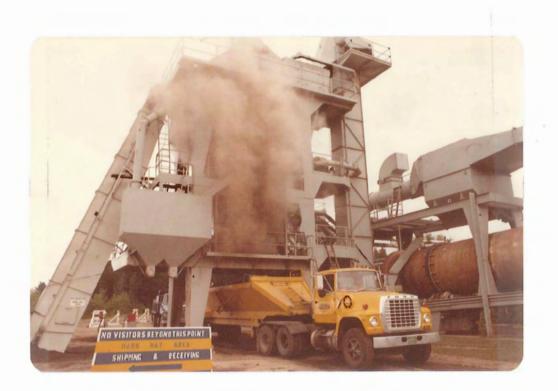
Figure 9 Maximum Emissions At Pug Mill Due To Venting Of Steam
