SOLAR ASSISTED HOT WATER SYSTEM

WATERFORD WELCOME CENTER

WATERFORD, VERMONT

FINAL REPORT 86-2
August, 1986

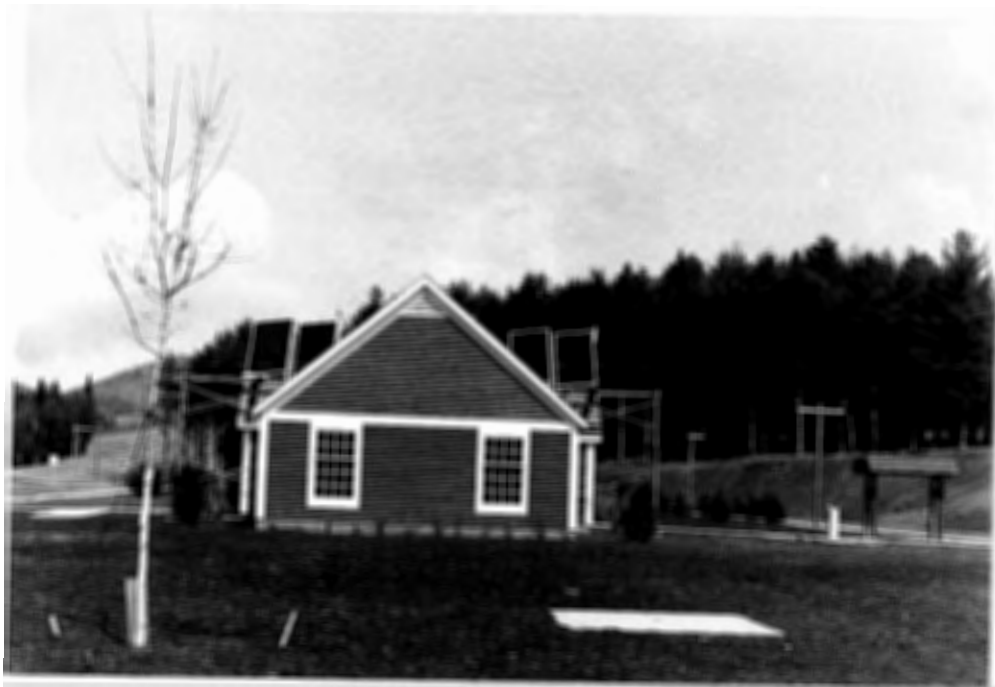
Welcome Center - Southern Exposure

The building has a floor area of $2200 \pm$ square feet of which 1670 square feet are devoted to public use. The longitudinal axis of the building is 10° east of due south. The southern roof exposures are on a 39.8° incline and free of shading. See site plan, Appendix B.

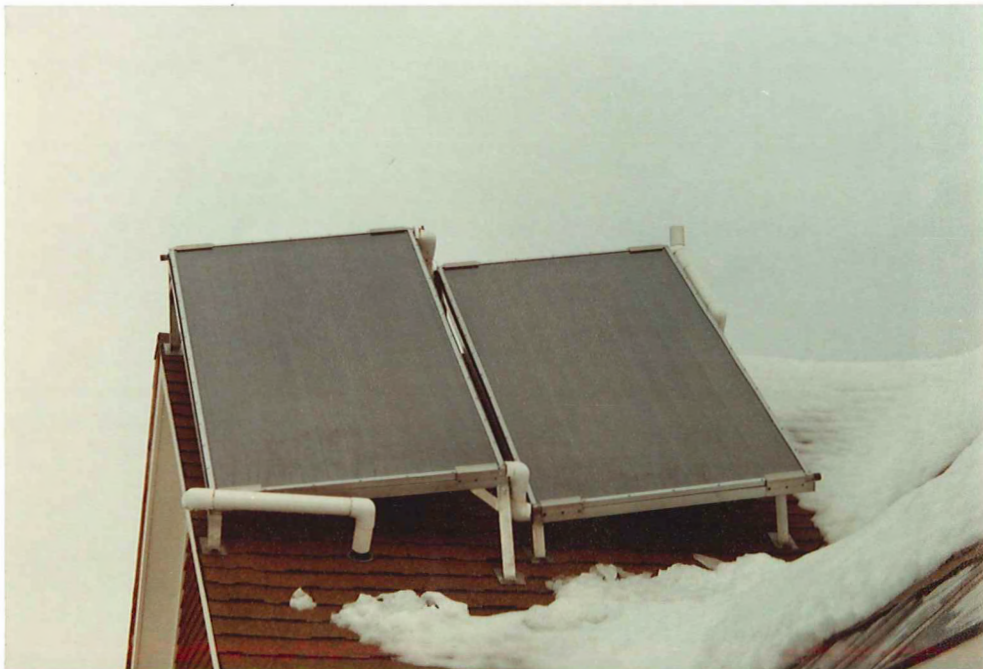
ROOF MOUNTED SOLAR PANELS

Panels were mounted in two separate banks of two panels each because of building design. The two banks were connected in series with the panels in each bank connected in parallel/reverse return.

Basically, the closed-loop system consists of four Grumman model #332A solar collectors, Grumman Sunstream CF-100A heat exchanger, X-trol #3 auxiliary pressure tank and Solarstream hot water heater tank. The closed-loop system used antifreeze to transfer heat from exterior mounted solar panels to the interior mounted heat exchanger where energy is transferred to the hot water system. This allows for year round operation. The collectors are 4' x 8', weighing 120 pounds per panel, insulated with 7.7 R value foam type insulation and single glazed with low iron tempered glass. Resulting transmissivity of the panel is 89%. Mounting brackets were manufactured to obtain ideal collection angles on the southern exposure roofs.

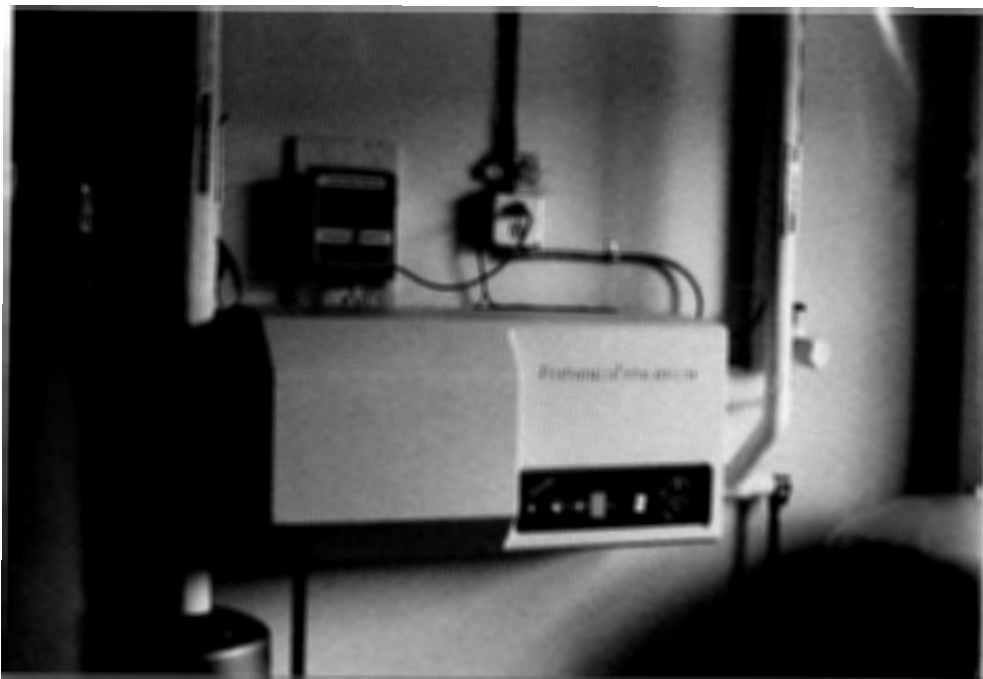
The Sunstream heat exchanger module consists of a double-wall, center flow heat exchanger which provides insurance against potable water contamination; two sealed, no-maintenance circulator pumps, one for collector fluid and one for water; an expansion tank; check valve; relief valve; C-30 differential temperature controller with high-temp cut off; two manual hose bibs for easy filling; solar loop pressure temperature gauge, three position operating mode switch and molded cover. Manufacturer's detailed description and schematic of the heat exchanger can be found in Appendix C.

SUNSTREAM HEAT EXCHANGER

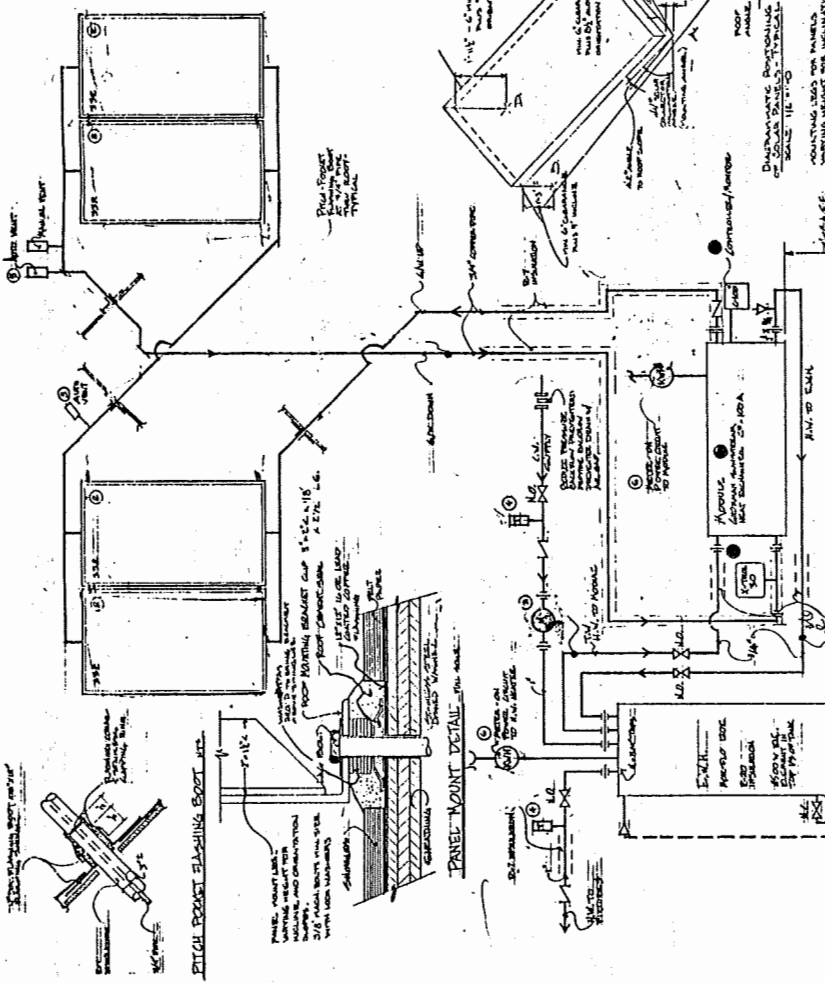
SCHEMATIC DIAGRAM 17

SEE DIAGRAM 21 - PLUMBING - FOR INTERFERENCE WITH BUILDING PLUMBING SYSTEMS

The hot water tank is a 120 gallon tank insulated to R-20. The top third can be heated with a backup 4500 watt electric element. The tank is tapped on top with four internal pipe legs of varied length extended into the tank to prescribed depths to gain maximum efficiency from the solar system. The system requires no other back-up. The Vermont Agency of Transportation plans of the hot water solar collector system are shown in Figure 1, page 7.

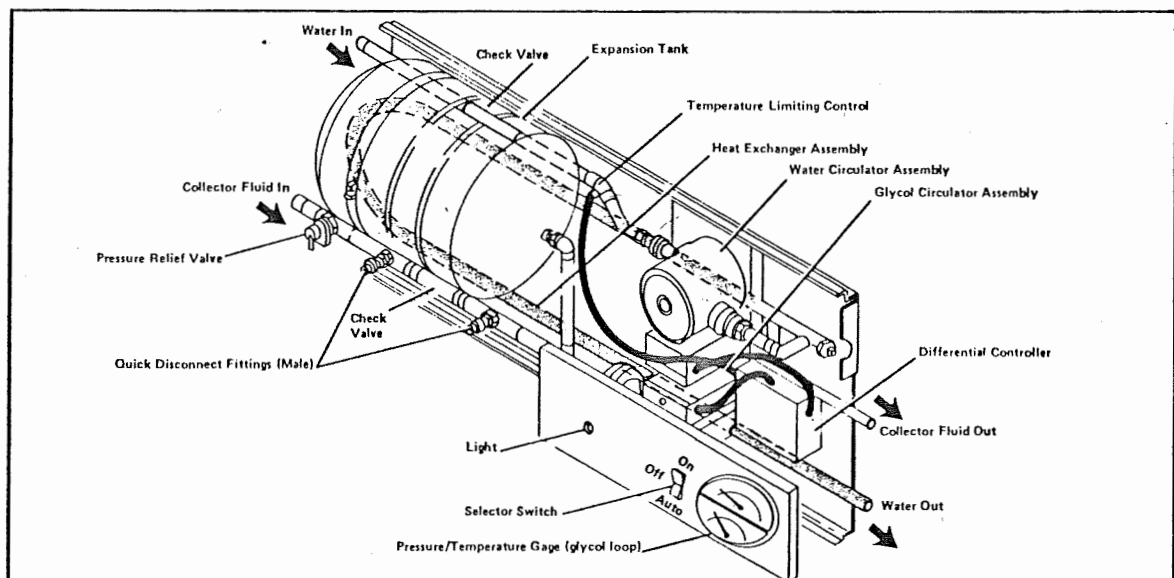
Figure 1. Model CF-100A Components

The counterflow heat exchange module contains:

- ☐ A highly efficient double-wall exchanger
- ☐ Two low-power circulators
- ☐ A differential controller
- ☐ An expansion tank
- ☐ A pressure/temperature gauge
- ☐ Necessary switches and valves

As indicated, the counterflow heat exchanger is constructed of three copper tubes fitted inside each other. Water flows in one direction through the center tube, which is rifled to increase heat transfer surface. An antifreeze solution moves in the opposite direction through parallel passages in the outer tube. Between the two are passages which provide leak detection and prevent any contamination of the potable water supply.
