EXPERIMENTAL USE OF COLD  
RECYCLED ASPHALT PAVEMENT ON  
VERMONT ROUTE 64

REPORT 88-2

REPORTING ON WORK PLAN 81-R-13

STATE OF VERMONT  
AGENCY OF TRANSPORTATION

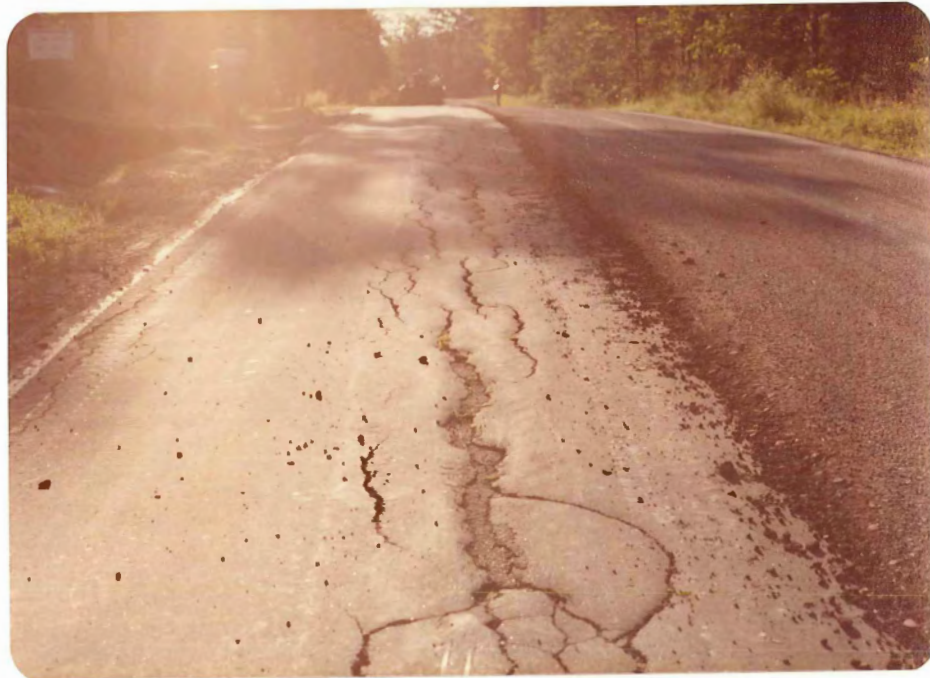
The photo above shows preconstruction condition (on the left) compared with the newly laid recycled pavement before sealing on the right.

Four locations were chosen as test sections to document the existing roadway condition. Each test section was 150' long and the combined lengths represented approximately 4% of the project length. Each section was analyzed for rutting and cracking. The rutting in the wheel path was between 4/16" and 15/16". There were 608 linear feet of cracks per 100' of road. Only one percent of the cracks were transverse. There were no transverse cracks that ran the entire width of the roadway which averaged 23.3'.

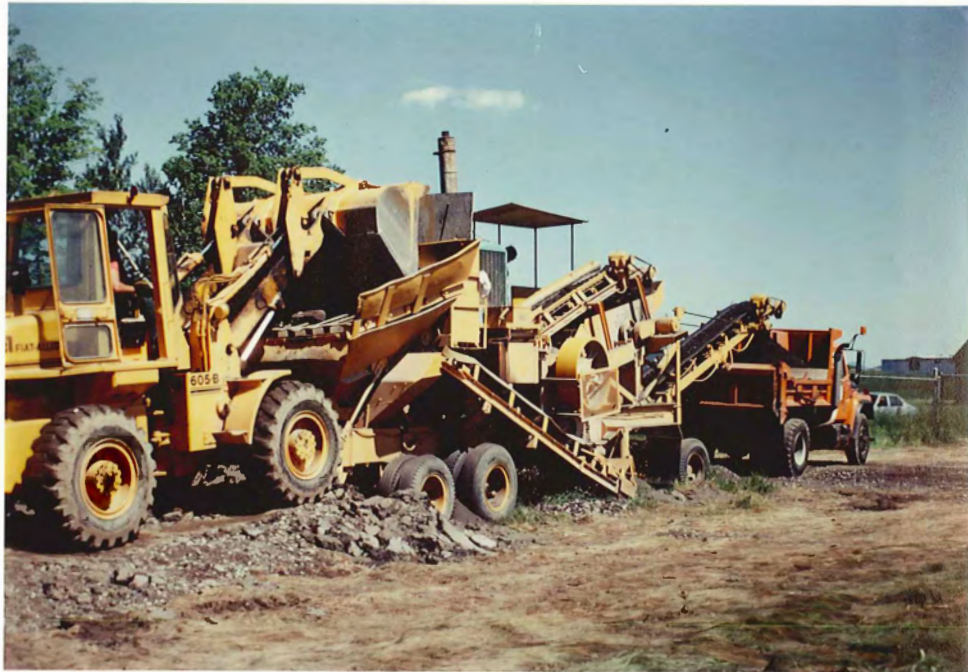
The portable crusher used to crush the airport material had a primary and a secondary system. Material was fed into the primary crusher which, using a screen and return belt, continually crushed material 2" and larger. Material smaller than 2" dropped into a secondary crusher which allowed only 1-1/2", or less, sized material to pass to the final conveyer belt. It was then emptied into an awaiting truck.

The crushing operation.

Crushing began during the second week of July. Initially some difficulty was encountered with large pieces jamming the hopper screen. This problem was solved by positioning two men with sledgehammers on a walkway to break apart the larger pieces.

Near the end of the crushing operation, the jaws of the crusher became worn. No adjustment was made immediately and this caused some material larger than 1 1/2" to be introduced into the stockpile.

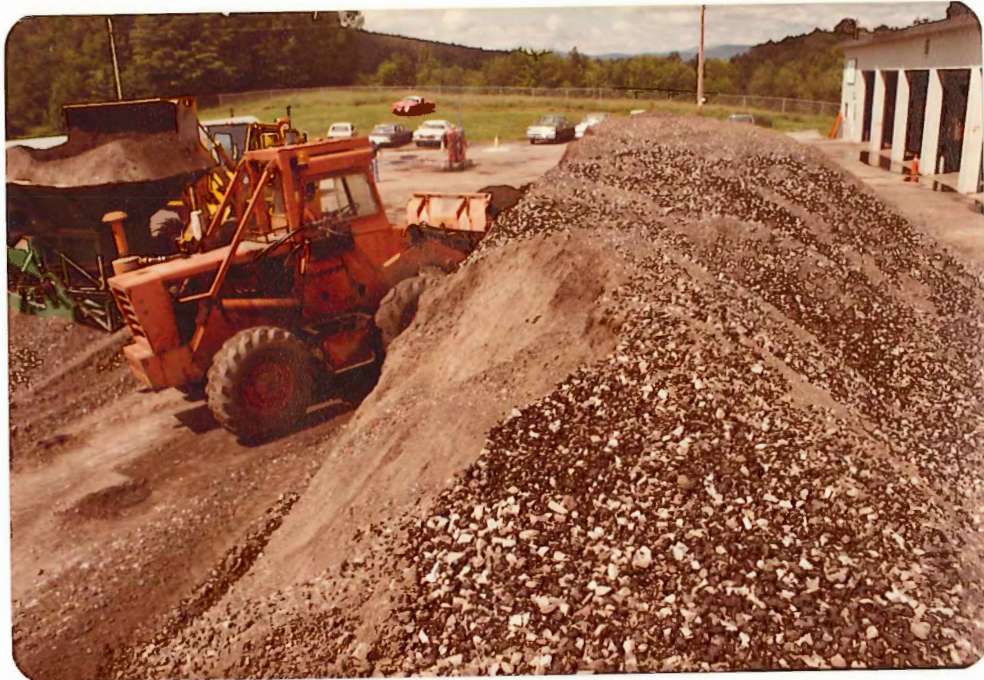
Stockpile of crushed material.

The material was hauled about 13 miles from the crusher to where it was stockpiled at a district garage near the project site. The crushing operation lasted 14 days and produced 2520 tons of material.

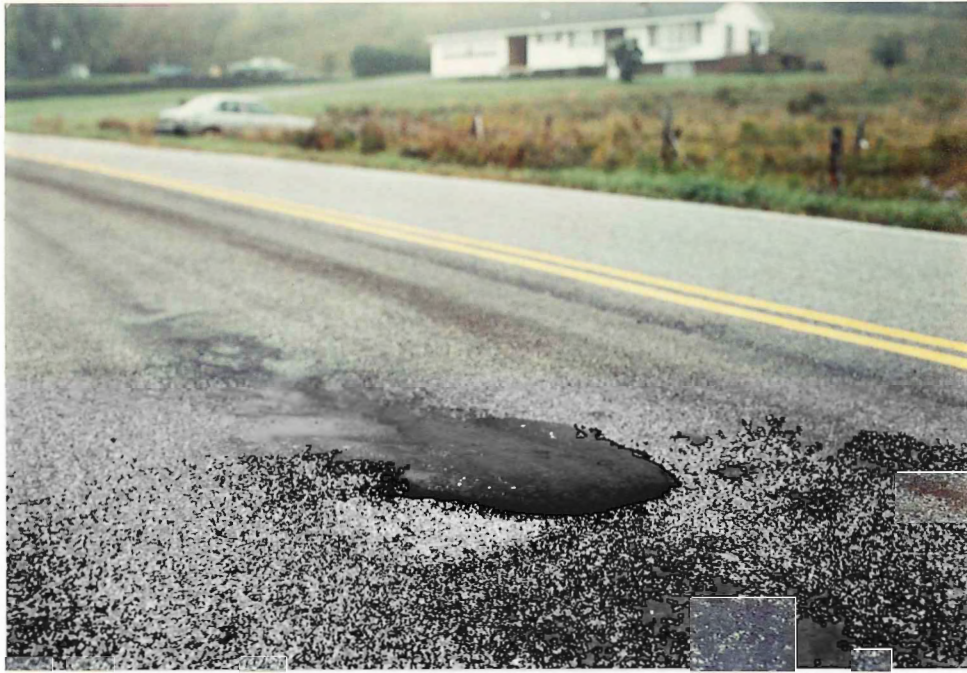
Two months after construction the shoving had become bad enough in spots to warrant corrective action (See next photo). One area of the project was overlaid with conventional hot mix to remedy the problem. This section is located in the vicinity of test section three, 1.8 mile east of the beginning of the project. The section is located on two steep grades of 6.4% and 10%.

This photo shows a patch which has been applied to correct shoving in the recycled pavement overlay.

Cold mix is usually left for several months to cure before the seal coat is applied. This allows the solvent to completely evaporate which in turn causes the asphalt binder to harden. The severe rutting on Mill Hill may have been due in part to a lack of sufficient curing time. The water in the emulsion did not evaporate before the mix was sealed, which slowed the hardening rate and led to shoving and rutting.

The hot mix that was used to overlay the sections of road that had shoved increased the cost of the project. This increased cost was applied only to the .4 mile section where the hot mix was actually placed. The cost for that section was \$3.68 per square yard.
