**Premark® 20/20 Flex High Skid Resistance Thermoplastic  
Williamstown, Vermont**

**April 2002  
Reporting on Work Plan 2000-R-4  
Initial Report**

State of Vermont  
Agency of Transportation  
Materials and Research

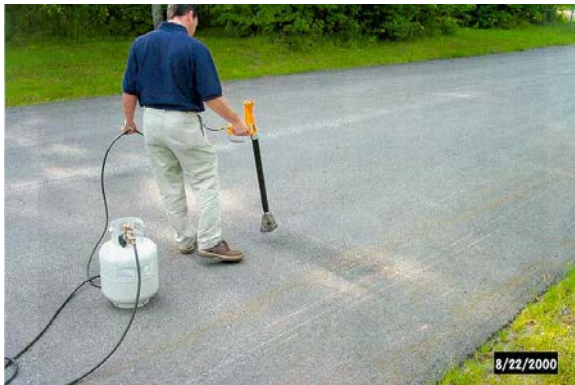
The installation process, as shown in Figures 2, 3, and 4, began by preheating the clean pavement surface. The purpose of this was twofold, to dry the surface and soften the asphalt binder in the bituminous pavement. The material was then placed over the preheated area and a torch passed over it until heated throughout and good adhesion was obtained.

**Figure 2.** Preheating pavement surface.

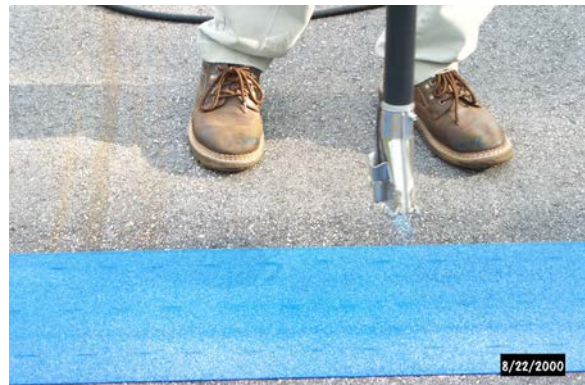
**Figure 3.** Heating preformed thermoplastic material.

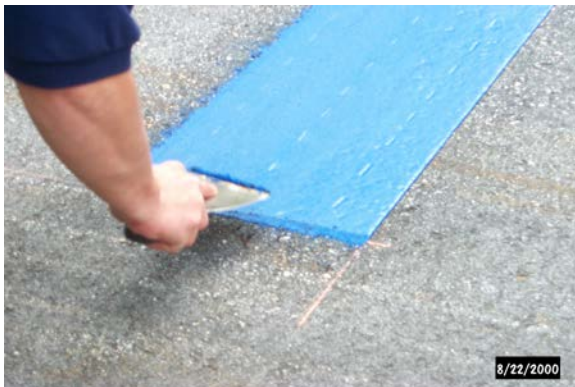
While the material was still soft, all four edges of Test Strip A and the northern, one foot wide edge, of Test Strip C were feathered with a straightedge to produce tapered faces with a maximum 1:1 slope. Test Strip B had no edges feathered.

**Figure 4.** Feathering edge of material.

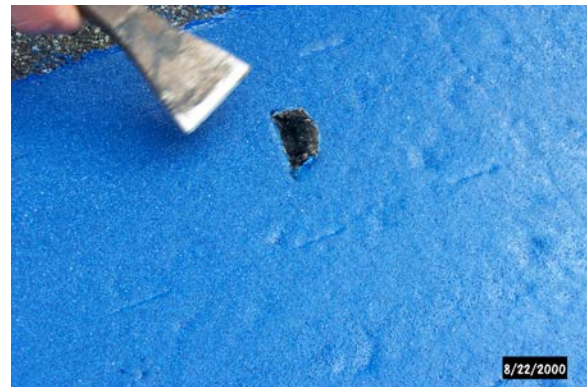
To check for adhesion of the thermoplastic material to the asphalt, a chisel test was performed on Test Strips A and B. After the material solidified, a small section was removed with a hammer and chisel, as shown in Figure 5. Both Test Strips A and B had asphalt adhering to the material when pulled up, indicating a bond between the pavement and the marking material. Placing the chiseled piece back in place and heating it with the torch resealed these areas.

**Figure 5.** Chisel test.

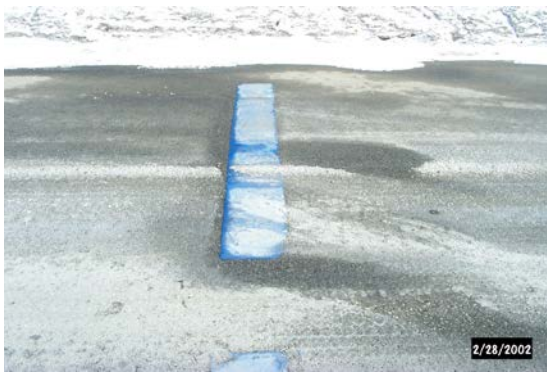
**Figure 6.** Markings prior to cleaning.

Readings collected in February 2002 were done in accordance with a test procedure created by the Vermont Agency of Transportation, Materials and Research Section. The procedure, designed to allow for the collection of retroreflectivity data in cold weather climates, includes a cleaning procedure and a manufactured Plexiglas™ box supplied with a heat source to generate a minimum ambient air temperature of 40°F as specified in ASTM E1710-97. Figures 6 and 7 show the markings before and after the cleaning process, respectively. And, the testing apparatus is shown in Figures 8 and 9.

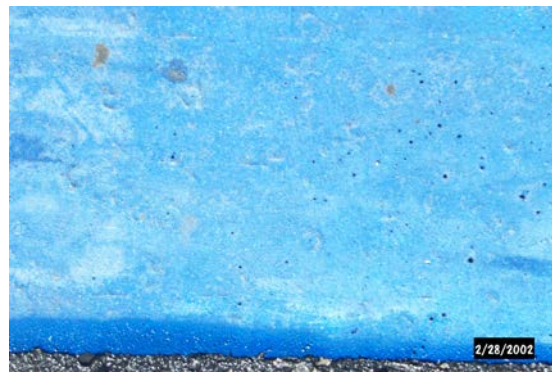
**Figure 7.** Markings after swept, washed, and dried.

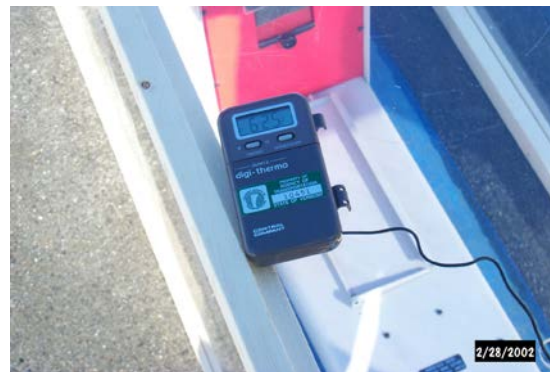
**Figure 9.** Temperature reading within Plexiglas™ box.

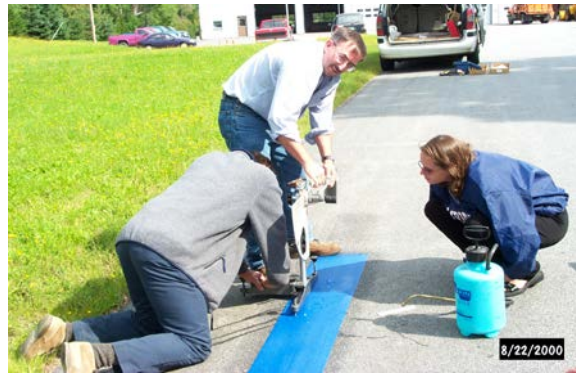
Skid resistance values were collected, as shown in Figure 10, using a British Pendulum Tester following the procedure outlined in ASTM E303-93. Values collected are presented in Table 2. MASTRAD, Quality & Test Systems in Bardsey Leeds, United Kingdom, calibrated the instrument in October 2001. Refer to Appendix A for a copy of the calibration test certificate.

**Figure 10. Skid test with British Pendulum Tester.**

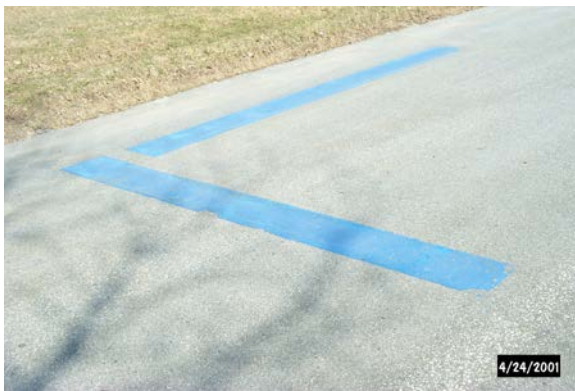
After eight months of service, including one winter maintenance season, the 125 mil thick preformed thermoplastic marking material remained well intact. Test Strip A, with all four edges feathered and placed perpendicular to the traffic flow, exhibited the most distress. As seen in Figures 11 and 13, the south edge of the material and two corners experienced chipping. Test Strip B, placed adjacent to Test Strip A and perpendicular to traffic flow, had no edges feathered and showed similar signs of distress in the same locations but of a lesser degree, as shown in Figures 12 and 14. Test Strip C, with only the northern one-foot edge feathered, and placed parallel to traffic flow experienced little distress with only one corner chipped, as shown in Figure 11.

**Figure 11.** Test Strip A and C after eight months.

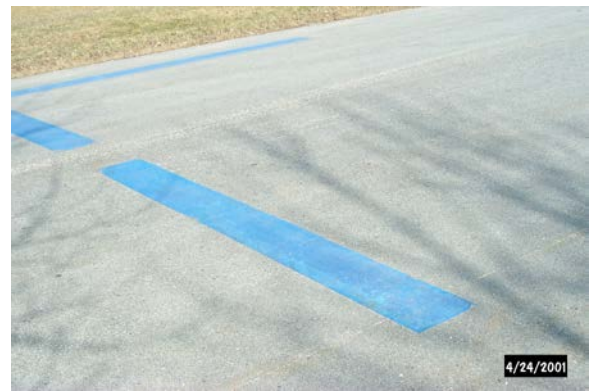
**Figure 12.** Test Strip B after eight months.

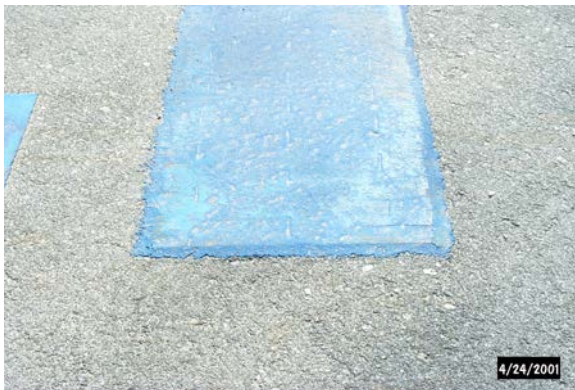
**Figure 13.** Test Strip A (west end) with feathered edge after eight months.

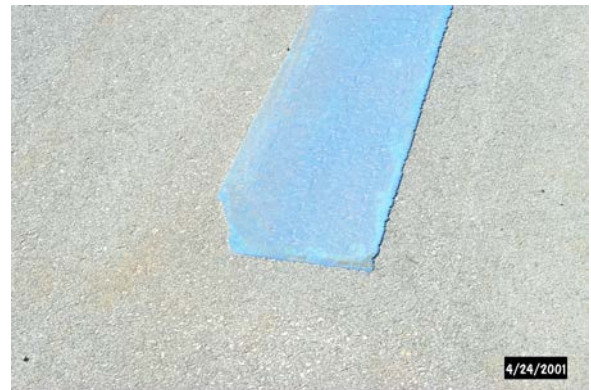
**Figure 14.** Test Strip B (west end) without feathered edge after eight months.

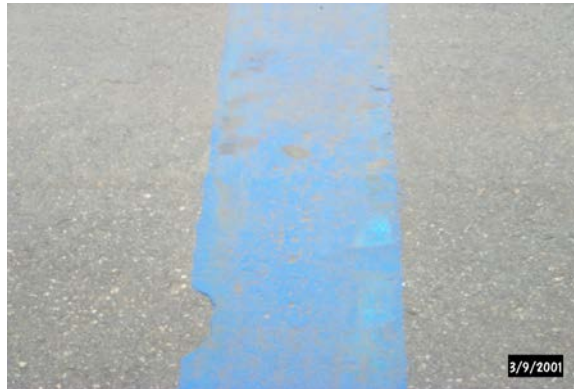
During a site visit in March 2001, it was observed that the abrasive characteristics of the material allowed for small particles of sand to be lodged within the marking material as shown in Figure 15. Future site visits revealed that the sand residual washed out over time with the rain.

**Figure 15.** Sand particles lodged in material.

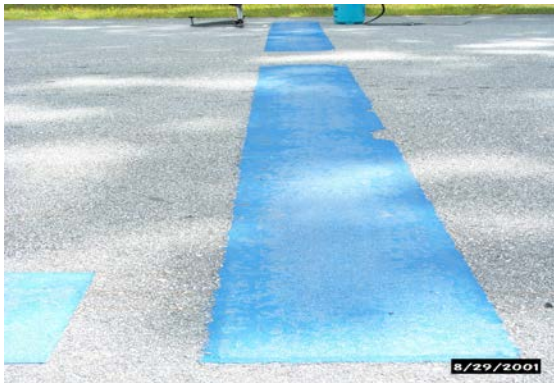
After 12 months of service, the preformed thermoplastic revealed a change in the material's surface along the edges exposed to wear and plow abrasion as seen in Figure 16. The change in the material's characteristic may affect the skid resistance along these leading edges since a loss of some abrasive material occurred. The damage extended approximately 1 ½ inches into the strip at its grooved dimension.

**Figure 16.** Test Strips A and B after 12 months of service.

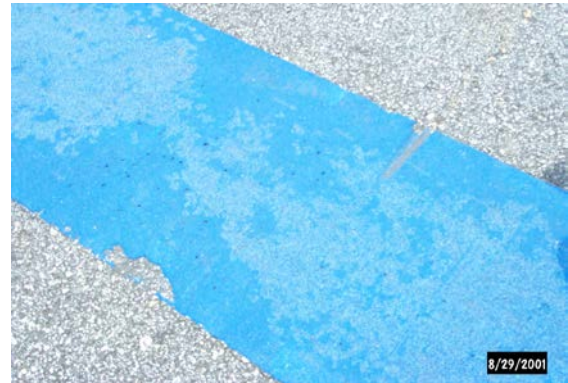
In addition, the material began to develop 'pin holes' as shown in Figure 17. According to technical staff at Flint Trading, Inc., this is likely the result of a year of wear on the material that caught up to air bubbles that were present at the time of installation. These air bubbles were likely developed during the heating of the material from trapped moisture or gases in the pavement. These holes are considered only cosmetic and reported not to effect the performance of the material or its service life by the manufacturer.

**Figure 17.** 'Pin Hole' development.

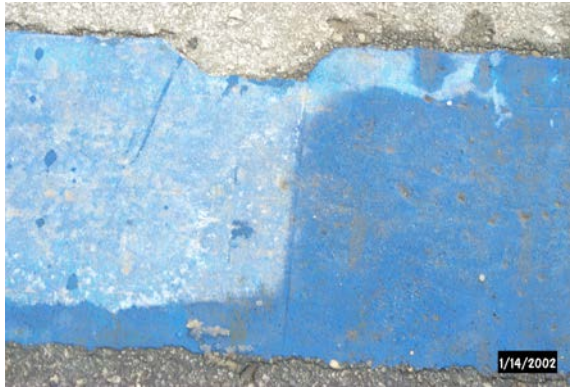
**Figure 18.** Detail of plow damage after 17 months of service.

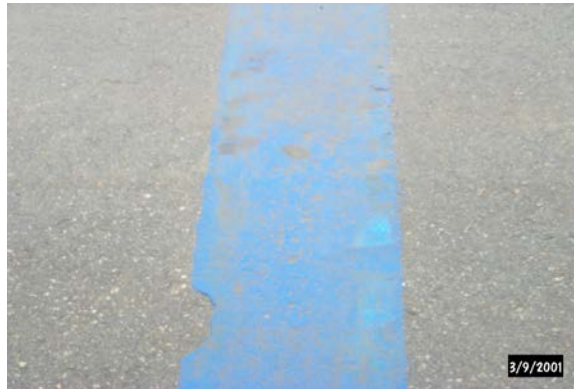
During a site visit in March 2001, it was observed that the abrasive characteristics of the material allowed for small particles of sand to be lodged within the marking material as shown in Figure 15. Future site visits revealed that the sand residual washed out over time with the rain.

**Figure 15.** Sand particles lodged in material.

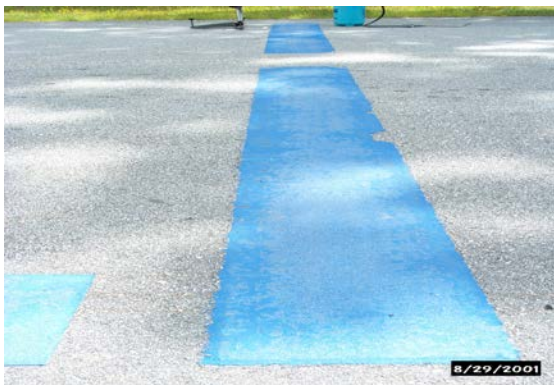
After 12 months of service, the preformed thermoplastic revealed a change in the material's surface along the edges exposed to wear and plow abrasion as seen in Figure 16. The change in the material's characteristic may affect the skid resistance along these leading edges since a loss of some abrasive material occurred. The damage extended approximately 1 ½ inches into the strip at its grooved dimension.

**Figure 16.** Test Strips A and B after 12 months of service.

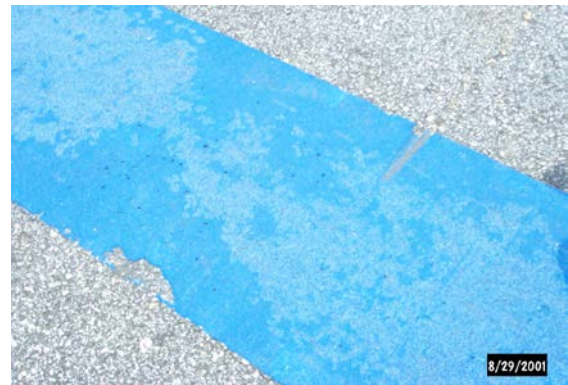
In addition, the material began to develop 'pin holes' as shown in Figure 17. According to technical staff at Flint Trading, Inc., this is likely the result of a year of wear on the material that caught up to air bubbles that were present at the time of installation. These air bubbles were likely developed during the heating of the material from trapped moisture or gases in the pavement. These holes are considered only cosmetic and reported not to effect the performance of the material or its service life by the manufacturer.

**Figure 17.** 'Pin Hole' development.
