**Field Evaluation of Snowplowable Raised Pavement Markers  
on the Vermont Interstate Highway System**

**August 2002  
Reporting on Work Plan 2001-R-6  
Initial Report**

State of Vermont  
Agency of Transportation  
Materials and Research

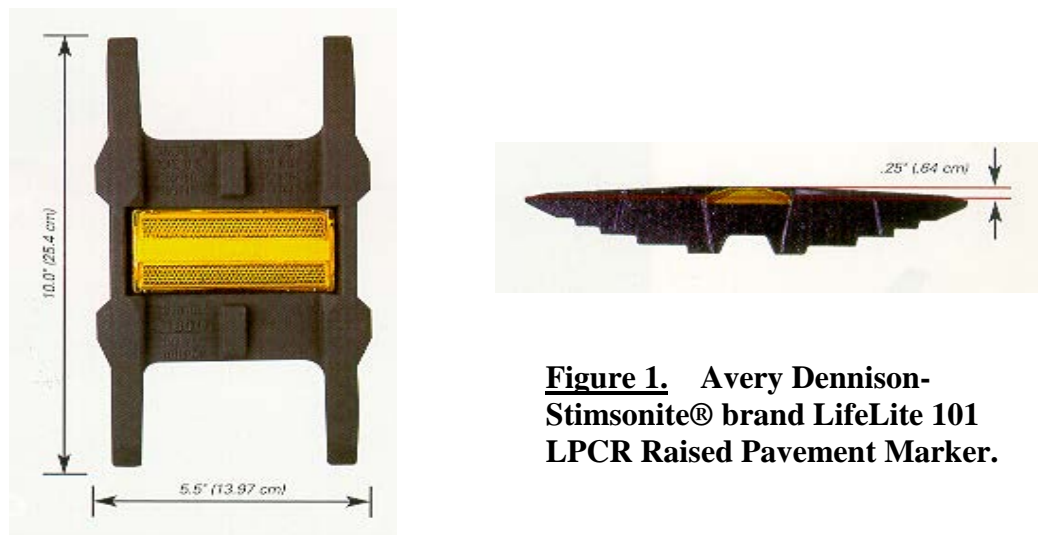
Avery Dennison-Stimsonite® brand LifeLite 101 LPCR raised snowplowable pavement markers are a narrow, “H-shaped” device designed with a low ramp angle to provide enhanced traffic marking delineation with better plowability than non-snowplowable markers. The two-component system consists of a nodular iron casting and reflector. The low-profile casting is constructed with two integral center rails that aid in providing protection to the reflector. The overall unit, as shown in Figure 1, measures 10” long by 5.5” wide by 1.76” deep and weighs about 4.9 lbs. When installed, a total of 0.25” protrudes at a sloping angle above the road surface.

**Figure 1.** Avery Dennison-Stimsonite® brand LifeLite 101 LPCR Raised Pavement Marker.

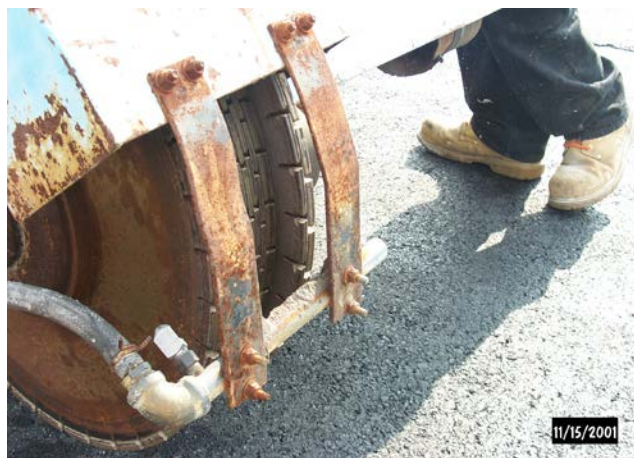
The equipment used in the installation of the raised pavement markers included a power-driven concrete saw and a pressurized epoxy adhesive system. The concrete saw, shown in Figure 2, is designed with a stack of 18" diameter concrete saw blades bordered by 20" diameter saw blades on each side. With a single plunge, the groove created is in the same configuration as the marker, allowing for a close match for the inset.

**Figure 2. Concrete Saw.**

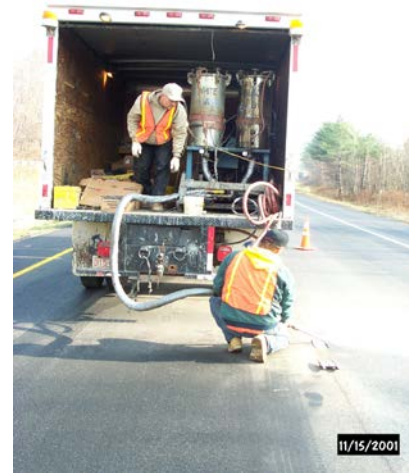
The epoxy adhesive system, shown in Figure 3, consisted of two independent pressurized tanks that feed through two independent lines to a disposable plastic application tip. The two components, discernable by color, one white and one black, met at the nozzle and mixed within the spiraled chamber of the application tip producing a gray adhesive material.

**Figure 3. Epoxy Adhesive System.**

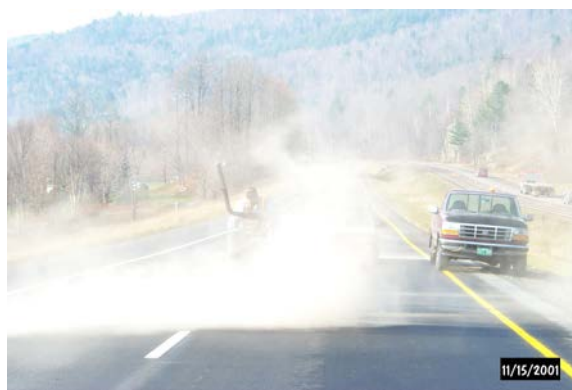
The installation began at 12:15pm on the north end of the project area and proceeded southerly. The average ambient air temperature during the course of the installation was 55° F. At the start of the installation, a problem with a loose drive belt delayed the process for about 15 minutes, but once remedy there were no additional problems with the equipment. The self-driven concrete saw proceeded through the project with one man guiding it, making a plunge cut in the shape of the SRPM housing. A lot of dust was produced from the dry saw process, as shown in Figure 4, creating a visibility issue for a brief period of time.

**Figure 4. Sawing Recess for SRPM.**

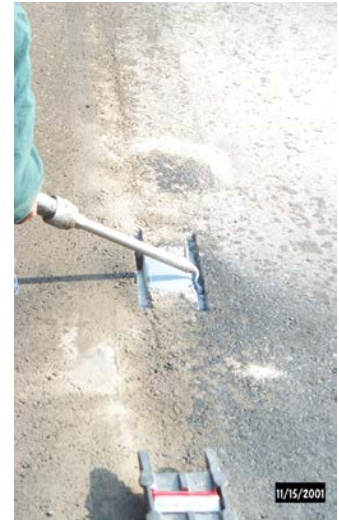
After the groove was cut the area was blown clean with compressed air and the epoxy adhesive was placed covering both the center portion and the legs of the cut out as shown in Figure 5. The two-component epoxy adhesive was heated to 130-140° F to produce a free flowing material. After the adhesive was placed, the marker was immediately set within the cut-out by rocking and working the marker into place then gently stepping on it until the epoxy emerged around the marker as shown in Figures 6 and 7. If an excess amount of epoxy was extruded, a paint scraper was used to smooth-out the material around the marker and, if not, additional epoxy was added. The proper amount of epoxy is essential to keep the marker intact but too much could block or cover the reflective device.

**Figure 5.** Placing epoxy adhesive.

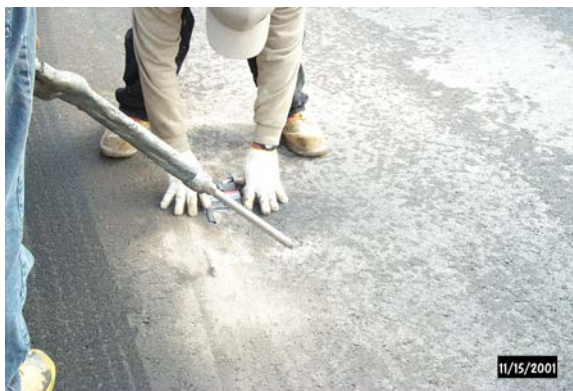
**Figure 6.** Setting marker in place.

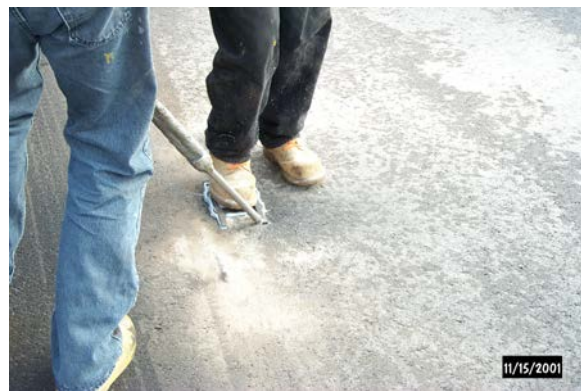
**Figure 7.** Securing marker in grooved area.

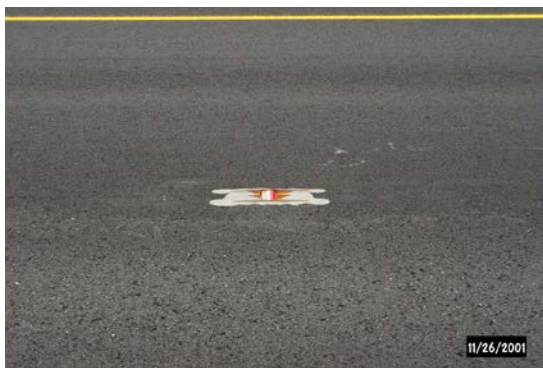
As the process progressed, with one individual operating the saw and two others applying the adhesive and setting the markers in place, it was discovered that some of the recesses were requiring significantly more epoxy. It was determined that this was the result of the grooves being sawn too deep, likely caused by how the concrete saw was being brought down onto the pavement surface. This was discovered at MM 66.40, at which time the saw was at MM 65.85. The individual operating the saw was informed and modified his practice and those setting the markings concluded that not all the grooved areas between the above mentioned mile markers were effected.

It appeared in general that the majority of the markers received an excessive amount of epoxy, including in front of and in some cases up to the reflector, as shown in Figure 8, and a few others lacked epoxy as shown in Figure 9. No additional problems developed during the installation and the total time required to place the 123 markers was 2 hours 45 minutes.

**Figure 8.** Excessive amount of epoxy adhesive.

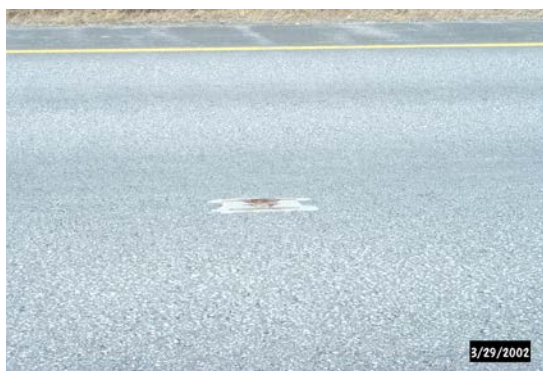
Shortly after the SRPMs' installation it was detected that one of the markers was installed backwards, revealing the "red" side of the delineator. Personnel assigned to the construction project corrected this by removing the reflector and reattaching it in the proper direction. As the result of not having the recommended adhesive available at the time, the delineator at this location became dislodged within a few months as shown in Figure 10.

**Figure 10.** Dislodged reflector after four months of service.

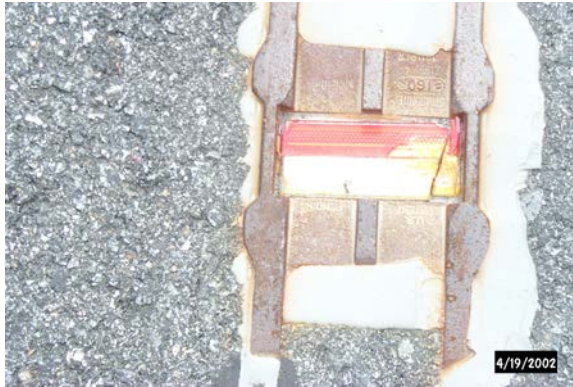
Initial observations of the SRPMs were favorable in both dry and wet night retroreflectivity. But, over the winter season the effectiveness of most of the reflectors began to diminish. Residual sand and salt build-up on the reflectors from routine winter maintenance was a primary contributor to the loss of reflectivity. In addition, some of the reflectors were damaged, possibly by plow blades and studded tires. After six months, a total of 22 of the 123 reflectors experienced significant damage, as shown in Figure 11, 8 had minor damage, as shown in Figure 12, and one reflector was lost. A summary of each marker's condition is exhibited in Table 1.

**Figure 11.** Significant lens damage.

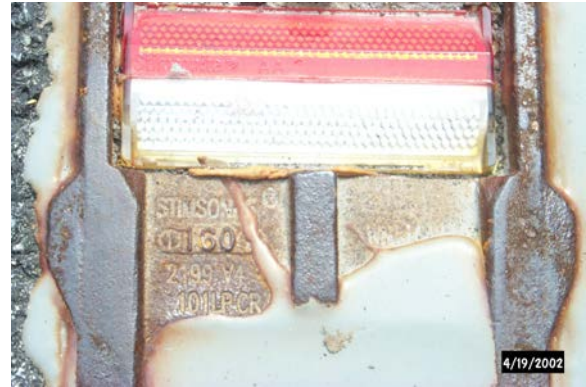
**Figure 12.** Minor lens damage.

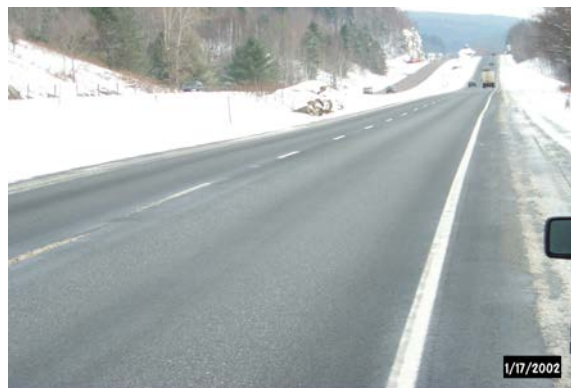
Despite both the low-ramp angle and low profile of the SRPMs, the plow trucks experienced a “jump” of the plow as they passed over each marker. In order to minimize this effect, maintenance personnel modified their plowing techniques in the area to avoid any disturbance. Instead of passing over the SRPMs, they plowed adjacent to them and salted the center portion of the road. This eliminated the jarring impact on the drivers and potential damage on the plow blades. This practice still allowed the maintenance crews to keep the road adequately clean as seen in Figure 13.

**Figure 13.** Test site area during winter season.
