**Recessed Thermoplastic Pavement Markings
Montpelier, Vermont**

**Reporting on Work Plan 95-R-15
Final Report**

State of Vermont
Agency of Transportation
Materials and Research

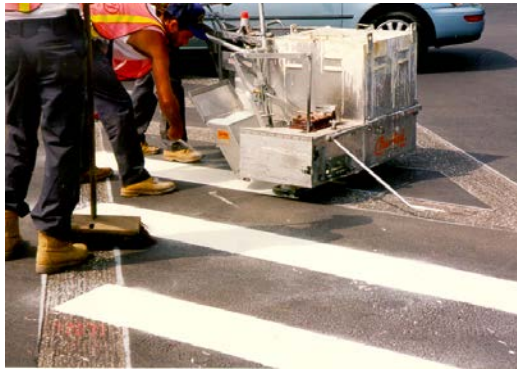
Figure 4. Inlaying thermoplastic material in grooved areas.

The thermoplastic pavement markings were applied the following day. At the time of the application, the pavement surface was dry and the ambient air temperature was 70 degrees Fahrenheit. The material was applied with a handcart in the same manner as traditional surface-laid thermoplastic legends and symbols. Because the ground area was 5 ½" wide, and the die for the thermoplastic markings was 6" wide, a ¼" each side of the grooved area adhered to the pavement surface (Figure 4).

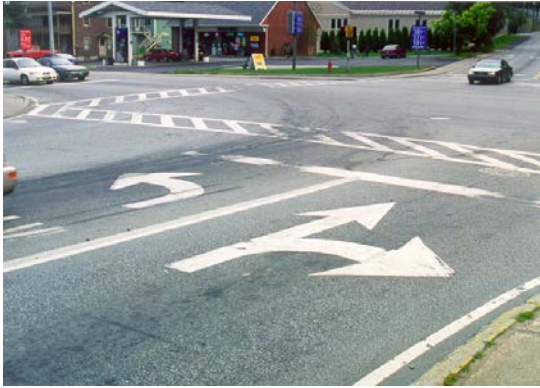
Figure 5. US Route 2 (Main St) – 1998.

Arrow symbols, stop bar and crosswalk are inlaid thermoplastic.

(Photo taken August, 1998)

After three years of performance, the inlaid markings began to deteriorate. The most significant loss occurred within the wheel paths of the stop bars and arrow symbols. Wear would be expected here since these areas are subjected more to the acceleration and deceleration of vehicles. All four crosswalks also exhibited signs of wear in the wheel paths, producing an estimated 10% loss of these markings, as shown in Figures 5 through 8.

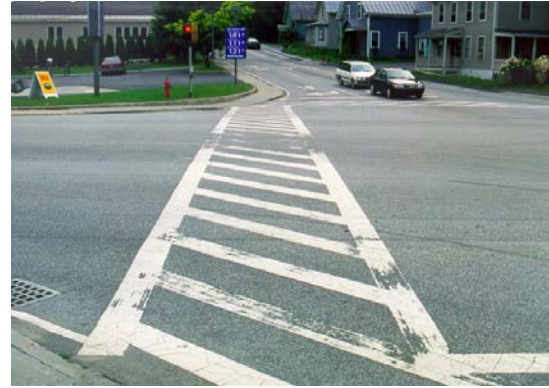
Figure 6. US Route 2 (Berlin St) – 1998.

Crosswalk is inlaid thermoplastic.

(Photo taken August, 1998)

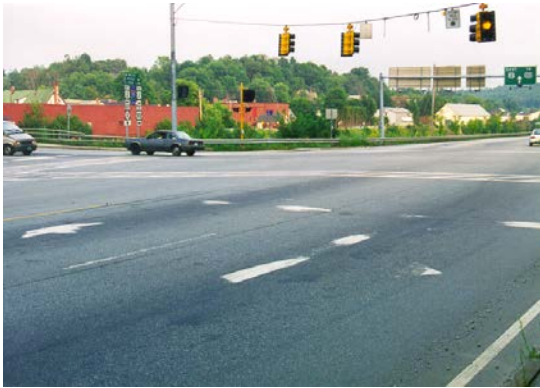
Figure 7. Memorial Drive – 1998.

**Crosswalk is inlaid thermoplastic.
Arrow symbols are surface laid.**

(Photo taken August, 1998)

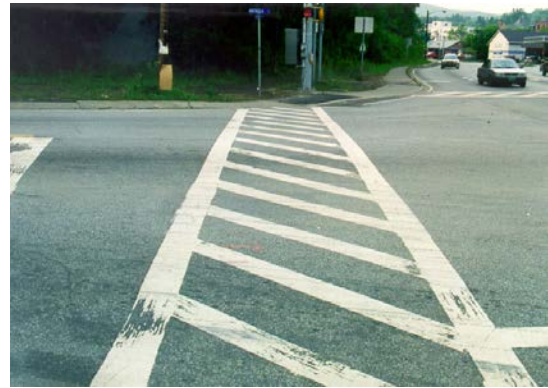
Figure 8. VT Route 12 (Northfield St) – 1998.

Arrow symbols, stop bar and crosswalk are inlaid thermoplastic.

(Photo taken August, 1998)

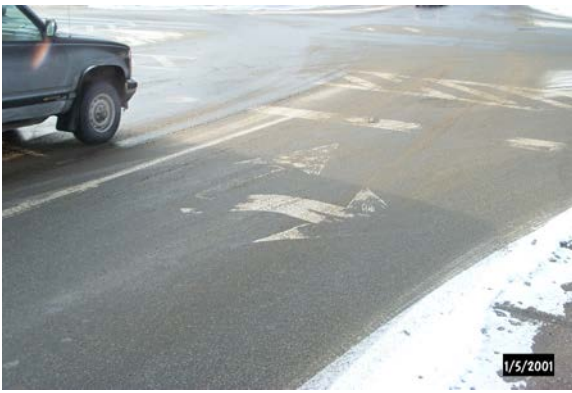
Figure 9. US Route 2 (Main St) – 2001.

Arrow symbols, stop bar and crosswalk are inlaid thermoplastic.

(Photo taken January, 2001)

After 4 ½ years, most of the inlaid thermoplastic markings exhibited significant deterioration. US Route 2, both Main and Berlin Streets, had undergone the most damage, with an estimated 40% loss of the crosswalks. Additionally, deterioration on VT Route 12 (Northfield St) and Memorial Drive continued with predominant wear in the wheel paths, as shown in Figures 9 through 12.

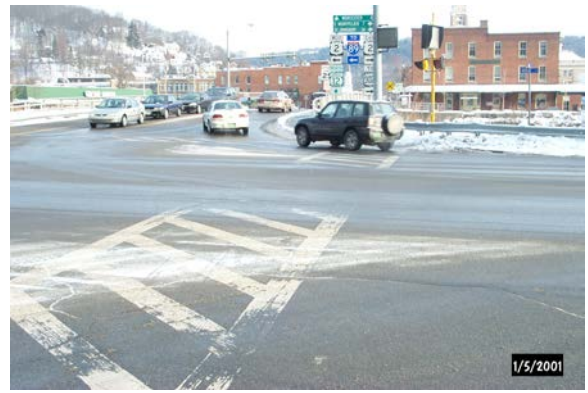
Figure 10. US Route 2 (Berlin St) – 2001.

Crosswalk is inlaid thermoplastic.

(Photo taken January, 2001)

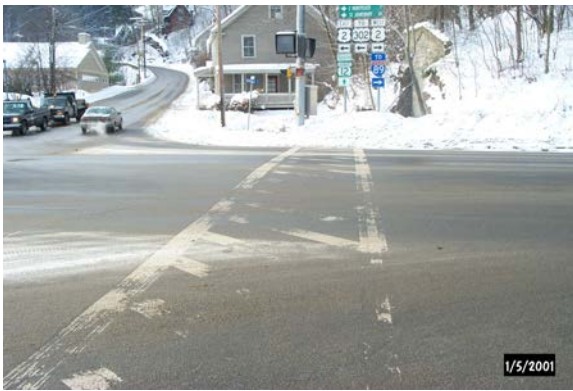
Figure 11. Memorial Drive – 2001.

Crosswalk is inlaid thermoplastic.

(Photo taken January, 2001)

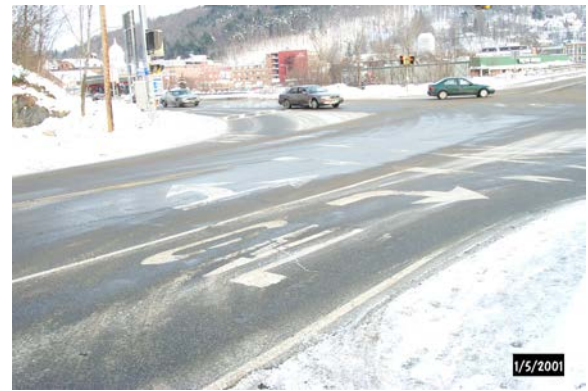
Figure 12. VT Route 12 (Northfield St) – 2001.

Arrow symbols, stop bar and crosswalk are inlaid thermoplastic.

(Photo taken January, 2001)
