**Product Evaluation
on**

**ATM Removable Rumble Strips
Report No. 2003-1**

**Reporting on Work Plan 2001-R-2
Final Report**

State of Vermont
Agency of Transportation
Materials and Research

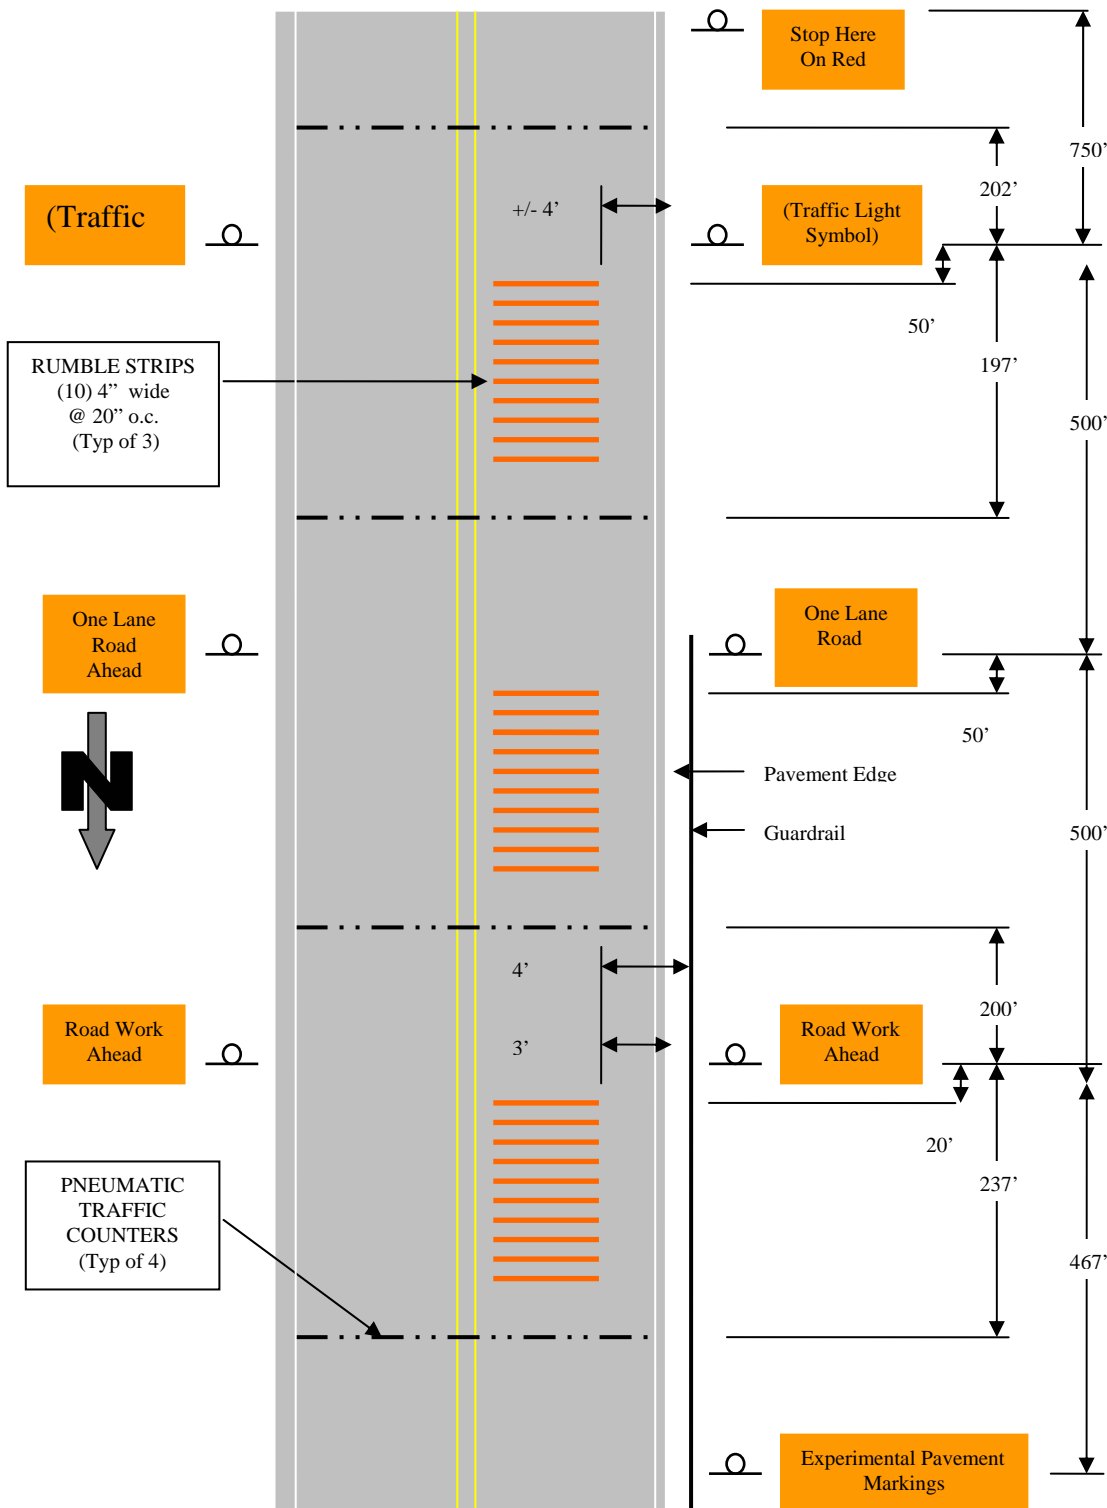
The test site was laid out in accordance to the manufacturer's recommendation as shown in Figure 1. The rumble strips, placed in three separate groups of 10, were evenly spaced 20 inches center to center. Each group was located 20-50 feet before a construction warning sign to help aid in gaining the motorist attention to the adjacent temporary warning sign.

Figure 1. Actual Test Site Layout – Warren, VT.

Recognizing that the travel-way is used by bicyclists, the rumble strips were cut into eight foot lengths and placed a minimum three feet from the pavement edge providing an unobstructed passage way. In the event a bicyclist crossed a rumble strip, only a single layer of material (0.150 inch) was placed to generate a minimum “bump.” In addition, a sign was placed approximately 470 feet prior to the first set of rumble strips reading “Experimental Pavement Markings,” to inform motorist and bicyclists of the test site area.

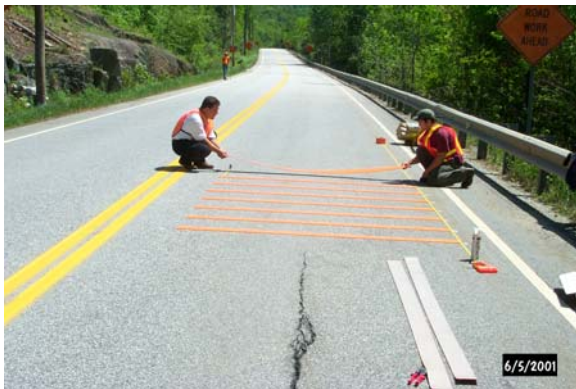
The material was cut into eight-foot strips, positioned, and tamped down using a tamper cart with 200 pounds of weight as shown in Figures 2 and 3. A minimum of three full passes (back and fourth) was made over the length of the strip. Care was taken ensuring that each pass was longitudinal to the strip, with no twisting motion over the material. Traffic was allowed to pass over the rumble strips immediately after placement.

Figure 2. Placing the rumble strips.

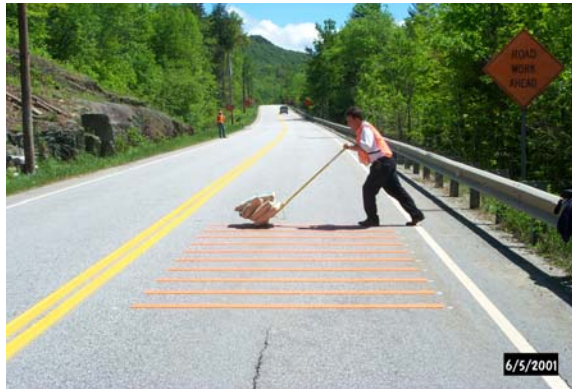
Figure 3. Tamping the rumble strips.

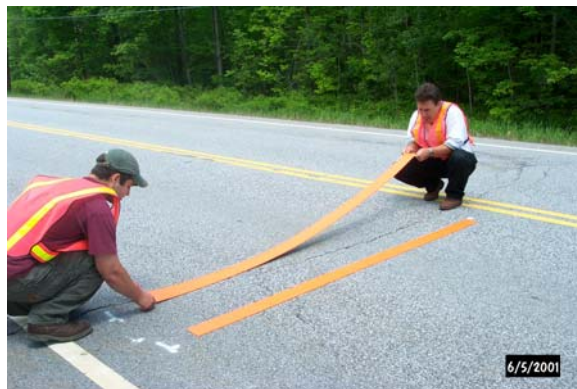
Unlike the two southerly test groups, the northern group was located only 20 feet, rather than 50 feet, from the construction work zone sign due to significant cracking of the pavement. The purpose of the relocation was to avoid the possibility of failure due to any movement of the pavement structure. In the most southerly group area a minor transverse crack was unavoidable and therefore required on test strip to be placed perpendicularly over the crack as seen in Figure 4.

Figure 4. Placing strip over minor crack at most southern test group.

Routine investigations of the test site area revealed the product remained intact, with no material loss or damage, over its four-month service life. The most northerly test strip group, with one strip placed over a transverse crack, remained unaffected by the minor road surface deterioration.

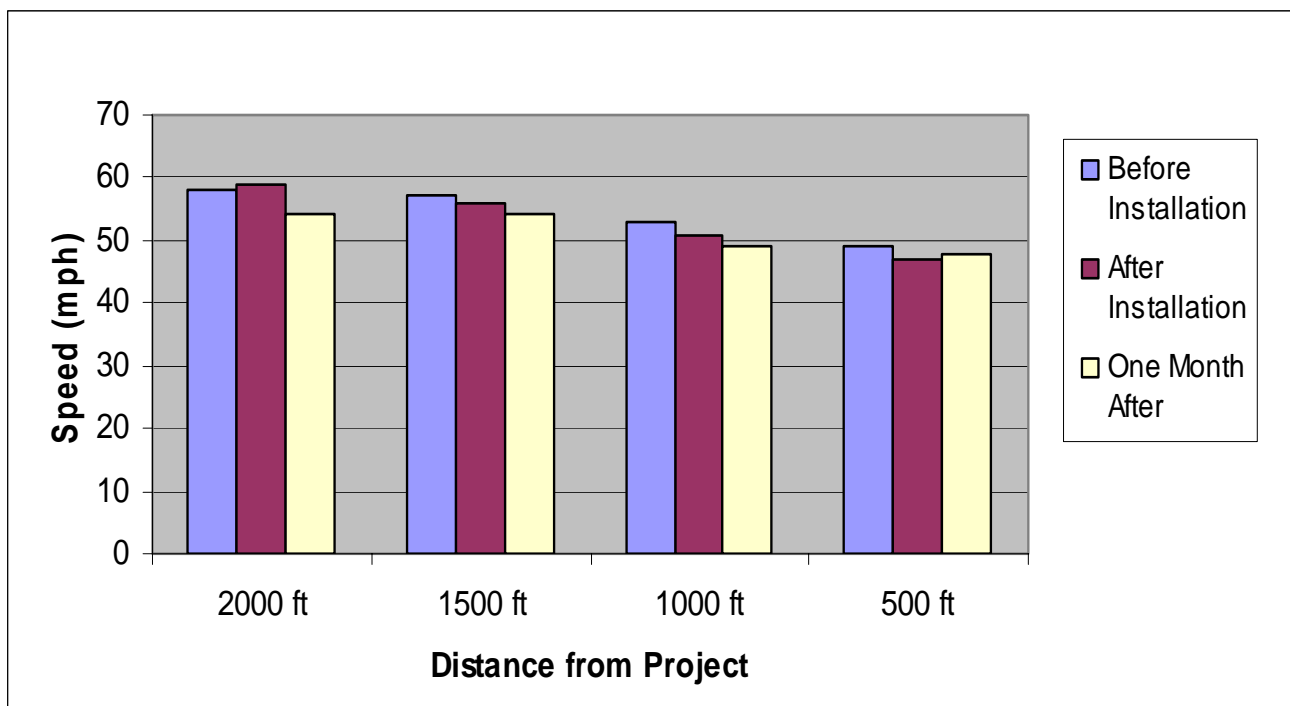
From this data we can conclude the average speed of the vehicles decreased over the duration of the project and the percentage of vehicles in the 10 MPH pace increased. The 85th percentile speed shown in Figure 5, the speed typically used in traffic analysis and usually represents the speed that most people travel, decreased at all the data collection points after one-month, as seen in Figure 6. The percentage of vehicles travelling over 55 MPH continued to decrease over the course of the project at all the test site groups as seen in Figure 7.

Figure 5. 85th Percentile Speed

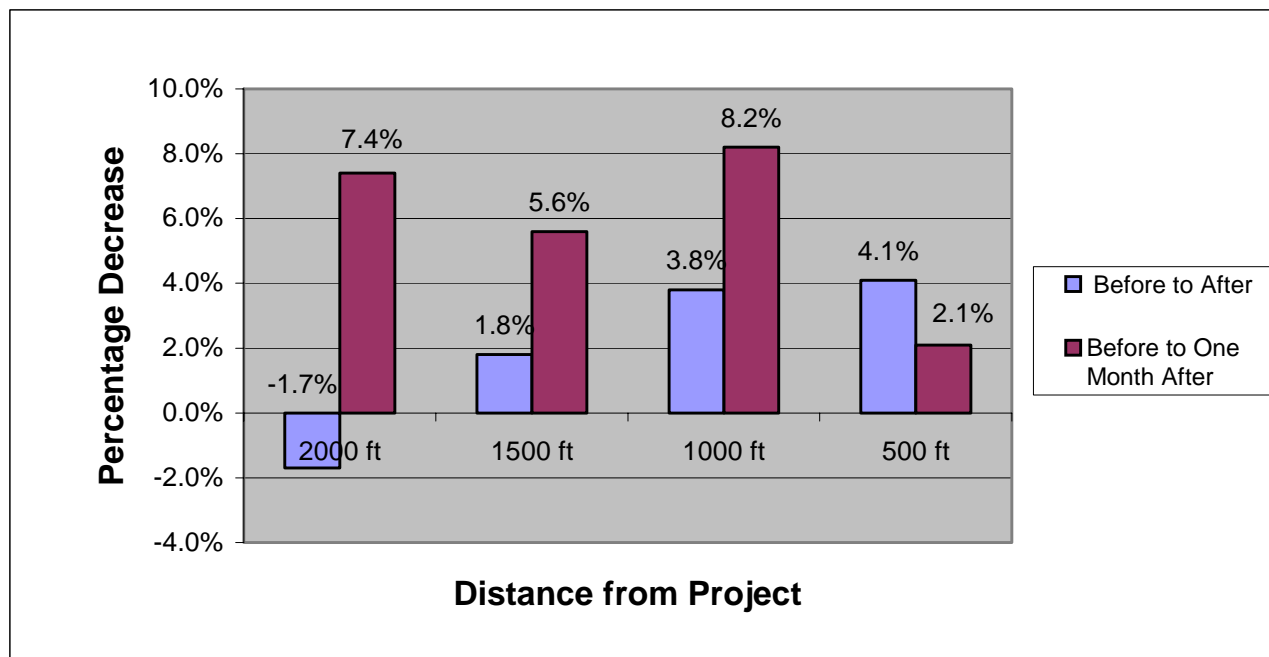
Figure 6. Percentage Decrease in the 85th Percentile Speed.

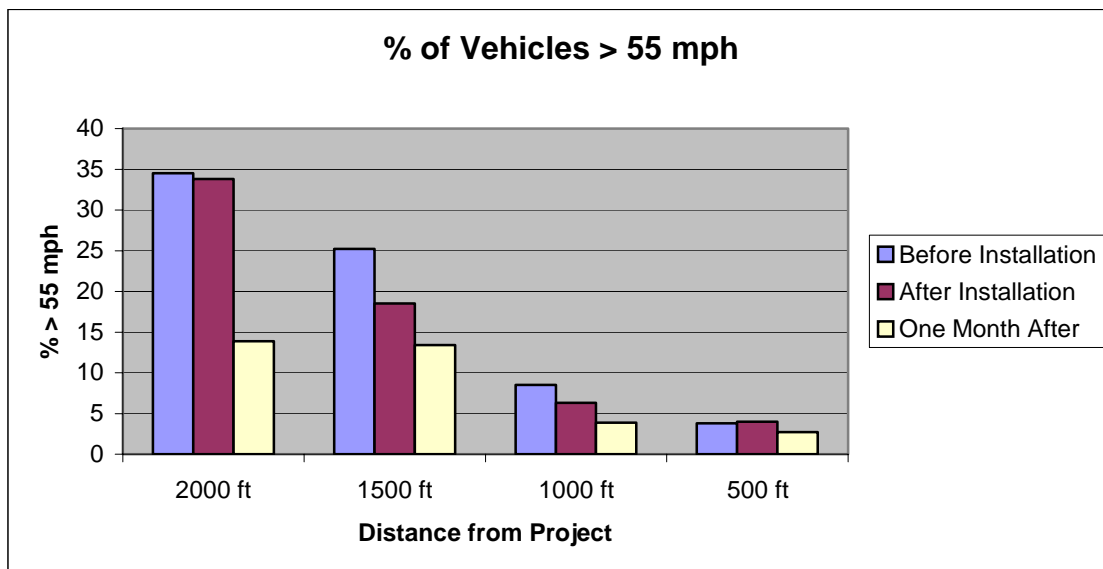
Figure 7. Percentage of Vehicles over 55 MPH.

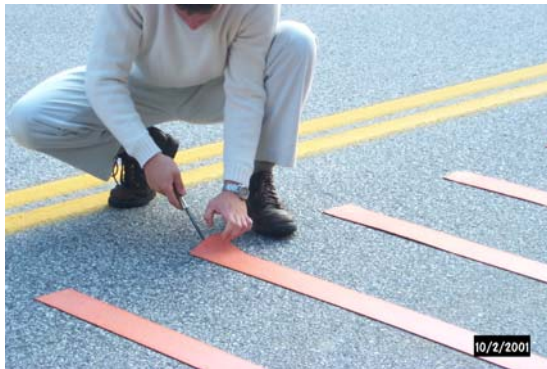
On October 2, 2001, the temporary rumble strips were removed. The removal of the material required no special tools or equipment, only a rigid flat-tip tool. Each strip was pried up on its

narrow end with a flat-tip screwdriver as shown in Figure 8, after which it was slowly pulled up along its length, coming up in full-length strips as shown in Figure 9.

Figure 8. Prying-up the material.

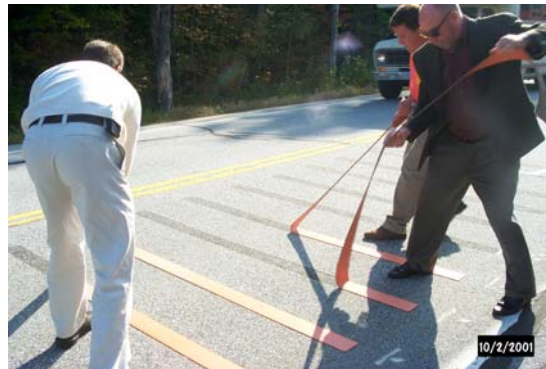
Figure 9. Removing the rumble strips.

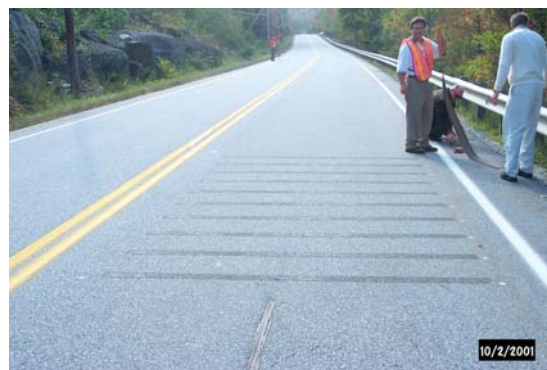
All 30 rumble strips were removed in full-length pieces with little effort. The road, as seen in Figure 10, exhibited no damage as the result of the temporary rumble strip application. The time required to remove all the test strips was less than one hour.

Figure 10. After the rumble strips removal.
