**Pavement Marking Durability  
Statewide**

**December 2005  
2005-2**

State of Vermont  
Agency of Transportation  
Materials and Research Section

1. Report No. <b>2005-2</b>	2. Government Accession No.	3. Recipient's Catalog No.	
4. Title and Subtitle <b>Pavement Marking Durability in Vermont</b>		5. Report Date

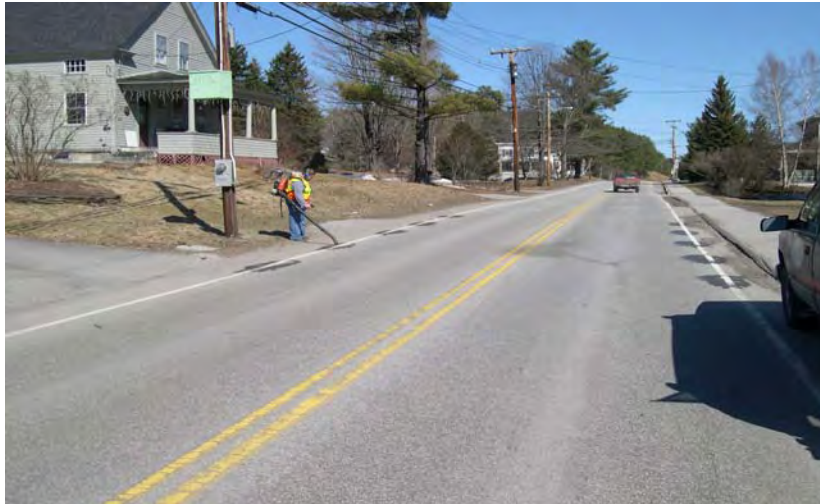
The subsequent photograph illustrates how the lines are dried after they are cleaned

**Figure 1. Winter Cleaning Protocol (Drying of the Lines)**

During those periods of time when winter readings are required, a modification to section 9 of ASTM E1710 is followed to ensure that the lines are cleaned before sampling. This protocol for this is to clean the lines by dispensing a 50/50 mixture of water and windshield washer fluid via a portable sprayer to remove large particulate matter, such as residual salt, dirt and other debris. Then the lines are thoroughly rinsed with the water dispenser which removes the windshield washer mixture. A squeeze mop or sponge is used to remove as much excess water as possible, followed by a rag wipe of the surface to clear away any remaining debris and moisture. The lines are then dried with an air compressor or similar device. Retroreflectivity testing is completed following the methods as indicated in E1710.

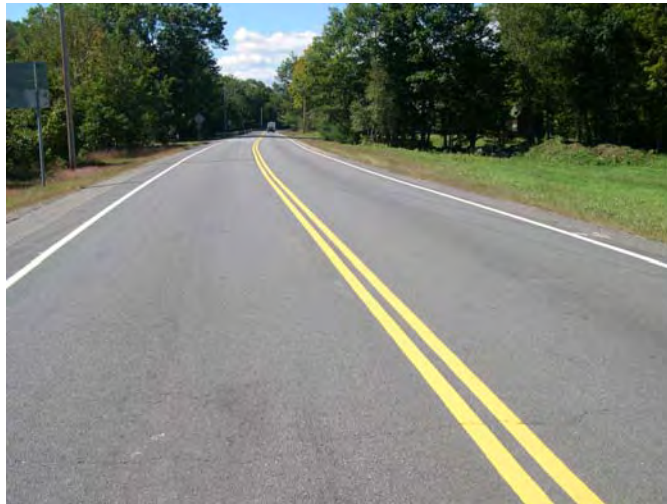
**Figure 3 -2002 Cavendish/Wethersfield – Test Site 1**

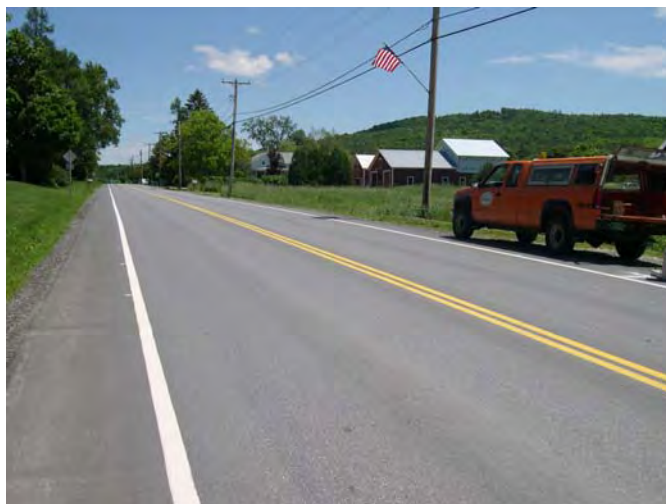
**Figure 5 -2002 Williston-Richmond Test Site 2**

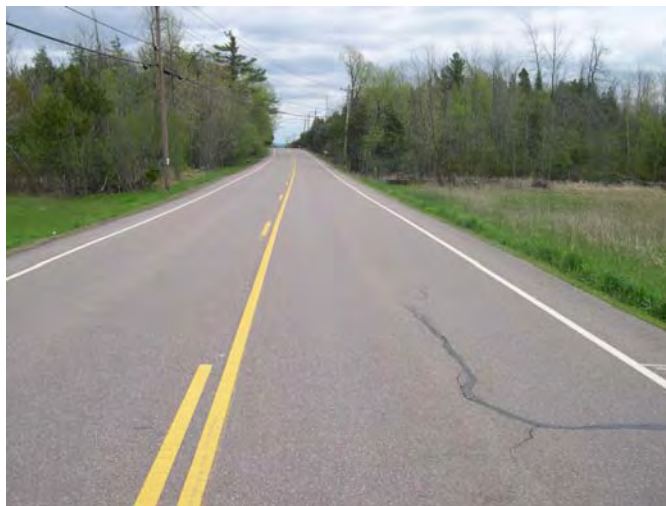
**Figure 7 -VT 314 Grand Isle (2000) Test Site 2**

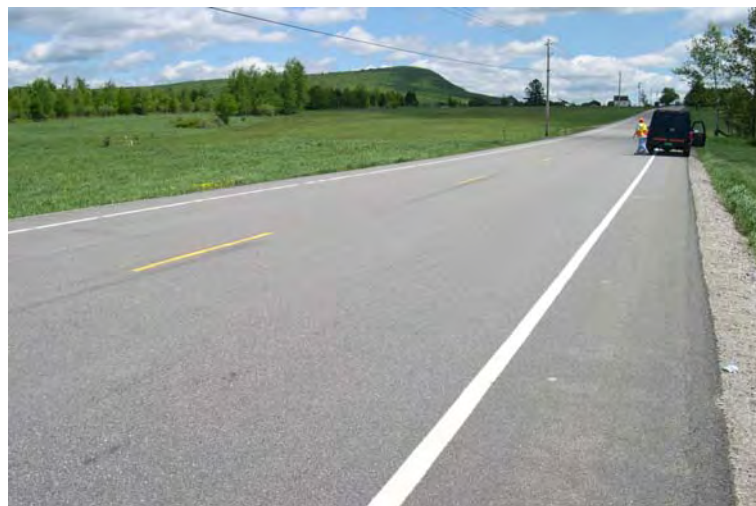
**Figure 9 - 2001 Norton-Canaan Test Site 1**

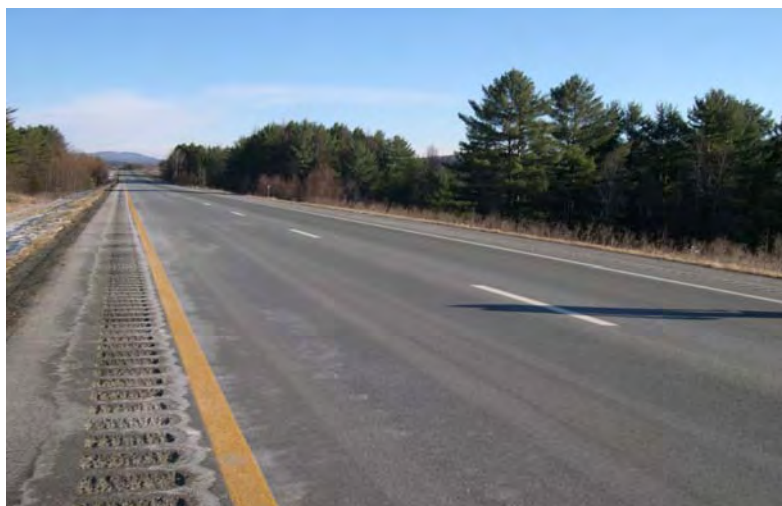
**Figure 13 -2002Lyndon- Sheffield Test Site 3  
I 91 Southbound, Epoxy**
