**Performance Grade Asphalt Cement
Waterford, Vermont**

February 2006

Reporting on Work Plan 1994-R-4

State of Vermont
Agency of Transportation
Materials and Research Section

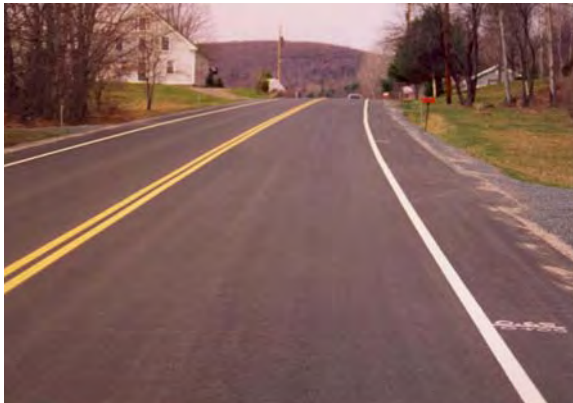
Figure 1: Test Site 0.65, 1994

A total of thirteen test sites were established. Of the thirteen test sites, seven sites were located within the control sections, and six sites were identified within the experimental sections. However, one of the control sections, TS 0.40, was established in a transition zone between the experimental and control sections. Due to the variance of the treatment within this area, this test site has been eliminated from the study and is no longer under evaluation. Each test site consists of a length of 100' in the direction of travel and are approximately 22' wide encompassing both the north and southbound lanes. Generally, each test site was examined annually for cracking, rutting, and IRI. The figures as provided below depict a typical test site immediately following construction and ten years after construction.

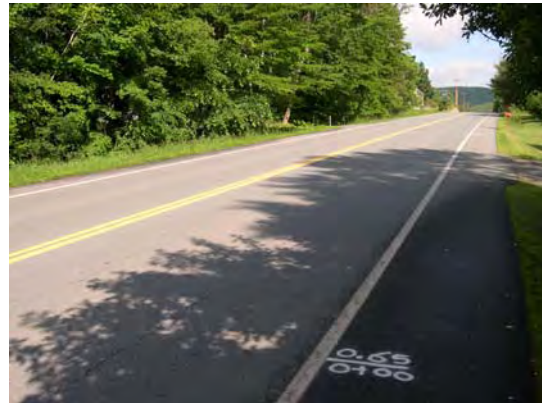
Figure 2: Test Site 0.65, 2004

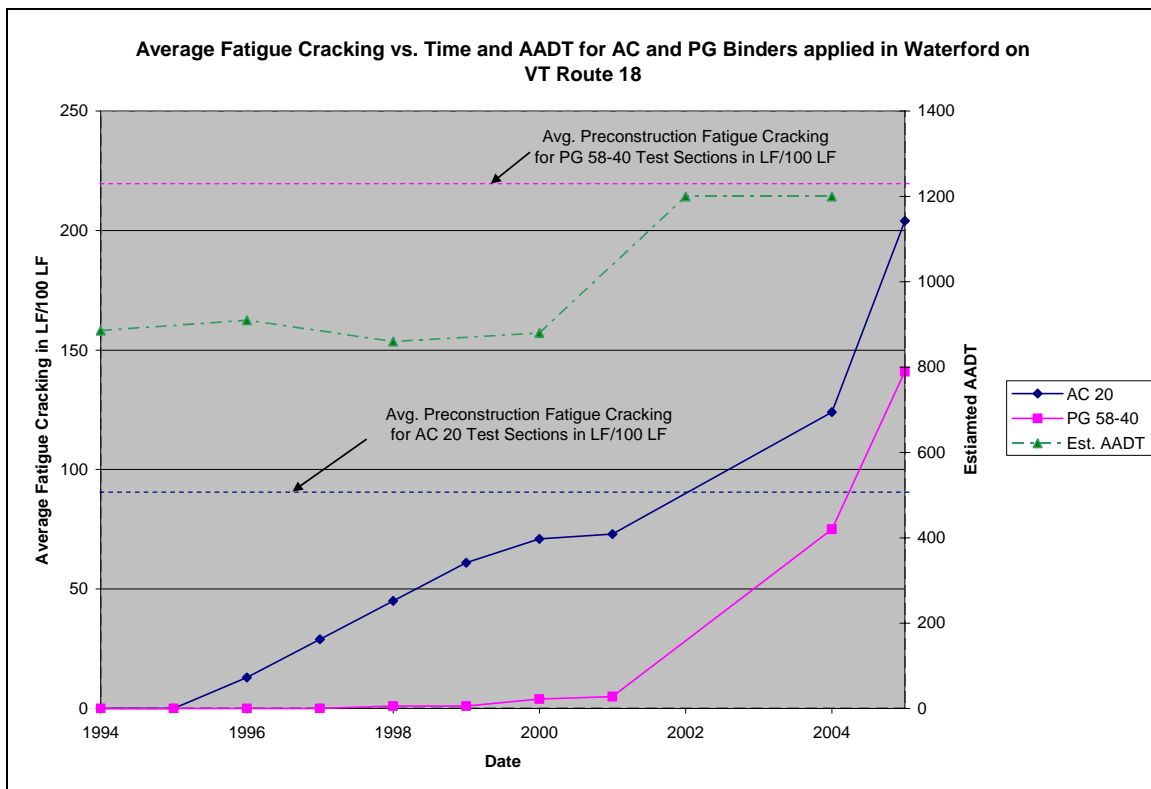
as an ESAL, or equivalent single axle load. An ESAL is defined by Clemson University as “the effect on pavement performance of any combination of axle loads of varying magnitude equated to the number of 80-kN (18,000-lb.) single-axle loads that are required to produce an equivalent effect.” Basically, pavements are designed to structurally support traffic loads which are often calculated by AADT or ESALs with regards to roadway use. ESAL information was not available for this investigation. Therefore a comparison between average cumulative fatigue cracking of the experimental and control sections vs. AADT is provided in Figure 3 below. Averages were calculated by adding up all of the recorded linear feet of cracking of each test section within one of the two mix types and dividing by the total number of test sections.

In this case, AADT is a constant variable across all test sections within the investigation. With that in mind, it appears that while the test sections containing the PG binder had a larger amount of preconstruction cracking, 230 LF on average, as compared with the AC binder test sections, 95 LF on average, it is clear there is a much greater accumulation of fatigue cracking within the AC test sections. Additionally, according to the failure criterion, which is met when the amount of post construction cracking is equal or greater than the amount of preconstruction cracking, the AC graded sections were interpolated to fail for fatigue cracking in 2002. There also appears to be a large increase in fatigue cracking following data collection in 2001 which may be partially attributed to the increase in AADT from 880 in 2000 to 1200 in 2002, as well as, the occurrence of accelerated deterioration over time. A nonlinear relationship between cumulative fatigue

cracking and time has also been identified as the slope of the accumulation increases between field visits.

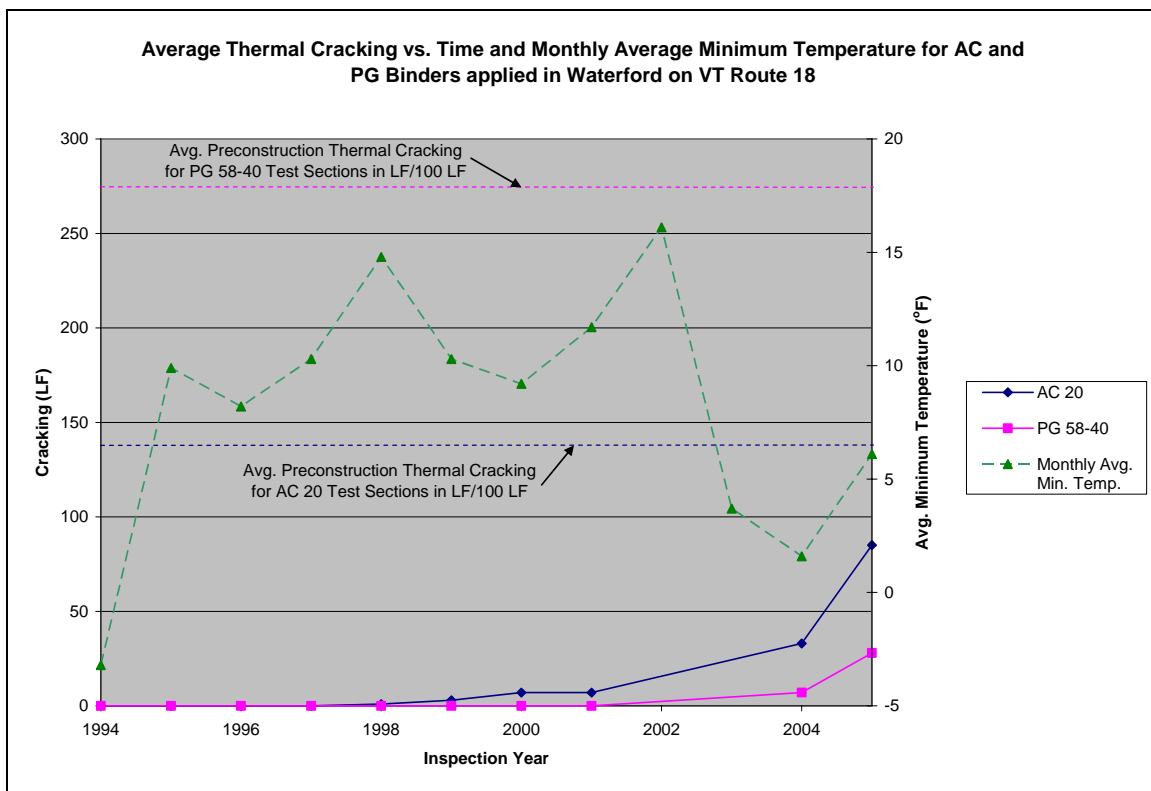
The formation of transverse cracking is largely due to climatic conditions and is often induced by freeze-thaw cycles or maximum low temperature shrinkage cracking. One of the main goals of this research was to implement a binder with performance based specifications with regards to temperature. The PG binder was expected to outperform the AC binder at low temperatures as it was designed. In addition to comparison of the cumulative transverse cracking between the experimental and control sections, monthly average minimum temperatures were attained from a weather station that resides in Burlington, VT, and are provided in Figure 4 below:

As with AADT, temperature remains a constant variable across all test sections. Although the average length of preconstruction cracking, 257 LF, within the experimental sections is much higher than the average length of preconstruction cracking, 137 LF, within the control sections, the PG graded binder clearly outperformed the AC binder. Although it is not depicted within the graph, as is often the case when calculating averages, two out of six test sections containing the AC binder failed between site visits conducted in 2004 and 2005. Conversely, no test sections have failed with the experimental pavement. While data was not gathered in 2002 and 2003, there is an increase in the accumulation rate of thermal cracking which may be the result of the

average minimum temperature of 3.7°F in 2003. The rate of accumulation also increases between 2004 and 2005 which is most likely due to an average minimum temperature of 1.6°F. In any case, a non-linear relationship between rates of accumulation vs. time has been identified. It is important to note that the onset of thermal cracking does not occur with the experimental section until 2002 within the experimental section, while thermal cracking was apparent with control sections during the 1998 field visit. Additionally, there is a larger rate of accumulation within control sections as delineated by slope of the data points.

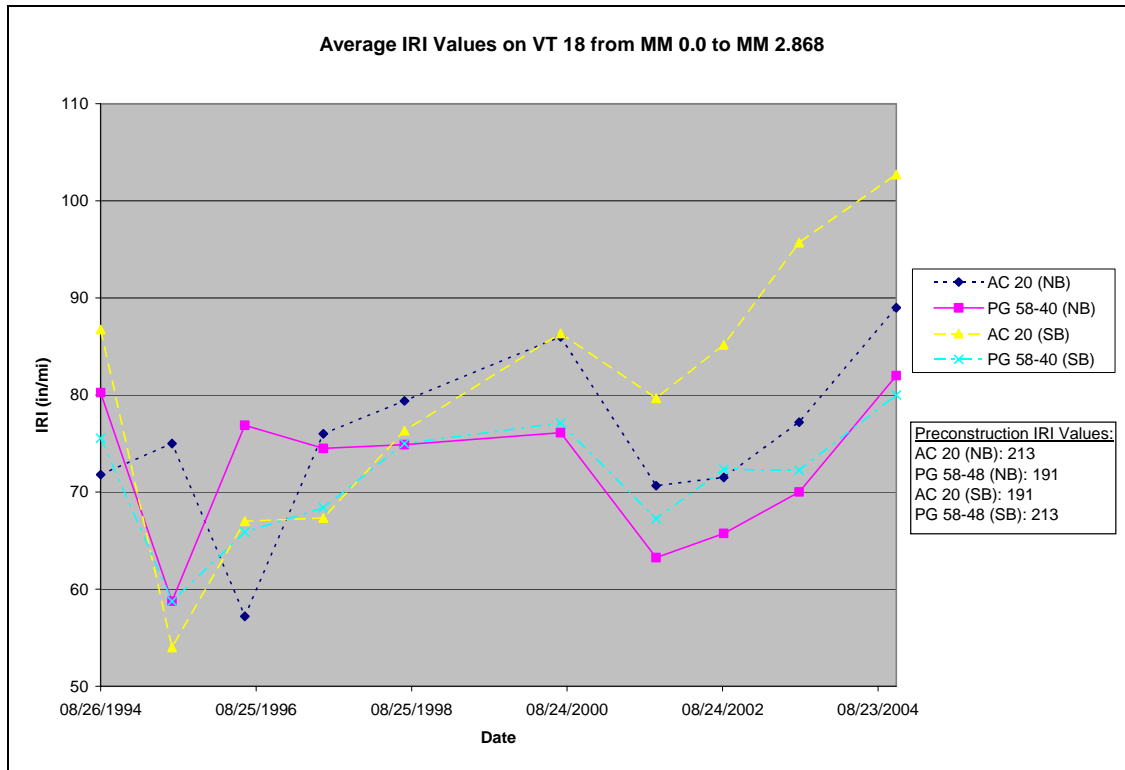
Figure 5

IRI, or International Roughness Index, is utilized to characterize the longitudinal profile within wheel paths and constitutes a standardized measurement of smoothness. According to Better Roads Magazine, “the pavement’s IRI in inches per mile measures the cumulative movement of the suspension of the quarter-car system divided by the traveled distance. This simulates ride smoothness at 50 miles per hour.” IRI values were collected on an annual basis with the exception of 1999 through the Pavement Management Section of VTrans utilizing road profilers. Please note that the data was collected by different vendors through the investigation which resulted in poor correlation between collection events. The following figure provides a summary of the IRI data:

There are some discontinuities within the data set. Usually IRI values are at a minimum immediately following construction as the pavement condition is optimum and will then degrade over time. Therefore, it was anticipated there would be an upward trend throughout data collection. However, the initial IRI values are greater than those from following years which is most likely caused by the variation in testing equipment. The data from 2001 through 2004 does appear to have a consistent upward trend. In 2004, the IRI value was 88 in/mile, well below preconstruction conditions. This inference may not be accurate due to the variability of sampling equipment. It was documented that three different road profilers were utilized for the collection of the IRI values throughout the investing period. Each of the road profilers vary from one another which causes discontinuities between annual data sets. In addition, while the AC-20 sections may appear to be increasing at a greater rate than the PG 58-40 sections from 2001 through 2004, it is difficult to make a conclusion with regards to which binder outperformed the other. It is also important to keep in mind that IRI is directly related to all pavement distresses. Due to the fact that the rutting data is inconclusive and the data displays large variations, it is reasonable to presume that a comparison between binder types cannot be made at this time. It is recommended that all future IRI values be collected by the same profiling device for research projects evaluating various pavement treatments in order to provide consistency and accuracy.
