Tensar Mesa™ Retaining Wall System Initial Report 2006-5 August 2006

Reporting on Work Plan 2001-S-9 Category II Experimental Project

> State of Vermont Agency of Transportation Materials and Research

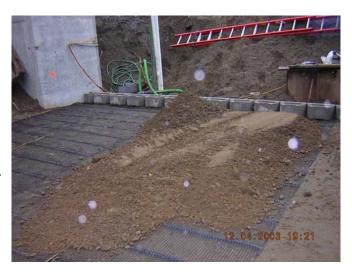
The retaining wall system supplied by Tensar achieves its structural integrity through the use of geogrid, placed within layers of compacted material, which are attached to concrete blocks to form a reinforced earthen embankment, wall or abutment (Figure 1). The blocks are formed with grooves which are then fitted with plastic clips to provide a means of securing the geogrid to the blocks during construction (Figure 2). The geogrid is laid out horizontally behind the panels, secured to the blocks and covered with compacted select The layered system of backfill. geogrid forms a mass which is sufficiently stable to provide structural support without the use of piles.

Figure 1: Geogrid being placed in layers of compacted fill.

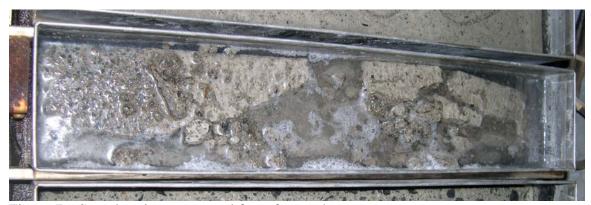
Both samples performed very poorly. The test method requires up to 300 cycles or failure, whichever occurs first. Neither sample could continue the test past 200 cycles, as they had fallen apart. Figure 7 shows Sample 1 when testing was terminated after 194 cycles.

Figure 7a: Sample prior to removal from freeze-thaw apparatus.

In conclusion, it is recommended that the Tensar MesaTM retaining wall system for use on Agency projects be withheld until the manufacturer can clearly demonstrate that the facing units will not deteriorate in a freeze-thaw environment in the presence of de-icing chemicals. The authors feel that this important issue has not been adequately addressed through prior research and field studies.

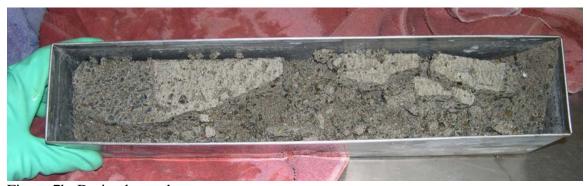
Figure 7b: Drained sample.

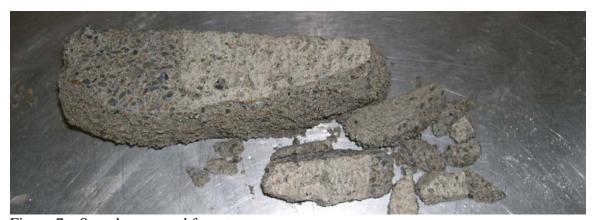
Figure 7c: Sample removed from tray.

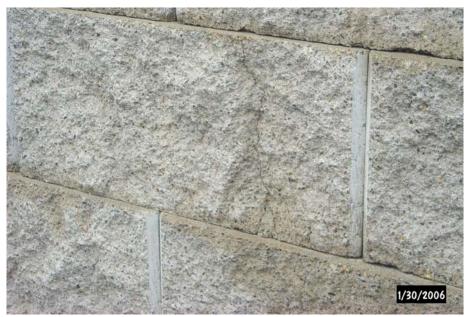
Two blocks (Figure 8) appeared to have vertical stress fractures. The blocks were not located in the same vicinity.

Figure 8a – Vertical fracture

It is also recommended that this project be monitored into the future for any adverse changes and the changes are reported in future updates.

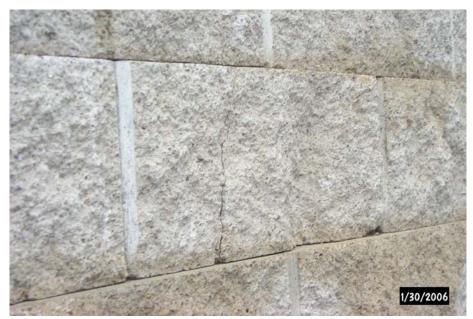
Figure 8b – Vertical fracture
