**Cold Recycled Bituminous Pavement  
Chester/Springfield, Vermont  
Final Report**

**January 2007**

**Report 2007 - 2  
Reporting on Work Plan 92-R-7**

State of Vermont  
Agency of Transportation  
Materials and Research Section

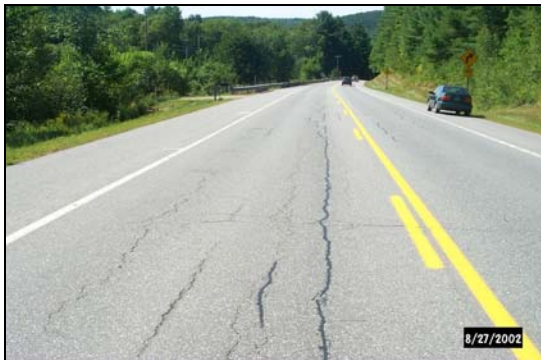
Figure 1 – Test Site 5.9 (Cold Plane)

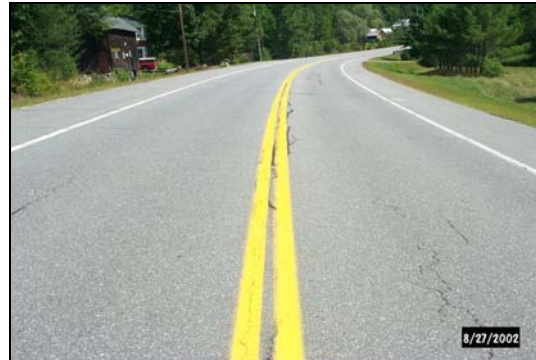
Figure 2 - Test Site 7.2 (CRB)

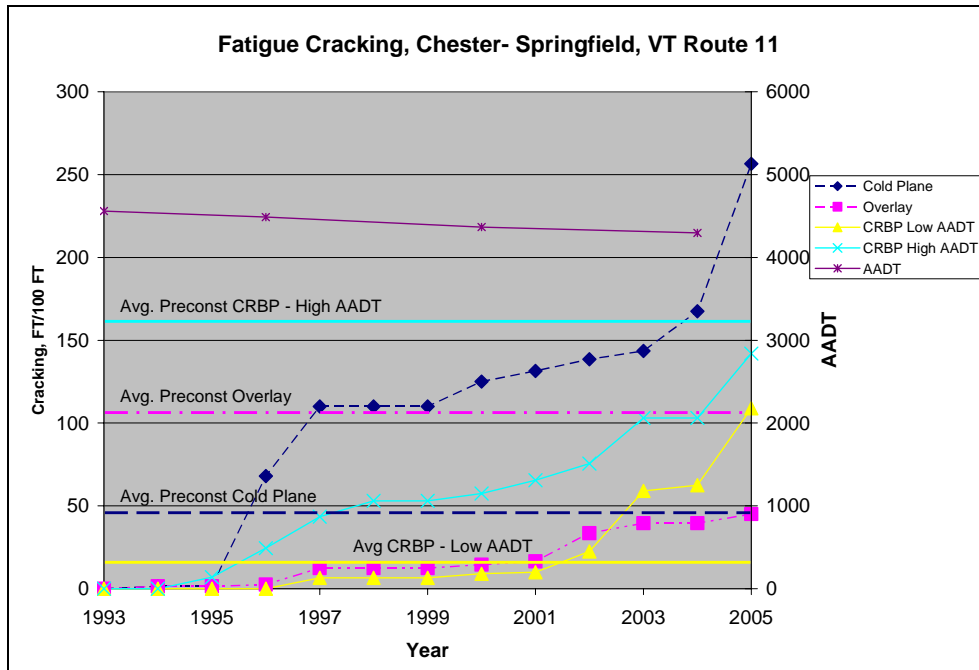
Figure 4 – Fatigue Cracking

A weighted average AADT was utilized in Figure 4, otherwise defined as an average of quantities that have been adjusted by the addition of a statistical value to allow for their relative importance in a data set. However, it is important to keep in mind that the AADT, provided in Appendix D, was not a constant variable across all test sites. The AADT did remain consistent across the control sections and the first two tests of the CRBP sections. However, the AADT within the last two test sites of the CRBP section was almost twice that of the other test sites. As previously discussed, AADT is an important parameter when defining the traffic loading across a pavement. While the AADT only describes the average number of vehicle passes a day, it may be surmised that additional vehicles will include additional truck traffic or heavier weighted vehicles resulting in an increase in fatigue cracking. In addition, local soil maps provided by the National Conservation Service, indicate that matrix below the lower and higher AADT sections consists of a stony or rocky subgrade and a sandy loam, respectively. Both should provide adequate subgrade support, although loams typically contain sand, silt and clay, resulting in slower rate of consolidation and a propensity to retain water.

However, the results from the graph do not confirm the theory that a greater amount of traffic contributes to a higher rate of fatigue cracking. Rather the test sections located within a lower AADT area returned to preconstruction levels earlier. In the case of the cold plane control section, preconstruction levels were met within two to three years following construction. Additionally, the CRPB section within the lower AADT area met preconstruction levels sometime between 2001 and 2002, nine to ten years following construction. Conversely, the standard overlay in the lower AADT area and the CRPB section in a higher AADT area have not yet encountered preconstruction levels.

It is interesting to note the consistency in the shape of the fatigue cracking rate, indicating similar pavement responses over time from all test sites. Additionally, the slope is not constant, with higher amplitudes resultant of increased failure rates. As expected, this may be attributed to the traffic stream during this time period.

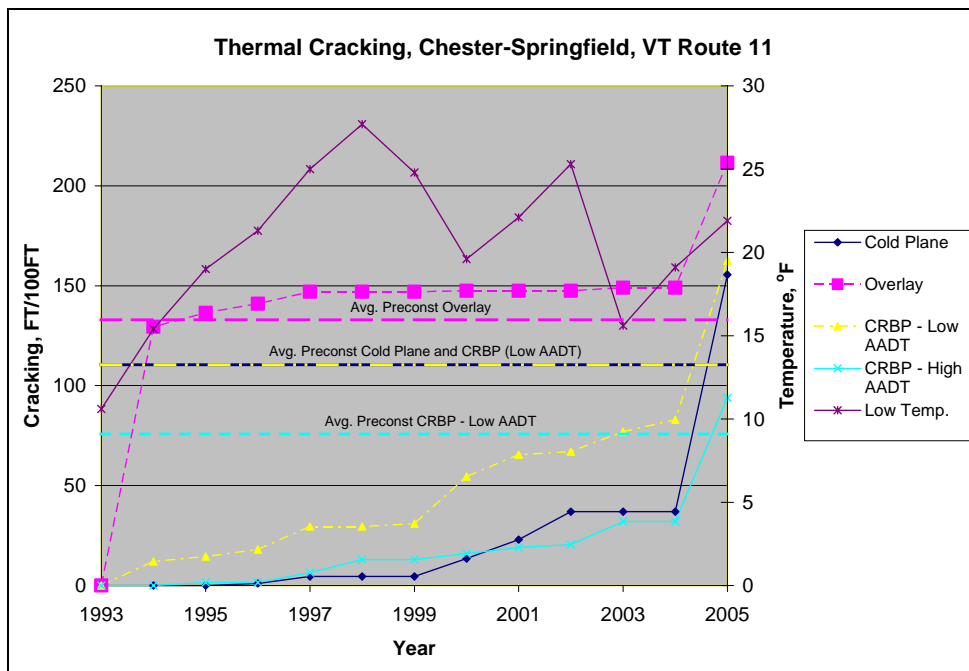
The formation of transverse cracking is largely due to climatic conditions and is often induced by freeze-thaw cycles or maximum low temperature shrinkage cracking. In addition to comparison of the cumulative transverse cracking between the experimental and control sections, monthly average minimum temperatures were attained from a weather station that resides in Burlington, VT, and are provided in Figure 5 below:

Figure 5 – Thermal Cracking

Unlike AADT, temperature remains a constant variable across all test sections. While the average amount of preconstruction cracking was variable across all sections, the minimum amount of thermal cracking was identified within the CRBP low AADT section at an average of 74 feet per 100 foot test section while the maximum amount of thermal cracking was found in the overlay section at an average of 132 feet per 100 foot test section. As would be expected, the standard overlay control section is the first to meet its preconstruction levels sometime between 1994 and 1995, only 1 to 2 years following construction. This is most likely due to reflective cracking from the underlying pavement and is further supported by the slope of the line. In examining 1997 through 2004, the amount of thermal cracking does not increase in this section. Surprisingly, all other treatments were found to meet preconstruction levels between 2004 and 2005, 11 to 12 years following construction. A reduction in the rate of thermal cracking may be expected within the CRBP areas due to the reclamation process. However, a greater

amount of reflective thermal cracking was expected within the cold planed areas. It is important to note that construction plans specified the removal of 3.5” of preexisting pavement within the cold planed areas and the reclamation of 3.5” of preexisting pavement within the CRBP sections. The rate of thermal cracking within the CRBP sections and cold planed area appears to be relatively consistent with the exception of the period between 2004 and 2005 consistent with the colder temperatures shown in the graph.

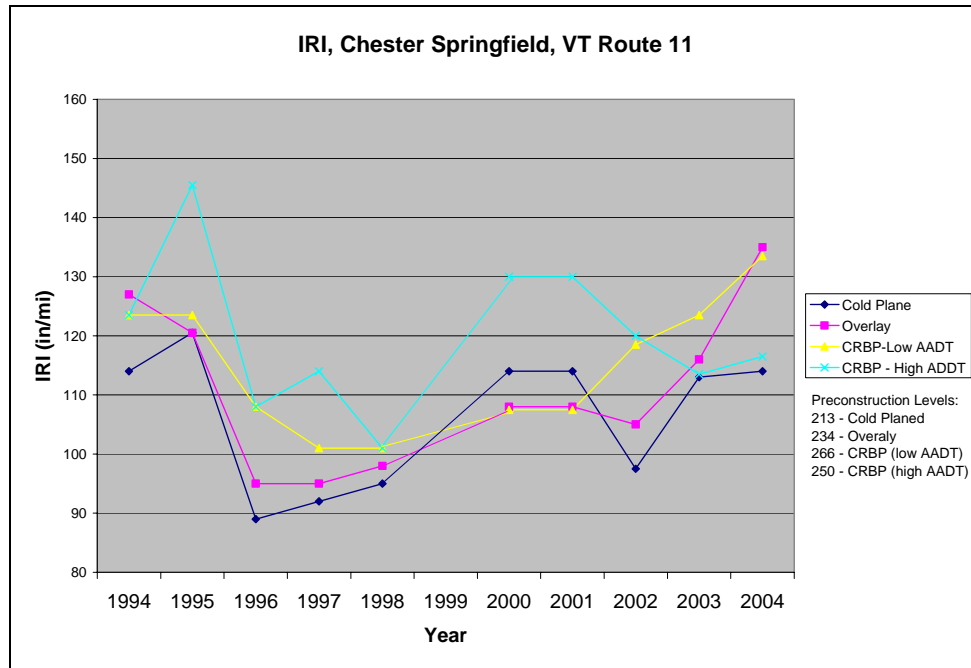
collected on an annual basis with the exception of 1999 through the Pavement Management Section of VTrans utilizing road profilers. Please note that the data was collected by different vendors through the investigation which resulted in poor correlation between collection events. The following figure provides a summary of the IRI data:

Figure 6 – IRI

There are some discontinuities within the data set. Usually IRI values are at a minimum immediately following construction as the pavement condition is optimum and will then degrade over time. Therefore, it was anticipated there would be an upward trend throughout data collection. However the initial IRI values are greater than those from following years which may be caused by the variation in testing equipment. There is a general upward trend between 1998 and 2004. In the latest data collected (2004), the IRI values for each pavement section were well below preconstruction values. This inference may not be accurate due to the variability of sampling equipment. It was documented that three different road profilers were utilized for the collection of the IRI values throughout the investing period. Each of the road profilers vary from one another which causes discontinuities between annual data sets. The ratio between the IRI data collected in 2004 as compared to preconstruction values are fairly consistent across all test sites and were found to range between 47 percent in the CRBP section with a high AADT to 57 percent in the overlay section. It is also important to keep in mind that IRI is directly related to all pavement distresses. It is recommended that all future IRI values are collected by the same profiling device for research projects evaluating various pavement treatments in order to provide consistency and accuracy. If there is a change in profiling device, there should be an effort to establish a correlation between data sets by selecting a number of reliable-data-value sites for measurement and verification.
