**3M Stamark Polyurea  
Liquid Pavement Marking Series 1200  
In Grooved Pavement Surfaces  
South Burlington, Vermont  
Final Report**

**July 2007**

**Report 2007 - 10  
Reporting on Work Plan 2002-R-1**

State of Vermont  
Agency of Transportation  
Materials and Research Section

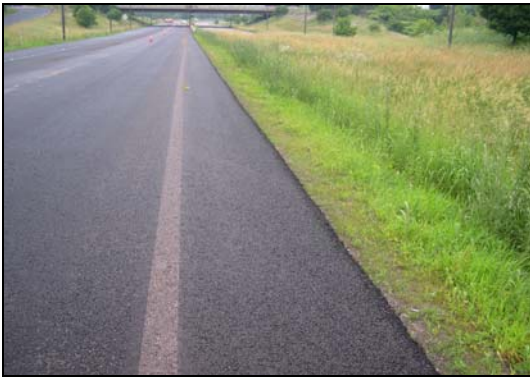
Figure 2- Recess for Yellow Edge Line

Pavement application was completed by F. W. Whitcomb Construction Corp. on Wednesday, June 11, 2003 in the eastbound lane and Sunday, June 22, 2003 in the westbound lane. Striping and groove installation operations were performed by L & D Safety Markings from Berlin, Vermont. Preparation of the roadway for the application of the pavement markings began on Sunday, June 29<sup>th</sup>, 2003. This involved milling the pavement with specialized equipment to a depth of 40 mils +/- 10 mils in the areas designated to be recessed, as shown in Figure 2, for all of the longitudinal markings including the right, left and center skip lines. Following recessing activities, heavy rain postponed the application of the LPM markings.

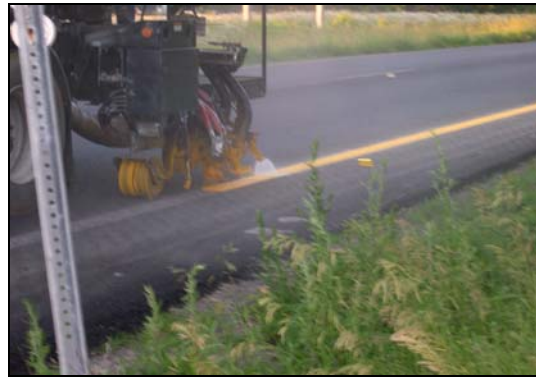
Figure 3- Yellow Edge Line Application

Application of the markings commenced on the evening of Monday, June 30, 2003. All markings were applied following the evening rush hour due to the high traffic volume. Weather conditions were clear with temperatures ranging from 78°F at 6:00 PM to 64°F at midnight. Installation of the yellow edge line in the WB lane between MM 1.433 to MM 0.334 began at 7:40 PM, as displayed in Figure 3. Immediately after placement of the WB yellow edge line, striping of the yellow edge line continued in the EB lane from MM 0.000 to MM 1.492. Application of the yellow edge line was completed by 8:30 PM. Installation of the white edge lines began at approximately 10:00 PM, as shown in Figure 4. Research and Development staff observed the placement of the EB white edge line until approximately 10:15 PM. All markings were completed before daybreak on Tuesday, July 1, 2003.

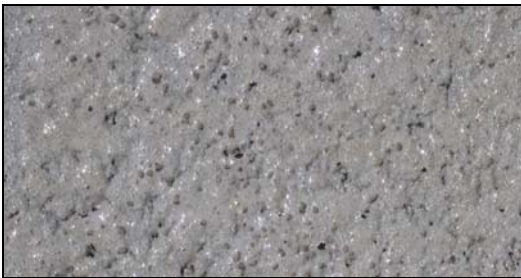
Figure 5 – Test Site 5 White Edge Line  
July 30, 2003, Wear Rating = 10

Retroreflectivity readings and visual assessments were collected on a periodic basis through the spring of 2007 utilizing an LTL 2000 retroreflectometer which employs 30 meter geometry. Photographic documentation was also gathered at individual test site locations during each field visit. Figures 5 through 8 show the condition of the yellow and white edge lines at test site 5, located at MM 0.950 WB, on July 30, 2003, 49 days following application, and at a recent site visit on May 30, 2007, four years following application, along with wear ratings of the markings. All retroreflectivity and durability readings were recorded onto the appropriate field forms and then compiled into a dedicated spreadsheet. The data collection process was carried out year round, including winter months when the ambient air temperature fell below the minimum temperature specified within the ASTM testing procedures of 40°F. However, care was taken to maintain the testing equipment above the minimum specification during travel and between test sites. Where warranted, the pavement markings were cleaned with a mixture of water and windshield washer fluid to remove any salt, dirt or other debris and then thoroughly dried prior to data collection in accordance with the “Protocol for the Cleaning of Line Striping to Test for Retroreflectivity.” A copy of the protocol is provided in Appendix A.

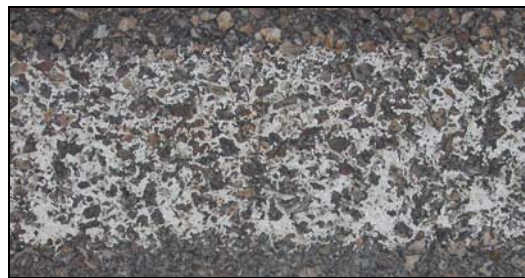
Figure 6 – Test Site 5 White Edge Line  
May 30, 2007, Wear Rating = 4

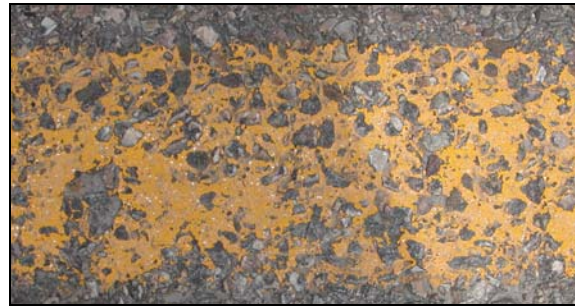
Figure 8 – Test Site 5 Yellow Edge Line  
May 30, 2007, Wear Rating = 5

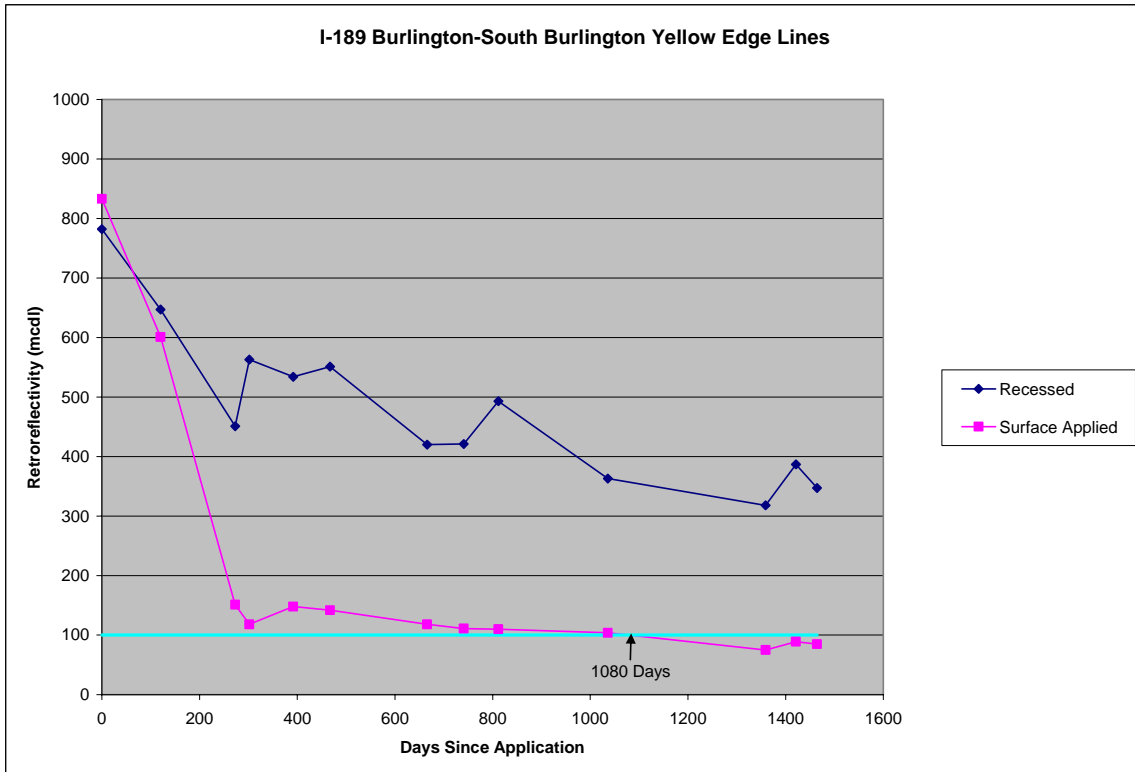
Figure 10 – Service Life of Yellow Edge Lines

A similar analysis was completed for the yellow edge lines to establish the estimated amount of time before the retroreflectivity values fell below 100 mcdl, as shown in Figure 10.

Based on the readings gathered so far, the recessed yellow edge lines have not yet reached the end of service life, as they were still well above 100 mcdl at the time of the last data collection. Therefore a service life estimate could not be performed. The readings for the surface applied markings fall below 100 mcdl after 1080 days, indicating that at this point the end of service life has been reached.
