**Evaluation and Comparison of
Epoplex LS-50 Epoxy
Lyndon/Sheffield IM 091 - 3(11)
Final Report**

**Report 2007 - 11
Reporting on Work Plan 2002-R-8**

State of Vermont
Agency of Transportation
Materials and Research Section

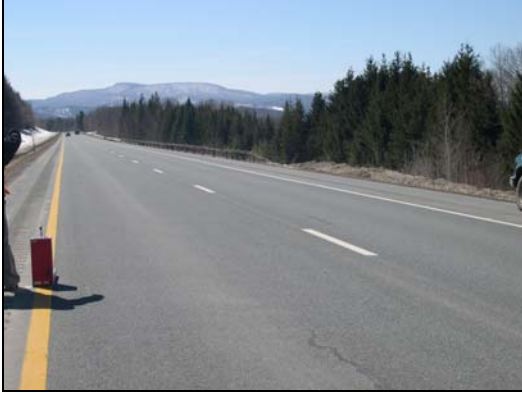
Figure 1 -Test Site 1, MM 150.00

Retroreflectivity readings and visual assessments were collected on a periodic basis through the spring of 2005 utilizing a LTL 2000 retroreflectometer which employs 30 meter geometry. Photographic documentation was also gathered at individual test site locations during each field visit. All retroreflectivity and durability readings were recorded onto the appropriate field forms and then compiled into a dedicated spreadsheet. The data collection process was carried out year round, including winter months when the ambient air temperature fell below the minimum temperature specified within the ASTM testing procedures of 40°F. However, care was taken to maintain the testing equipment above the minimum specifications during travel and between test sites. Where warranted, the pavement markings were cleaned with a mixture of water and windshield washer fluid to remove any salt, dirt or other debris and then thoroughly dried prior to data collection in accordance with the “Protocol for the Cleaning of Line Striping to Test for Retroreflectivity.” A copy of the protocol is provided in Appendix A. Two test sites are shown in Figures 1 and 2 below.

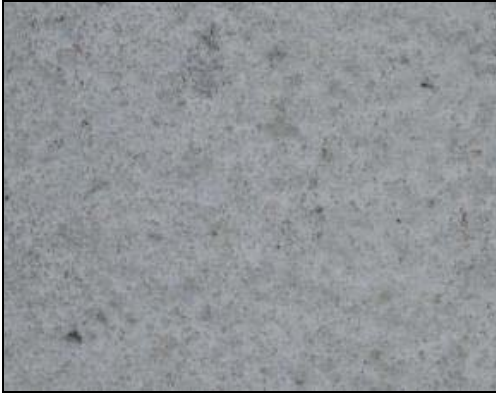
As anticipated, a significant drop in retroreflectivity, 156 mcdl on average, is evident across all markings following the first winter season. This is most likely attributed to shearing effects resulting from winter maintenance practices. In general, the markings continuously decay over time although there does appear to be a spike in December of 2003, one year following installation. Given the lower readings prior to and following this particular data collection event, the spike may have been caused by salt residue on the surface of the markings. In addition, while the retroreflectivity readings displayed a large loss following the first winter season and throughout this investigation, the durability readings remained high. This indicates that the epoxy binder was highly resistant to wear from tire abrasion and winter maintenance practices further supporting a problem with the application of glass beads. This may be caused by a number of factors including bead rate, the position sprayer in relation to the binder and/or insufficient ambient and roadway temperatures. Figures 3 and 4 display the condition of the binder in 2003 as compared to 2006, three years following application.

**Figure 3 – Test Site 1 (2003)
Durability =10**

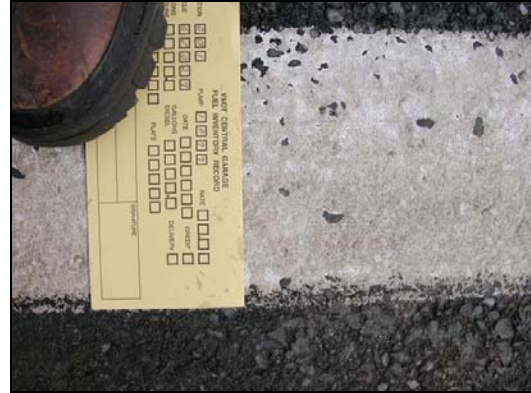
**Figure 4 – Test Site 1 (2006)
Durability = 9**

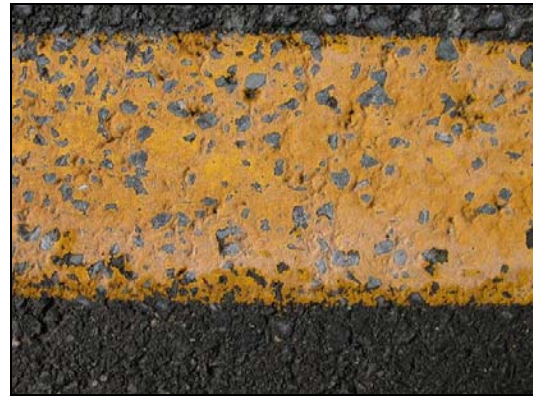
Once again, a significant drop in retroreflectivity, 95 mcdl on average, is evident following the first winter season. This indicates a substantial initial decay rate of 61%. The retroreflectivity continues to decay over time residing below the FHWA recommendation several months following application with greater losses during winter seasons and a slight rebound during summer months. Once again, the epoxy binder held up well in terms of durability and resistance to wear as shown in Figure 5 and 6 below. As stated previously, wear readings suggest a strong bond to the underlying pavement while the retroreflectivity readings indicate a weak bond to the epoxy binder.

Figure 6 – Test Site 2, 2006
Durability = 7

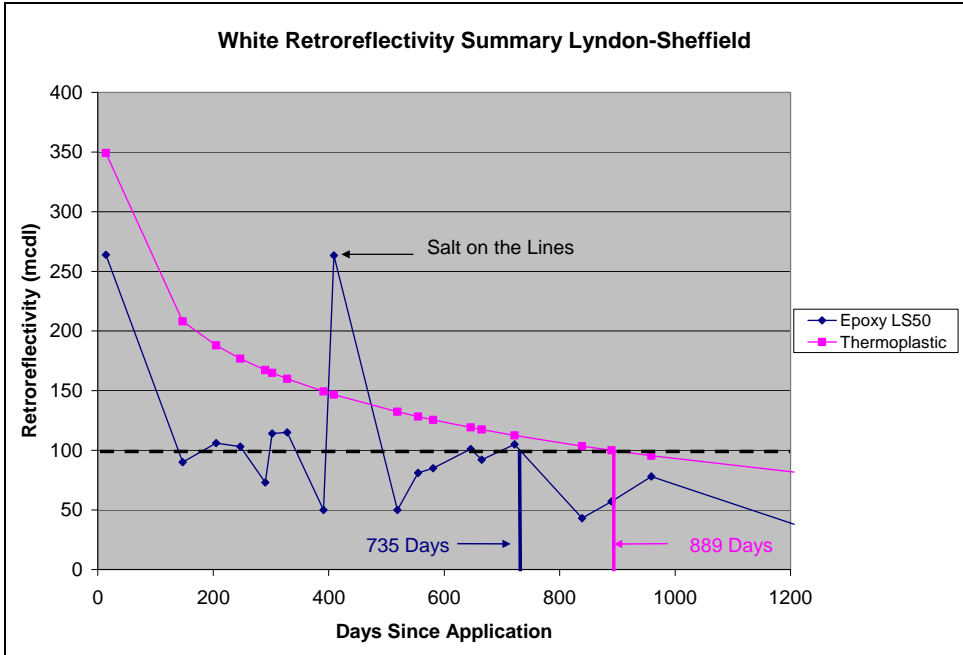
Service life estimates for the white line pavement marking could not be determined from Table 4 due to the large extent of time between data collection events. Therefore, a scatter plot of the data was generated in order to establish the approximate amount of elapsed time before retroreflectivity values fell below 100 mcdl, as shown in Figure 7. Please note that only white lines are modeled for this analysis due to the inherent variability of yellow pavement markings. Unfortunately, a control section comprised of a standard marking material was not incorporated into this study. However, a recent investigation, entitled “Pavement Marking Durability – Statewide,” was recently published concerning the overall durability and retroreflectivity of various durable markings. Decay models, incorporating data from various construction projects throughout the state of Vermont, were generated. Figure 7 contains a scatter plot of the epoxy markings as well as a decay model for the white thermoplastic markings for comparative purposes.

Figure 7 – Epoxy White Edge Lines vs. Thermoplastic Model

Estimated service lives for the white pavement markings are as follows:

- Epoplex LS50 – 735 days
- Thermoplastic – 889 days
