**Evaluation and Comparison of
Cold Weather Waterborne Traffic Paint with XSR
Middlesex/Moretown VT 100B
Final Report**

**Report 2007 – 12
Reporting on Work Plan 2006-R-3**

State of Vermont
Agency of Transportation
Materials and Research Section

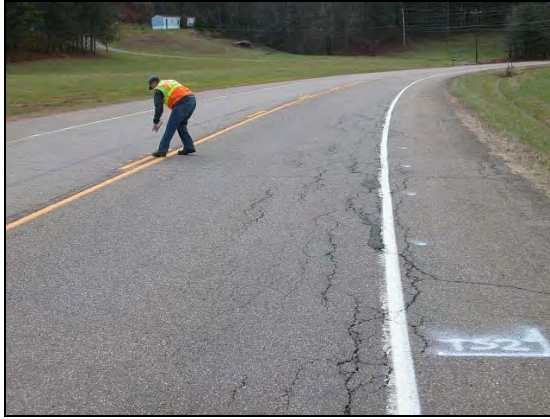
Figure 1 – XSR 11/09/06

The initial drop in retroreflectivity is also important to examine as it relates to proper curing. If properly cured, both the binder and the beads retain higher bond strength to all surrounding substrates and should be less susceptible to wear and tear from tire treads. Over a six day period, the initial retroreflectivity readings of the standard markings decreased by an average of 129 mcdl while the XSR marking decreased by 35 mcdl, suggesting that the experimental markings cured more readily at lower temperatures. As stated previously, wear readings were also collected. Wear readings are a visual assessment of the amount of substrate remaining and are rather subjective. This variable is dependent on several parameters, including proper application, wear from tire treads and winter maintenance practices, and ultraviolet radiation. Figures 1 through 4 display the marking materials immediately and seven months following application.

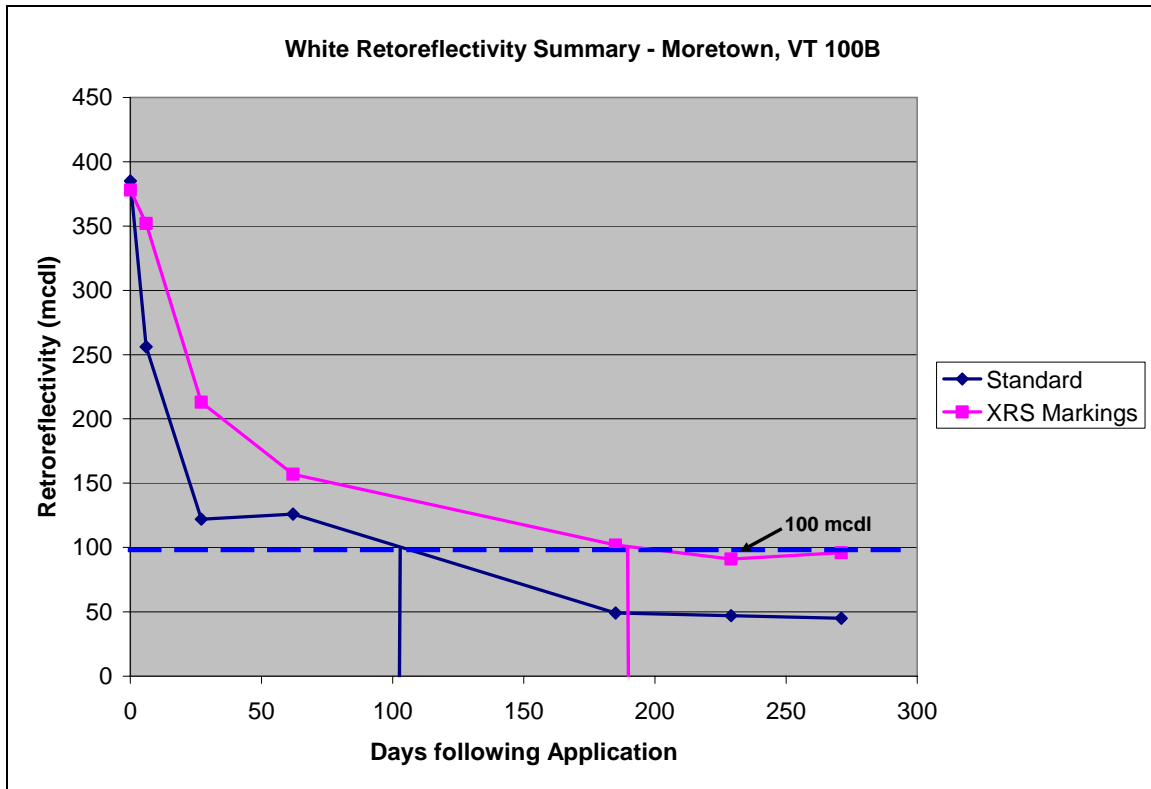
Figure 5 – XSR and Standard Marking Comparison

Service life estimates for the white line pavement marking could not be determined due to the large extent of time between data collection events. Therefore, a scatter plot of the data was generated in order to establish the approximate amount of elapsed time before retroreflectivity values fell below 100 mcdl, as shown in Figure 5. Please note that only white lines are modeled for this analysis due to the inherent variability of yellow pavement markings.

- Cold Weather Waterborne Paint with XSR – 188 days
- Standard Waterborne Traffic Marking Paint – 110 days

A cost analysis was performed with consideration to FHWA's minimum recommended retroreflectivity. Service lives were found to be 188 and 110 days for the XSR and control markings, respectively. While the initial cost of the XSR markings is slightly higher at \$7.10/gallon as compared to \$5.00/gallon for white markings, the cost analysis indicated that the XSR markings are more cost effective over the life of the marking materials, which was postulated to be less than one year.
