**Evaluation of ATM 300 Permanent
Durable Tape
Initial Report**

**Report 2007 – 18
Reporting on Work Plan 2007-5**

State of Vermont
Agency of Transportation
Materials and Research Section

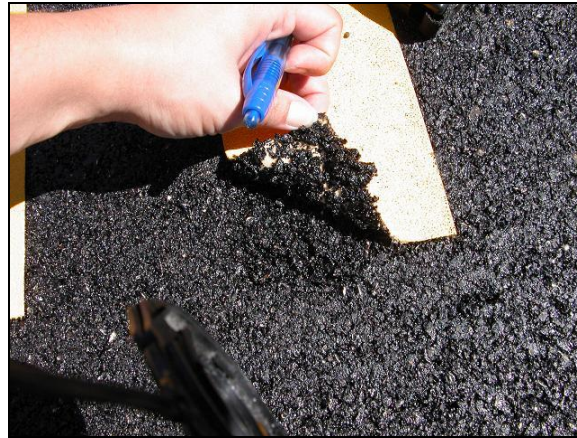
Some general observations during application included the ease of tape removal. As depicted in Figure 1, the tape readily lifted with hand force. However, the tape does appear to be well adhered to portions of the pavement. This may indicate that the pavement has not thoroughly set. There was also some evidence of shrinkage at the beginning and ending of each continuous tape section. The shrinkage appeared to pull the surface of the HMA as well. Interestingly, application literature states, “if tape distorts or wrinkles, surface temperature may be too hot or roller speed may be too fast.” These areas will continue to be monitored overtime.

Figure 1 – Tape lifted

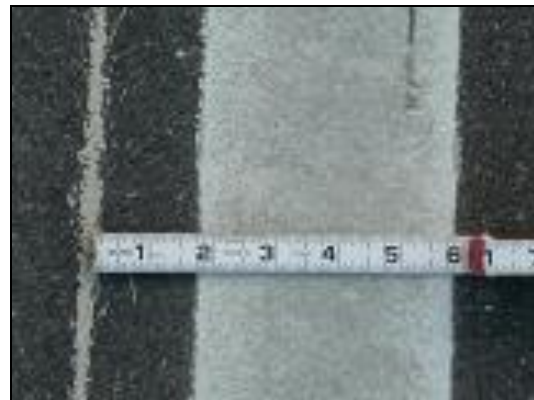
Retroreflectivity readings and visual assessments were collected utilizing a LTL 2000 retroreflectometer which employs 30 meter geometry. Photographic documentation was also gathered at individual test site locations during each field visit. All retroreflectivity and durability readings were recorded onto the appropriate field forms and then compiled into a dedicated spreadsheet. Initial site visits concerning the experimental markings were conducted on September 18th and September 25th, on the day of application and 7 days following application, respectively. An initial assessment of the thermoplastic markings was conducted on October 10th, 5 days following the application of the white edge line thermoplastic markings and 9 days following the application of the yellow centerline traffic markings. All pavement markings were found to be intact. Gas bubbles were noted within the thermoplastic markings as well as shadows as displayed in Figure 2 and 3. According to literature provided by Ennis Paint, gas bubbles are generally caused by either moisture or solvent trapped in the hoses or from overheating. Thermoplastic shadows may be generated by a heavily undulated road surface or die not riding evenly on the substrate. In either case, evidence suggests some problems during application which will most likely affect long term durability and retroreflectivity.

Figure 3 – Material Shadows on Line (TS 2)

Thermoplastic marking paint was applied to the remainder of the project on Tuesday, September 25th, Monday, October 1st, Thursday, October 4th and Friday, October 5th. This marking will be considered the control for comparative purposes. During an initial inspection gas bubbles and line shadowing was observed providing evidence of improper application. This will most likely have an affect on the overall durability and retroreflectivity.
