**GlasGrid Pavement Reinforcement System
Charleston and Barnet, Vermont
Final Report**

March 2008

**Report 2008 - 1
Reporting on Work Plan 95-R-11**

State of Vermont
Agency of Transportation
Materials and Research Section

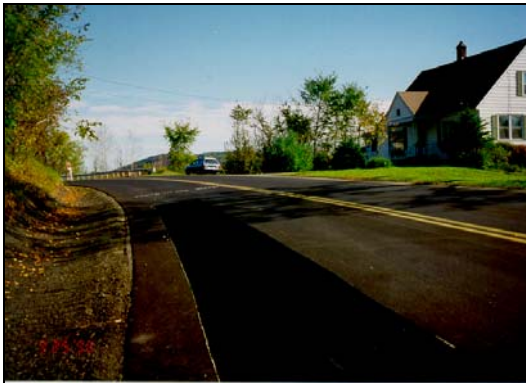
Figure 5 - GlasGrid Placement in Barnet

On September 25, 1998, GlasGrid[®] pavement reinforcement was placed on a portion of US Route 5 in the town of Barnet. The GlasGrid Detail Repair System (8502) was installed on the outside wheel path of the southbound lane. A preliminary crack survey of the test site clearly defined the location of the underlying concrete road base, with longitudinal and full-length transverse cracking. Severe fatigue cracking in the outside wheel paths was also evident, a distress possibly associated with the gravel subbase structure beneath the asphalt overlay, adjacent to the concrete slabs. This was probably created by the widening of the original concrete roadway. The test product was applied to a 100 ft x 5 ft section of the southbound lane as depicted in Figure 5. The material was installed by hand from a roll attached to the back of a pickup truck shown in Figure 6. The product was placed with the tacky side down on the leveling course and the material was coated with asphalt emulsion. The lane was then paved with a 1.5" wearing course. There was no manufacturer's representative present during the installation.

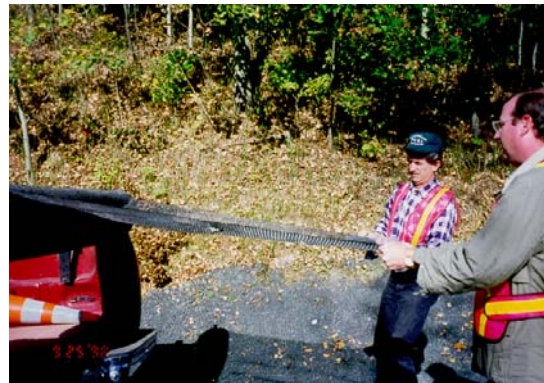
Figure 6 – Installation in Barnet

It should be noted that the manufacturer generally does not recommend using asphalt emulsion between courses. Also, in a 2000 telephone conversation with a GlasGrid sales representative while researching the possibility of another GlasGrid project, the Agency was advised against the use of GlasGrid as an interlayer between an old concrete road base and an asphalt surface because the properties of the material are not designed to handle the movement of concrete slabs. GlasGrid is designed to handle thermal expansion problems, not movement of the subbase like that caused by concrete slabs.

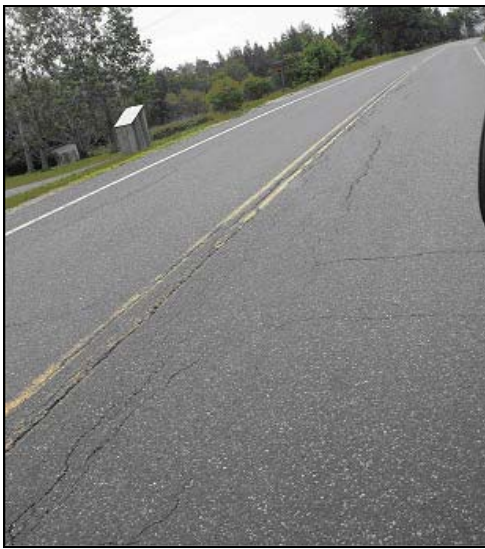
Figure 7 – Eastbound view, 2007

The cracking in the westbound lane continued to expand over the next two years, but not as severe as in the area outside of the test section. In July 2002, minor cracking was noticed in the inner wheel path of the eastbound travel lane. Again, this cracking appeared worse in the area outside of the test section, indicating that the GlasGrid may be aiding in retarding reflective thermal cracking. In August 2003, the cracking appeared to have increased in both travel lanes, although it appeared worse in the westbound lane. The pavement was observed to be in generally good condition at that time. A site visit in June 2007 revealed that fatigue cracking in the eastbound lane had increased significantly since the previous site visit and appeared to have more cracking than the westbound lane. Figures 7 and 8 display the cracking observed in the 2007 site visit. The westbound lane had developed minor fatigue cracking in the outer wheelpath as well as a few short transverse cracks in the middle of the lane. In general, less longitudinal cracking was observed in the test section than in the adjacent areas.

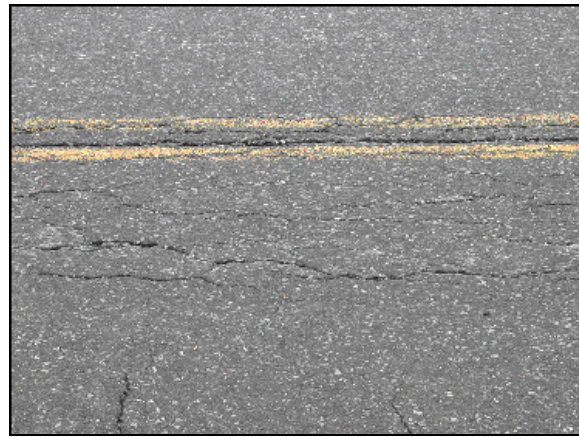
Figure 8 – Eastbound Lane cracking, 2007

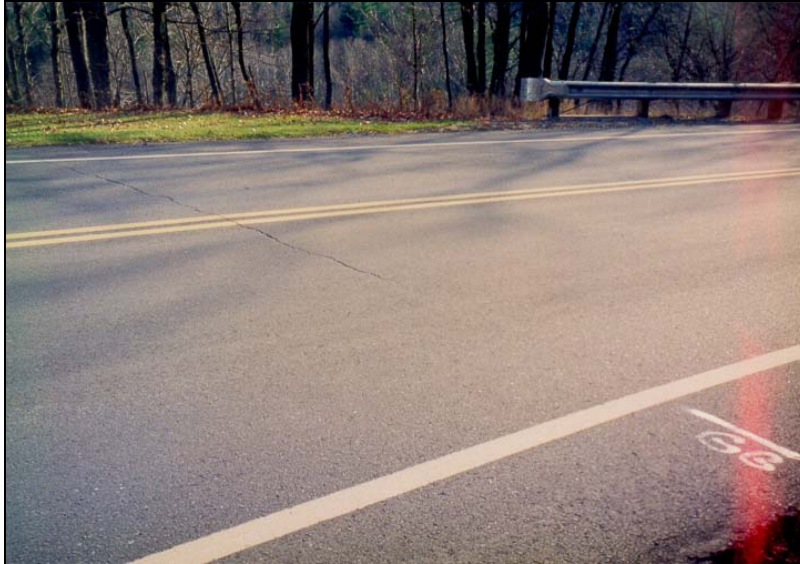
At the initial site visit in November 1999, only one year following installation, minor transverse cracking was observed. Two transverse cracks began in the northbound lane and spread slightly into the GlasGrid section of the southbound lane, as displayed in Figure 9. No evidence of longitudinal cracking, the primary type prior to the installation, was found. In July 2000, one of the previously noted transverse cracks had extended across the full width of the roadway and the other had extended all but one foot of the full width. Similar cracks, predominantly full width, were found both north and south of the test site. The first signs of longitudinal cracking were observed in June 2001 near the edge of the material in the southbound lane. The amount and length of transverse cracks also continued to increase, with some cracks up to 3 cm wide. No major new cracking was noted in July 2002, although the previously observed longitudinal cracks continued to increase in length. In August 2003, the site was found to be in relatively good condition with little deterioration in the GlasGrid test area.

Figure 9 – Barnett in 1999, 1 year after placement
