FINAL REPORT

DETECTION AND MITIGATION OF SUBSIDENCE AND VOIDS ON VERMONT ROADWAYS

I-89 Hartford and US 7 Manchester, Vermont

May 30, 2008

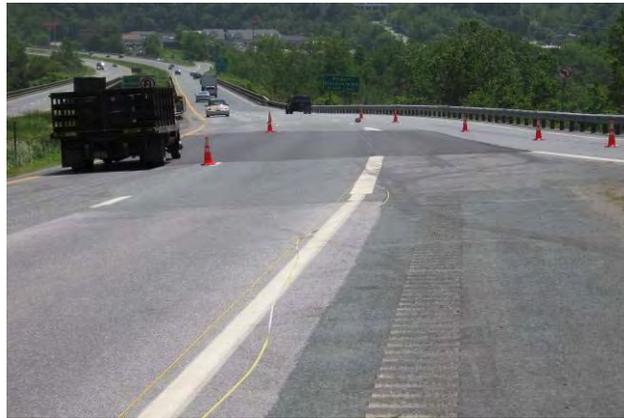
Figure 5.2 Interstate 89, Hartford, Vermont looking east toward New Hampshire. The asphalt patch extending across both southbound lanes indicates the region of subsidence.

The greatest settlement occurs in the driving (right hand) lane of the southbound side with some extension into the passing lane. The main portion of the dip extends approximately 100 feet along the driving lane and maximum settlement is close to 3 feet, leaving the original pavement structure altered by thick sections of asphalt overlay.

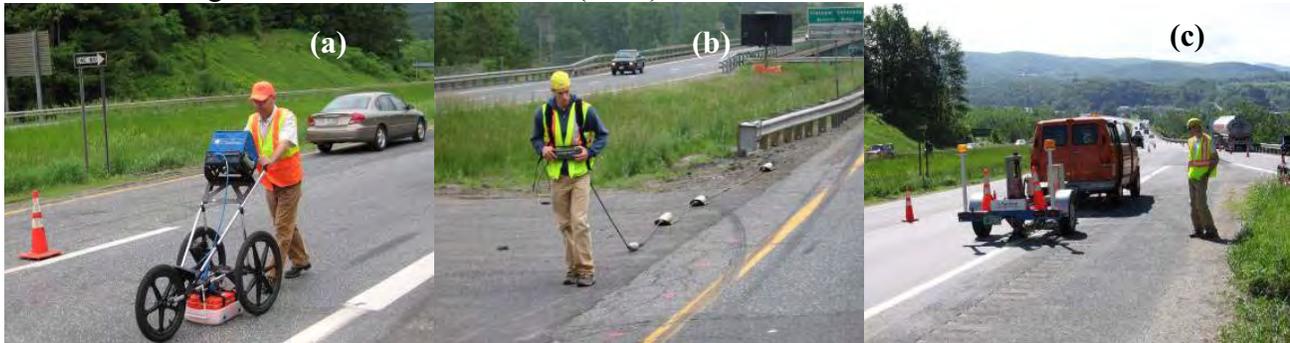
pavement surface. An array of geophones recorded corresponding surface deflections at locations radially unique to the loading plate. Figure 6.1 shows the three systems we selected. We also performed a trial survey with a rolling wheel deflectometer (RWD) at the I-89 site using a 53-foot tractor trailer rig outfitted with optical sensors to measure deflections.

Figure 6.1 (a) GSSI cart-mounted GPR. (b) Geometrics OhmMapper CCR towed array. (c) Dynatest® FWD trailer system.
