**Evaluation of Concrete Bridge Rail Cracking
Initial Report**

Report 2009 - 5

State of Vermont
Agency of Transportation
Materials and Research Section

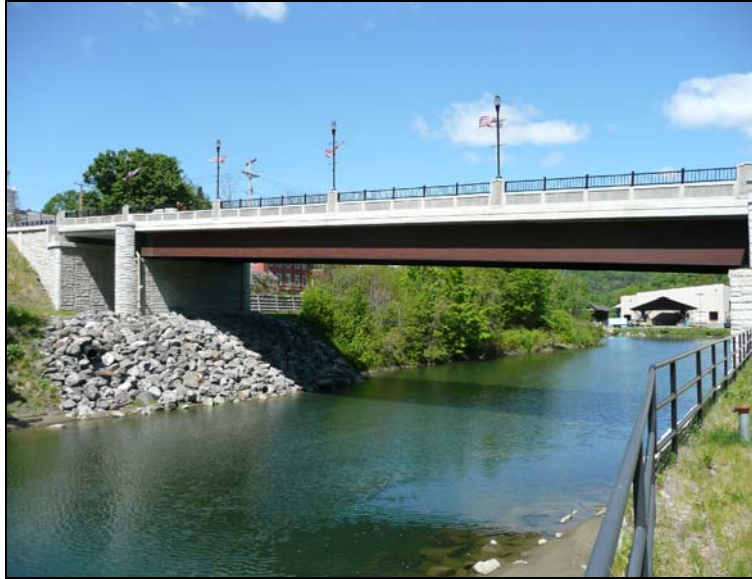
Rails were poured on four days from September 18 through September 28, 2006, with rubbing and finishing finalized on October 5, 2006. In all cases, forms were stripped off the day following casting and sprayed with a pressure washer in an attempt to expose the underlying aggregate for a ‘pebble’ finish along the exposed surfaces. This did not work as well as planned, as some panels contained an adequate ‘pebble’ finish while others retained a flat appearance. According to onsite personnel, this discrepancy was preliminarily due to insufficient construction practices as greater sufficiency with form release agents were developed during the finishing process.

Figure 1. Overview of the Bethel bridge.

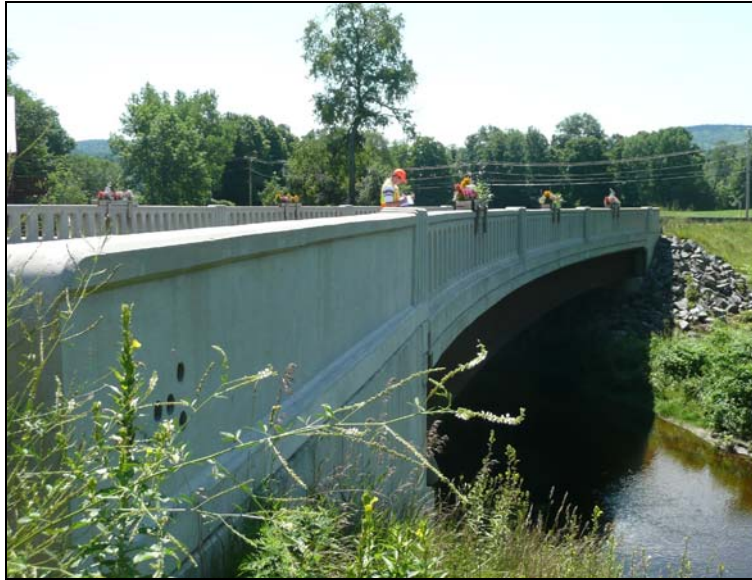
finally coated with silane for waterproofing on November 4, 2004. Figure 2 shows the finished product.

Figure 2. Overview of the Chester bridge.

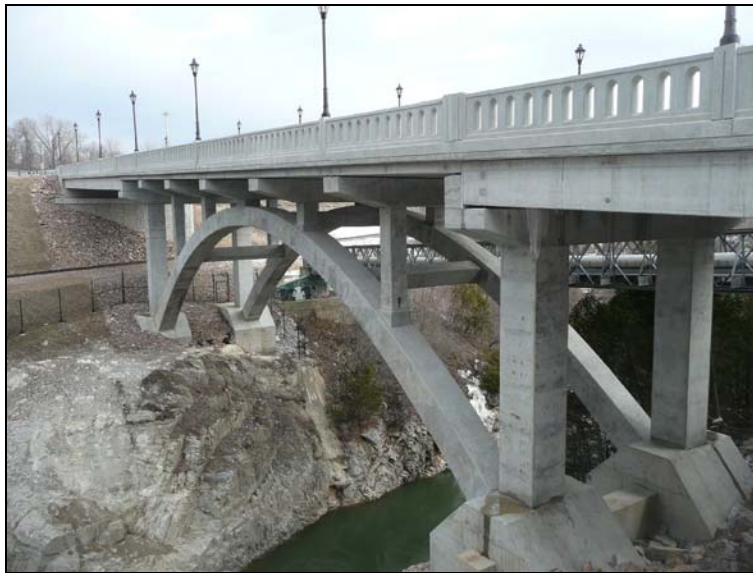
Figure 3. Overview of the Colchester - South Burlington bridge.

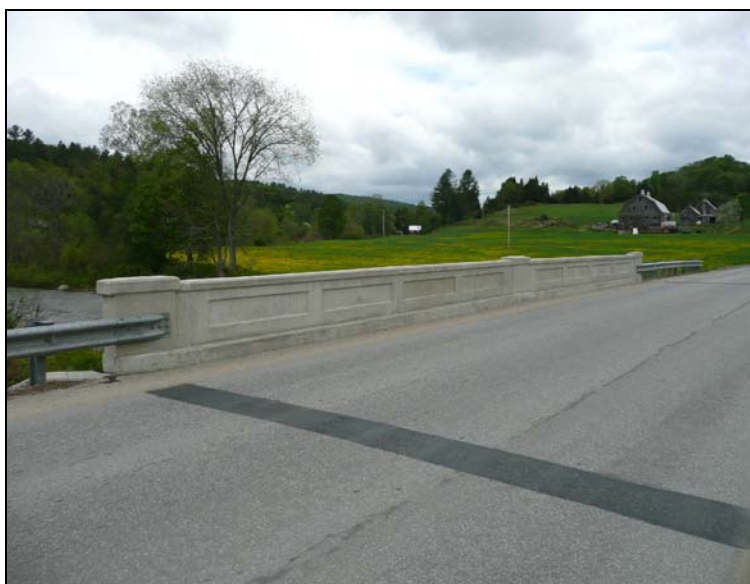
Pouring of the rails occurred on September 23 and 28 of 2004. In both cases form removal and rubbing began the day after casting and finished three days later. Silane was applied to the rails on October 27, 2004.

Figure 4. Overview of the Corinth bridge.

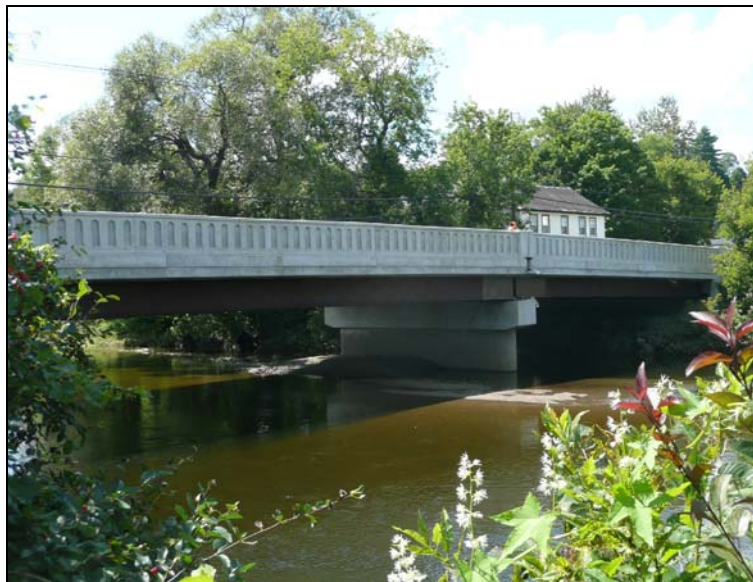
As with the previous Corinth bridge, the Lyndon bridge was rehabilitated with a new deck system. In 2004 the entire deck and rail structures were replaced with new concrete and reinforcing steel. This bridge is unique amongst the sample bridges as it is the only one consisting of three simple spans, which would produce a different stress profile across the structure. Rail design consists of partial window cut, i.e. a deep stencil on the surface.

Figure 5. Overview of the Lyndon bridge.

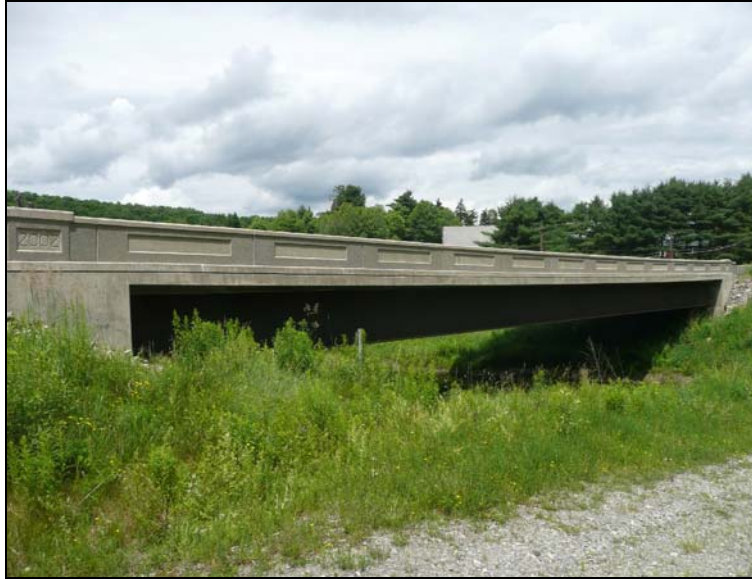
Casting of these bridge rails took place beginning on June 27, 2002 and continued through July 19, for a total of eight pour dates. No dates or comments were found referencing form removal or finishing of the rails. Rail design for this bridge consisted of solid sections with different surface finishing on the inner rectangular panels than was present on the outer areas, for aesthetic purposes.

Figure 6. Overview of the Morrystown bridge.

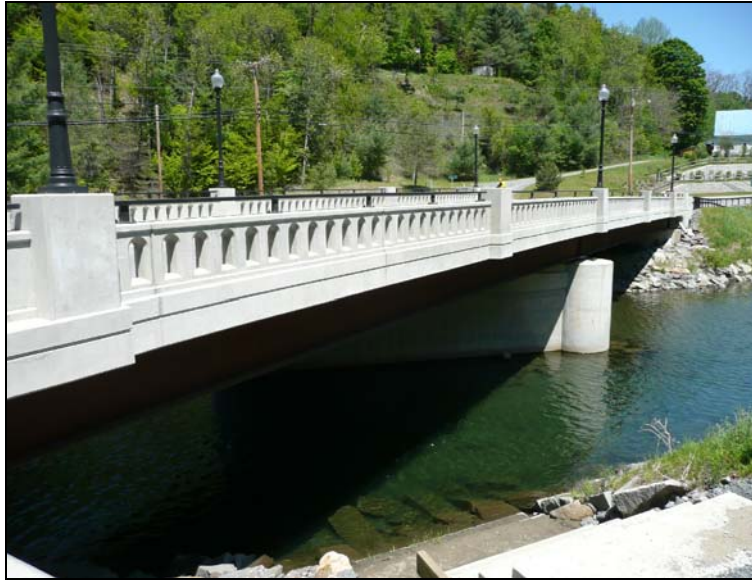
Rail pouring commenced on November 17, 2006 and finished on January 8, 2007. There were a total of 10 pour dates spread fairly evenly across this timeframe. Rail sections were cast in a leapfrog pattern, i.e. alternating sections and then filled in between afterwards. Forms remained on the concrete anywhere from 2 to 12 days depending on the conditions and were rubbed soon thereafter. Silane was applied within one month of casting in all cases. Rails for this bridge include gothic style windows with a top-mounted steel rail and lamp posts anchored to alternating pilasters.

Figure 7. Overview of the Tunbridge bridge.

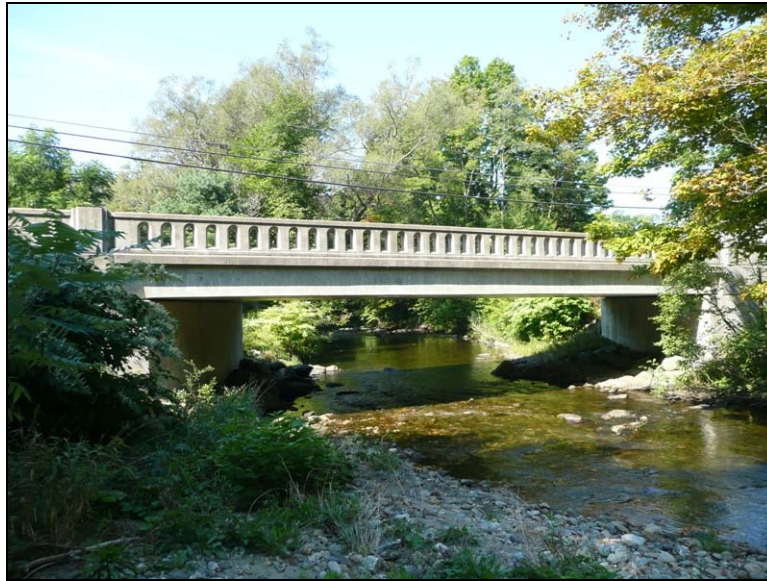
Figure 8. Overview of the Underhill bridge.

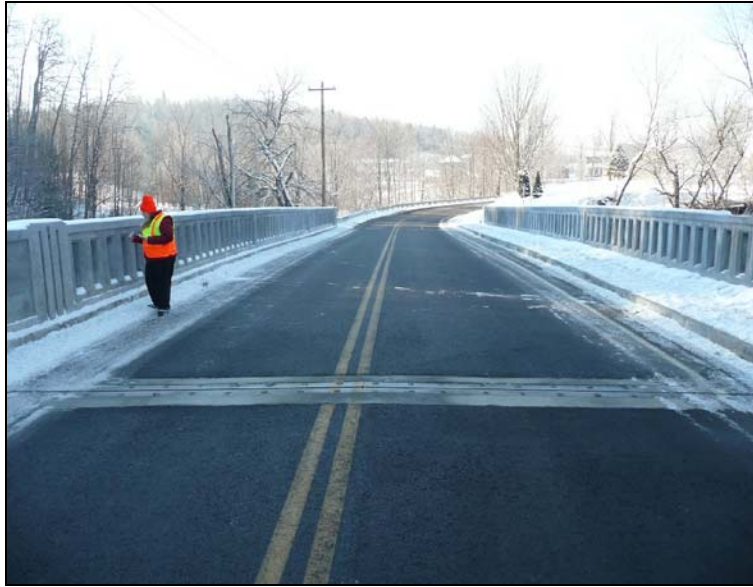
the rails commenced. Silane was applied to both rails on November 26. Rail design for this bridge consisted of Texas style rails with windows.

Figure 9. Overview of the Barton bridge.

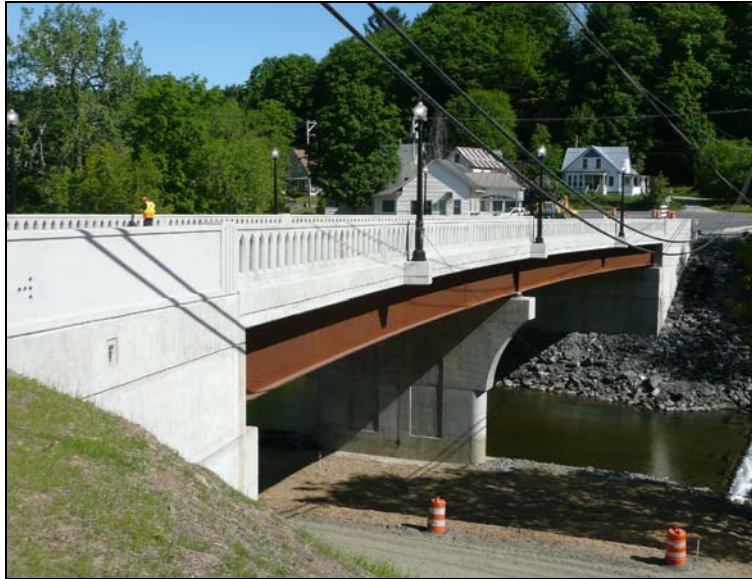
Downstream portions of the rail were poured during six days, from October 3 to 10, 2007 and the upstream were completed during an eight day period, from October 11 to 22. It was noted by the resident engineer that air contents of the concrete deliveries decreased steadily during the pours for the downstream rail on a daily basis, but were still within specification. For one section, “Section 7,” of the upstream rail, on the other hand, the air content was below specification. Section 7, from station 17+04 to 17+38 Lt, was poured on October 18. Forms were removed in all cases after only one day so that rubbing could begin in order to fill in any existing voids and smooth the finish of the rails. The rails were then kept wet by a hose and burlap for 10 days.

Figure 10. Overview of the Randolph bridge.

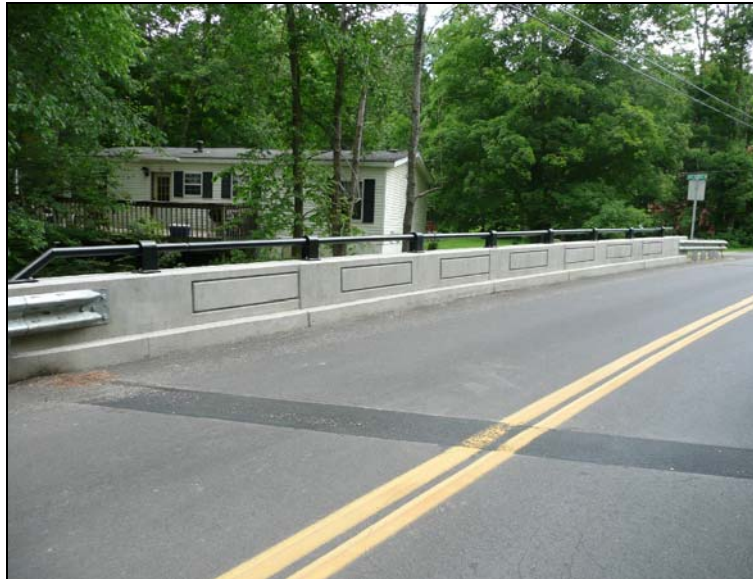
Figure 11. Overview of the Warren bridge.

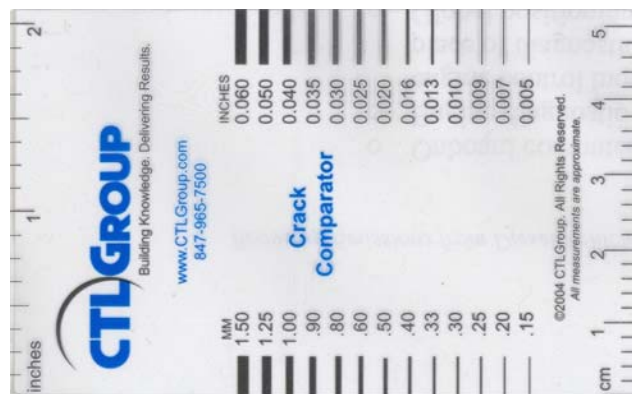
The approximate width of each crack was also noted on the crack diagrams. Crack widths were determined via the use of a common ‘crack comparator card’ donated by the CTL Group as shown in Figure 12. This transparent card is approximately the size of a credit card and contains reference lines for measuring crack widths in either mm or inches. Inches were utilized throughout this investigation for consistency and to reduce user error. Widths were estimated, by use of the cards, at a location along the crack representative of the average crack width. Therefore, the maximum width of the crack may not have been recorded.

Figure 12. Crack comparator card used to estimate crack widths.

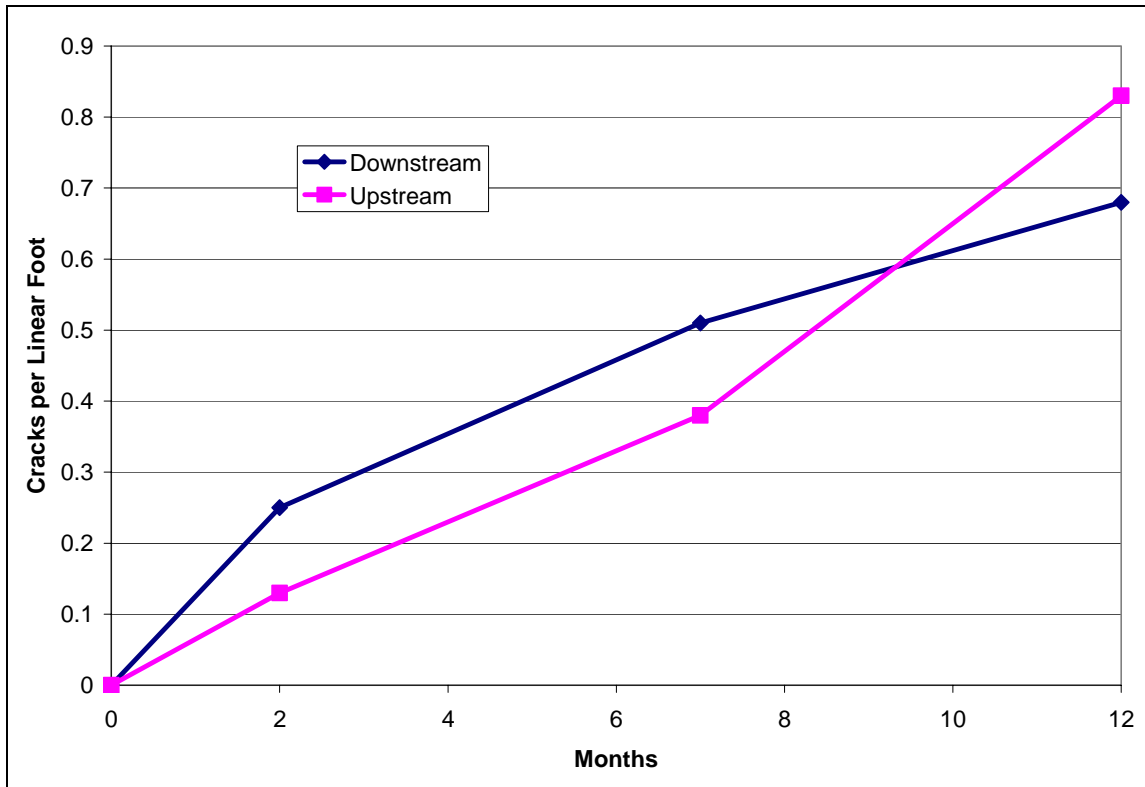
Figure 15. Plot of cracking over time for the Barton bridge rails.

The number of cracks along the Barton bridge rails, documented over the first year following construction, increased consistently between site visits as shown in Figure 15. On average, the amount of cracking along each rail has increased at a rate of about 0.06 cracks per foot per month, resulting in the average of 0.75 cracks per foot after 12 months of service. The crack widths, however, did not increase significantly, especially when compared to other bridges as will be discussed in the next section. During the five month period between the second and third site visit the widest cracks increased from about 10 mils to only 20 mils. The total count of the largest cracks was minimal compared to the total number of cracks overall; 10 out of 173 cracks were found to be greater than 20 mils, or 5.8%.

It is important to note that the concrete mix for this bridge contained a shrinkage control admixture, Eclipse Plus, as part of an experimental evaluation. It is possible that the admixture reduced the severity of the crack widths. However, the data collected provided evidence that the admixture did not eliminate or even reduce the amount of cracking along the rails, as it increased steadily over the year. If it were assumed that the admixture in fact performed well in limiting shrinkage cracking as anticipated, it would therefore be logical to believe that the cracking along the rails is then due to loading or other factors.

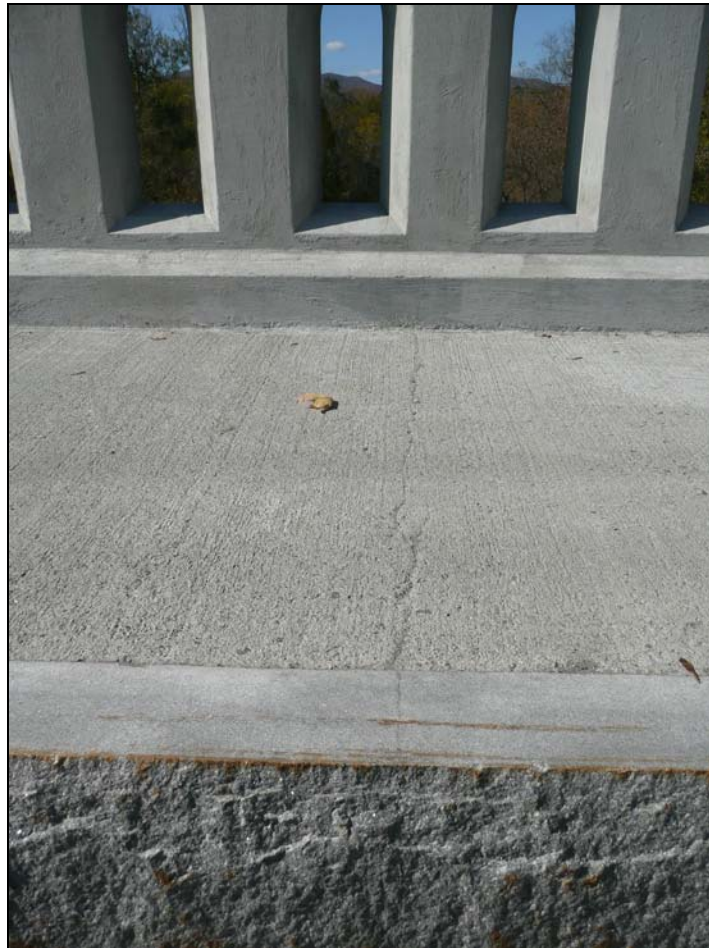
Figure 17. Cracking in Randolph rail, sidewalk, and curb.

Evidence that many cracks may be due to loading, and not simple shrinkage, is shown in Figure 17. This photograph depicts a crack beginning (or ending) at the bottom right corner of the center window in the rail and migrating downward to the concrete and continuing across the width of the sidewalk and finally across the top face of the granite curb. It is most likely due to stresses generated by periodic loading, as a shrinkage crack would be material dependent and therefore would not propagate into other structures cast at differing times and different materials. Several of these cracks are present on both the upstream and downstream sidewalks, all propagating through the rail as well and some through the curb. Since there is an asphalt overlay present on the bridge, it is impossible

to determine if the cracks continue into the bridge deck. Given the transverse locations of cracks on either bridge rail, it is plausible that some of these cracks may continue from one side of the bridge to the other. Out of all the bridges in the study, the Randolph structure has the highest AADT (16680) and truck traffic (1001), so it is subjected to large and repetitive loadings.

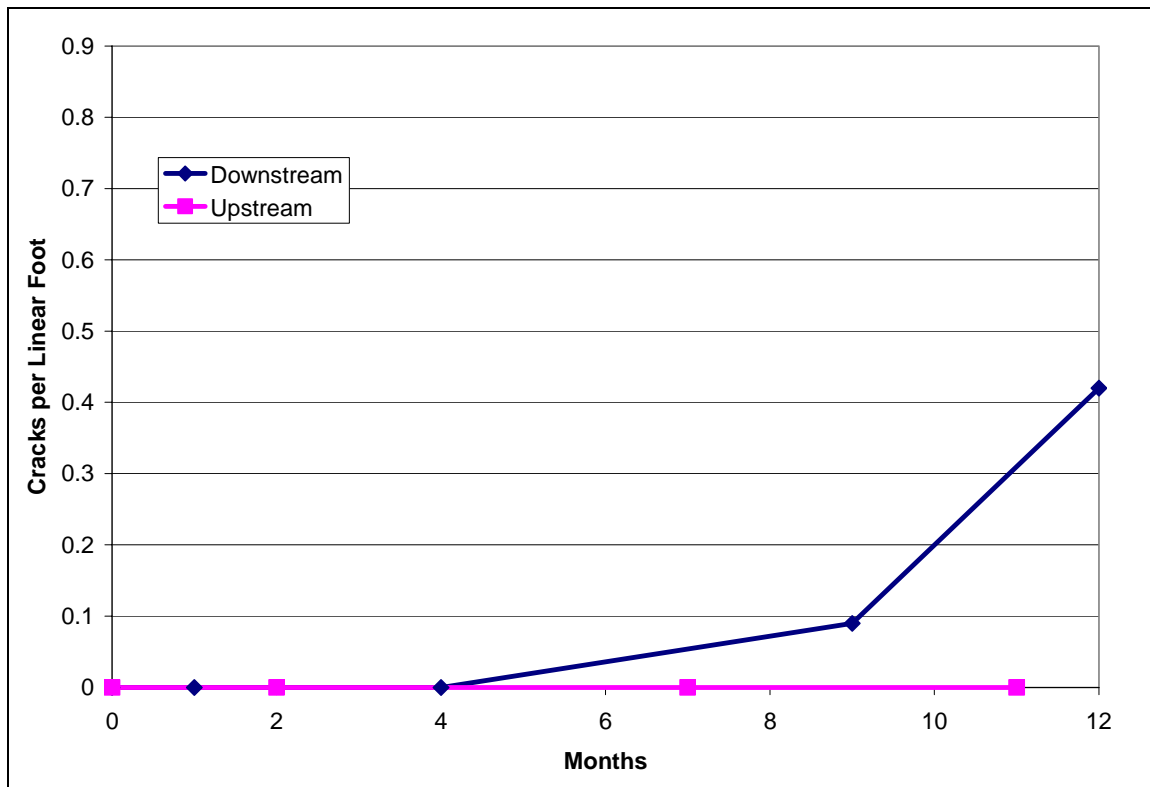
Figure 18. Plot of cracking over time for the Warren bridge rails.

The Warren bridge rails displayed yet another different trend from the other bridges, as can be shown in Figure 18. As of the eleven month visit, the upstream rail had yet to show any signs of surface cracking. As a note, the reason the upstream rail is eleven months old, while the downstream is twelve, is that the upstream rail was cast roughly six weeks later than the downstream rail. On the other hand, cracks did not begin to propagate along the downstream rail for at least the first four months following construction but since has started cracking at a higher rate, up to a total of just over 0.4 cracks per foot. This is approximately a 48% reduction in the number of cracks as compared to the bridge rails in Randolph and Barton. However as discussed previously this is a solid section and one would expect roughly half as many cracks to be present due to the geometric differences. The cracks that are now present on the downstream rail are all hairline cracks, very narrow when compared to the crack widths along many of the Randolph cracks.
