**Reclaimed Stabilized Base with Cement
Duxbury-Moretown, VT
Interim Report**

**Report 2009-10
Reporting on Work Plan
2007-R-1**

State of Vermont
Agency of Transportation
Materials and Research Section

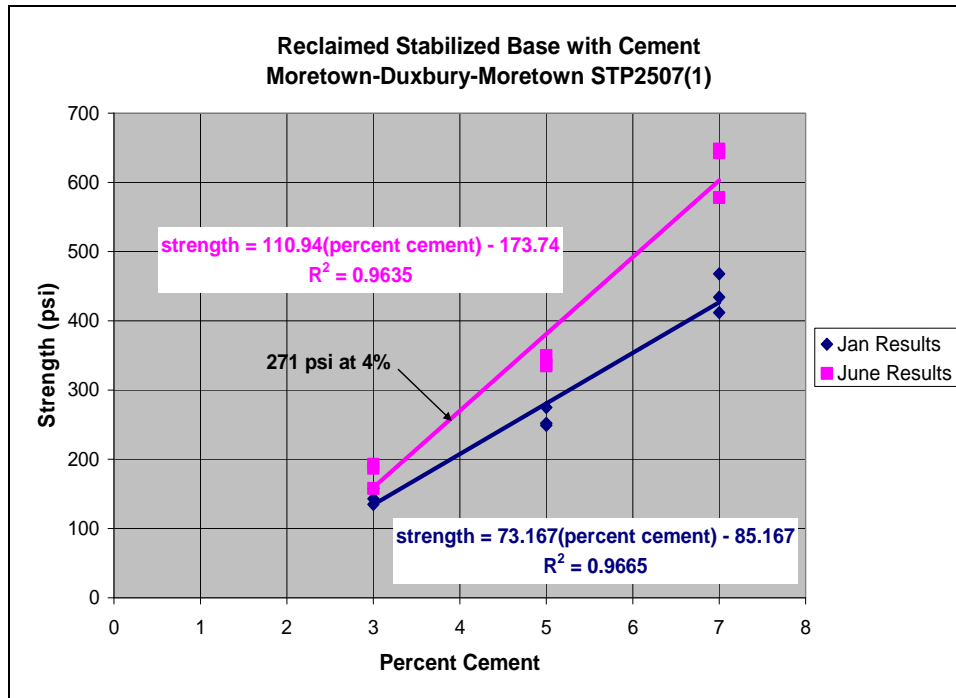
Figure 3. Agency of Transportation Test Results; Percent Cement Vs. Strength (PSI)

Figure 4 graphically displays the Agency’s test results from January 2006 and June 2007. It is interesting to note that 7 day compressive strengths from the samples collected in June were found to be greater than those collected during the previous summer. This is likely attributed to pulverizing and mixing of in-place materials prior to collecting samples as this composite represents actual field conditions. In addition, samples were collected from three locations rather than one. Based upon research conducted by other organizations and recommendations of the Cement Shippers Association, a 7 day compressive strength closer to 300 psi is desired. Therefore, the recommended cement percentage was reduced from 6% to 4%. According to the results plotted below, this was predicted to yield a 7 day compressive strength of 271 psi slightly below the target strength of 300 to 400 psi. Additionally, a target moisture content of 7.5% was specified. While informational, the subcontractors results were not considered in the determination of the amount of cement to be added to the reclaimed base.

All compressive strength results at cement contents of 3, 5 and 7% were plotted in Excel. A linear best fit trend line was fit to the data set. The desired cement content to generate a 7 day compression strength of 350 psi was determined and found to be 6%. Therefore, 6% cement was recommended and specified within the contract.

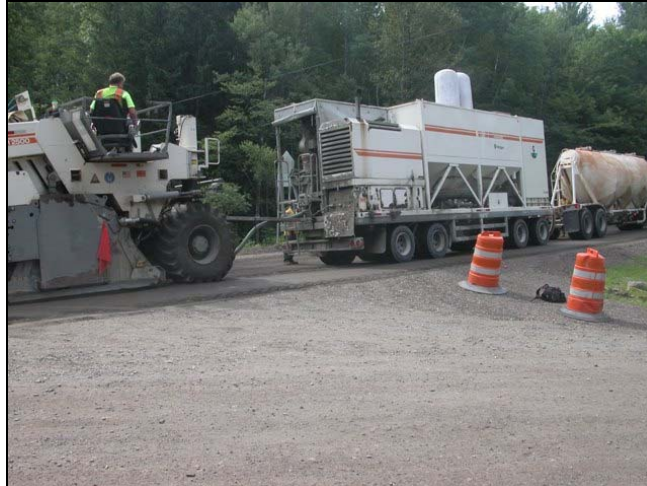
Figure 4 – Recycling Train

On July 16th Research personnel were onsite to observe the reclamation of an 800 LF beginning at MM 5.40 in the town of Duxbury. Reclaiming was conducted in 4 passes. The two outer passes were 7' wide and the two inner passes were 8' wide. The first two passes were in the southbound lane, and the latter two were in the northbound lane. Each pass consisted of a similar pattern. First the subbase was reclaimed to a depth of 8" while injecting cement slurry through the recycling train shown in Figure 4. The train proceeded at a rate between 4-6 meters/min. After, a vibratory sheep's foot roller made 5-7 passes over the reclaimed material. This was followed by an additional 5-7 passes with a vibratory roller depicted in Figure 5. Once two passes were completed along one side of the road, a grader and vibratory roller shaped and compacted the base to specification. Light traffic was released onto the stabilized base within 30 minutes of final compaction.

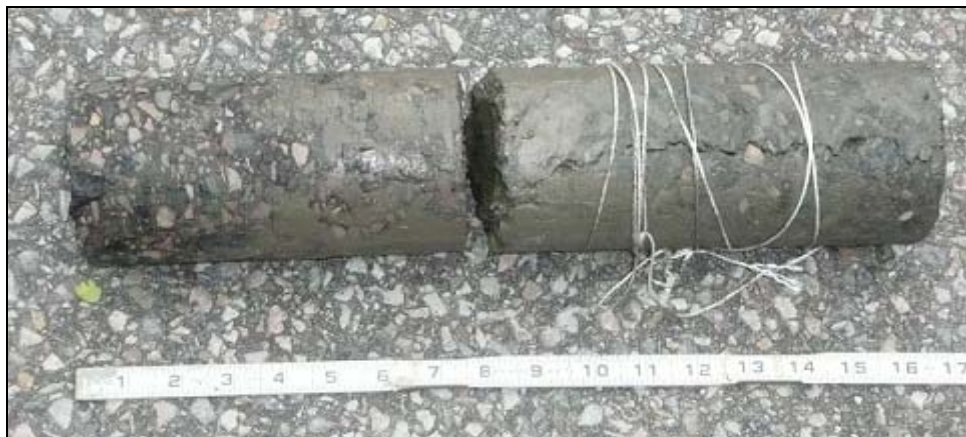
Figure 6 Core Extracted Over Crack

Of the three cores removed over observed surface cracks within the pavement, two were found to contain cracking that extended down to the base of the reclaimed layer. The width and appearance of the cracks were also found to be greater and more distinct within the reclaimed layer indicating that the cracks are bottom-up cracks, or cracks that propagated from the reclaimed layer into the bituminous concrete pavement. In addition, the majority of the cracks observed along the experimental section are transverse indicating that the cracks may be due to shrinkage or some form of thermal crack. A photograph of a core extracted over a crack is shown in Figure 6. The estimated width of this crack is 0.030 inches. The photograph shows roughly 8 inches of pavement (on the lefthand side) and 8 inches of reclaimed base (on the right).
