**Activated Approach Flasher System
Final Report**

**Report 2009 - 11
Reporting on Work Plan No. WP 2006-R-1**

State of Vermont
Agency of Transportation
Materials and Research Section

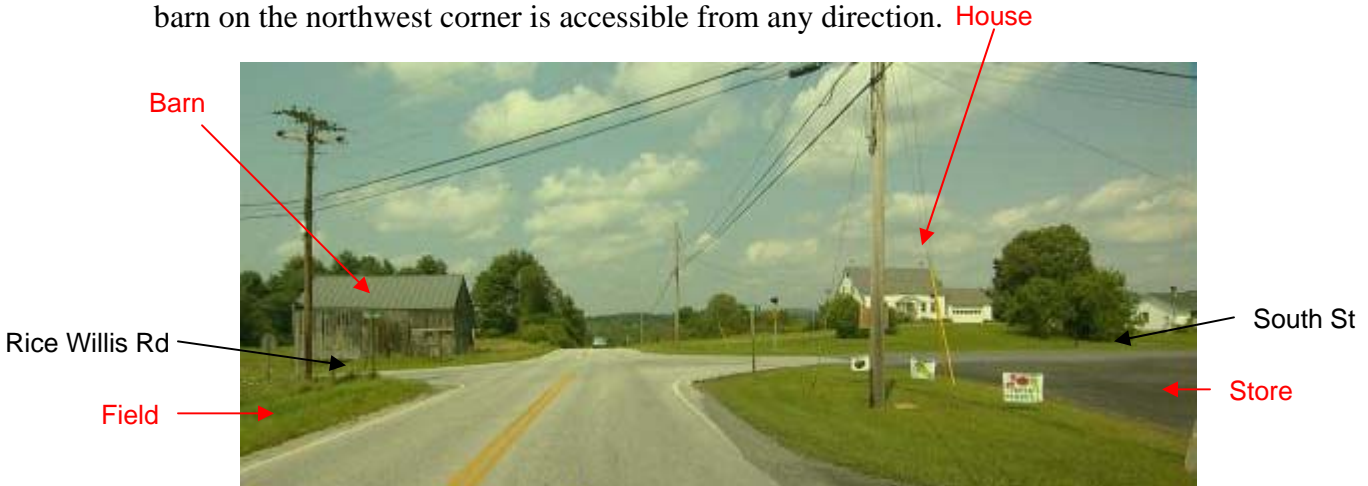
The land use at this intersection consists of a country store on the southeast corner, a house on the northeast corner, a barn on the northwest corner, and a field which is part of a residential property on the southwest quadrant.

Figure 2: Surrounding land use (looking North on VT Route 30).

A wide open entrance, approximately 100 feet in length, provides access to the country store from the south approach of VT Route 30. The country store is also accessible from South Street. The house on the northeast corner has a drive on South Street as well as another one on VT Route 30 about midway between the intersection and the crest. The barn on the northwest corner is accessible from any direction. House

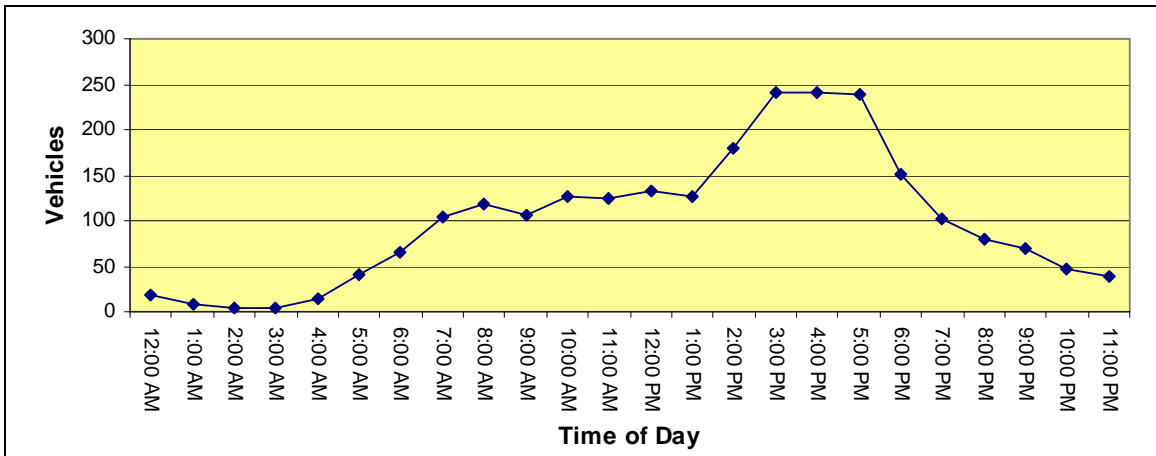
The 2006 estimated average daily traffic (ADT) on VT Route 30 south and north of the intersection was 3,800 and 4,600 vehicles respectively. The average traffic flow sorted by time of day on VT Route 30 in both directions is shown in Figure 3.

Figure 3: VT Route 30 traffic flow.

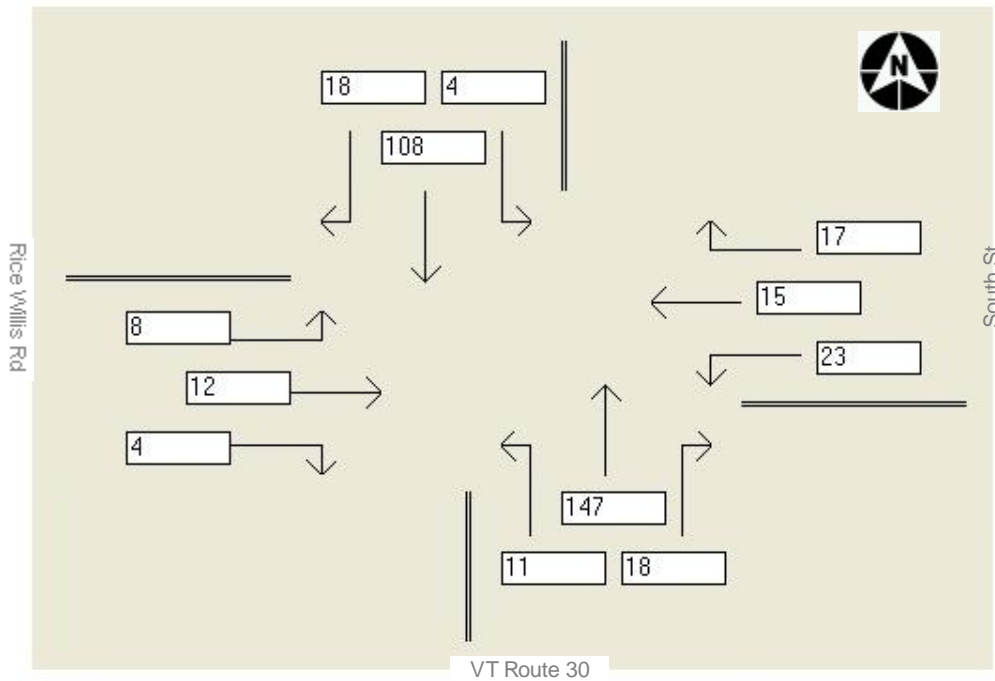
According to the turning movement counts, traffic entering this intersection is the heaviest during the afternoon peak period between 3:00 pm and 5:00 pm. Figure 4 displays the peak hour traffic volumes between 3:30 pm and 4:30 pm.

Figure 4: PM peak hour volumes (3:30 pm to 4:30 pm).

Turning movement counts performed in 2006 and 2008 show, for a ten-hour daytime period, about 1,200 vehicles traveling in each direction along VT Route 30. For the same ten-hour period, there are approximately 300 vehicles approaching the intersection from South Street, and about 200 vehicles approaching the intersection from Rice Willis Road. Throughout the day, 56% of the traffic along Rice Willis Road travels through the intersection and onto South Street. Conversely, the majority of traffic along South Street (40%) turns left onto VT Route 30 while only 31% travels through the intersection onto Rice Willis Road.

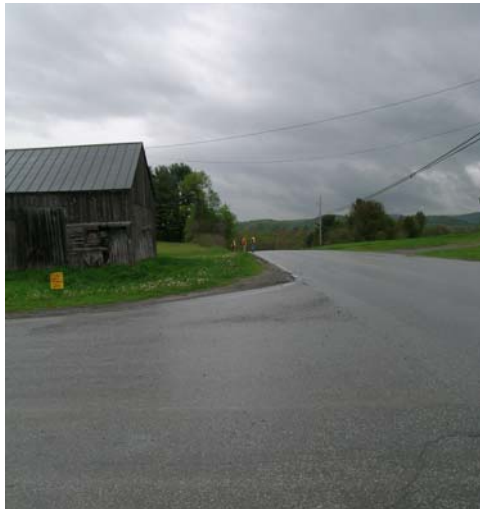
The available corner sight distance, or length of roadway a driver can see at any particular time, was measured in the field to be 228 ft when looking to the north from Rice Willis Road and 250 ft when looking north from South Street as shown in Figures 5 and 6.

Figure 5: Intersection site distance – looking North from Rice Willis Road.

In accordance with the 2004 edition of the “Geometric Design of Highways and Streets”, “intersection sight distance criteria for stop-controlled intersections are longer than stopping sight distance to ensure that the intersection operates safely.” As shown in Case B1, recommended intersection sight distance is provided for traffic approaching from either the right or the left for left turns from the minor road onto the major road for intersections with stop control on the minor road. As shown within the guidance, an intersection sight distance of 660 ft and 610 ft along the major road is recommended when passenger cars travel at speeds of 59 mph and 55 mph along the major road, respectively. These speeds represent the 95th and 85th percentile speeds along VT Route 30. Therefore, the current intersection sight distance for passenger cars making a left hand turn onto VT Route 30 is not acceptable.

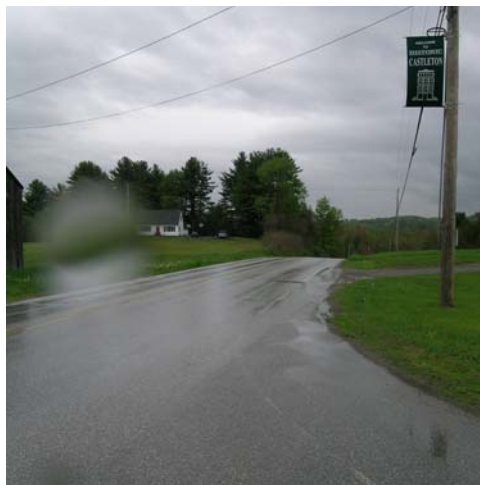
Figure 6: Intersection site distance – looking North from South Street.

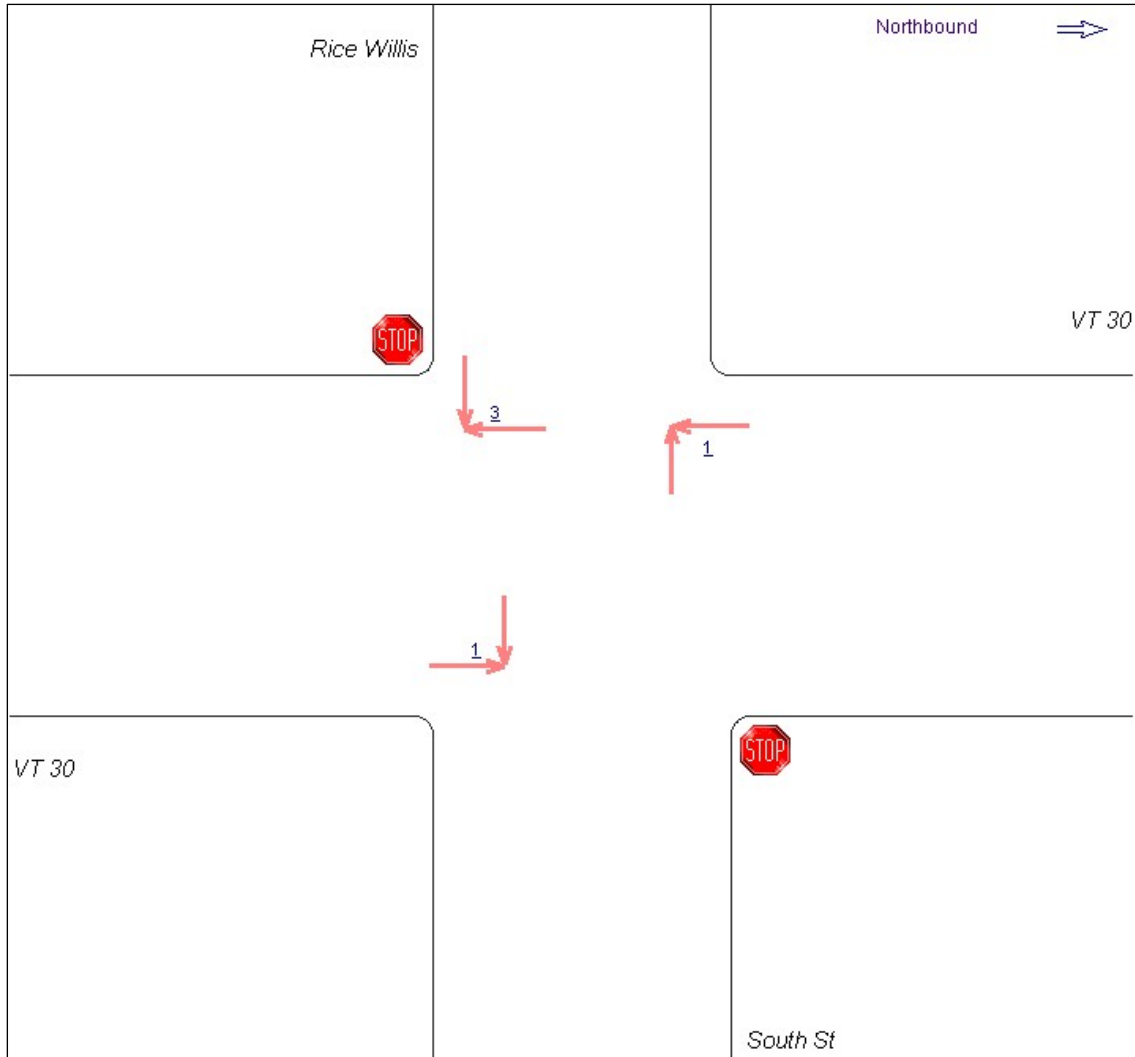
From January 1, 2001 to the time the beacon system was installed in October 2007, five crashes were reported to the Vermont Department of Motor Vehicles. One crash was reported in 2003, 2006 and 2007. Two crashes were reported in 2005. Over this period of six years and nine months, the crash rate per year was 0.72, and the crash rate per million entering vehicles was approximately 1.40.

Figure 7: Reported crashed (January 2001 through September 2007).

The five crashes reported during this period are shown in the collision diagram presented in Figure 6 (in this diagram, the numbers next to the arrow symbols represent the number of crashes for that crash type). As shown in Figure 6, the five crashes were all right-angle crashes. Four of these crashes involved vehicles traveling southbound along VT Route 30 and traffic approaching from Rice Willis or South Street. All five crashes took place in the afternoon, between 2:30 pm and 6:00 pm, and mostly on a weekend (80%). From the statements taken at the scenes, the motorists on the side roads had stopped at the stop signs prior to proceeding, indicating that the amount of corner sight distance may have been inadequate to accurately warn traffic of oncoming traffic.

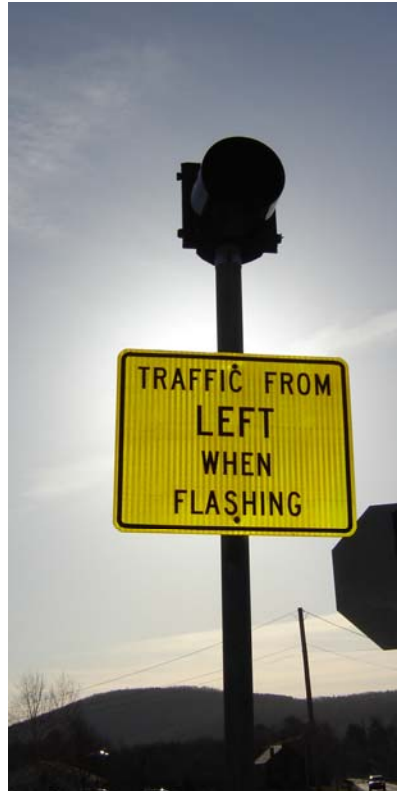
Two 30" x 24" warning signs were developed as shown in Figure 8. Two different legends, depending whether a vehicle is waiting on South Street or Rice Willis Road, are used to alert drivers of approaching traffic on from VT 30 north. The signs simply say "traffic from right when flashing" (for traffic facing South Street) or "traffic from left when flashing" (for traffic facing Rice Willis Road).

Figure 9: Example of warning sign.

The signs were made of fluorescent yellow sheeting type IX with three-inch capital letters (four-inch letters were used for the words "left" and "right"). As designed, the signs are legible for approximately 99 ft to 120 ft based on the letter height to legibility distance ratio recommended in the "Manual of Uniform Traffic Control Devices." Each sign was installed on a tubular post with a slip base to reduce the likelihood of the beacons being knocked down by large trucks.

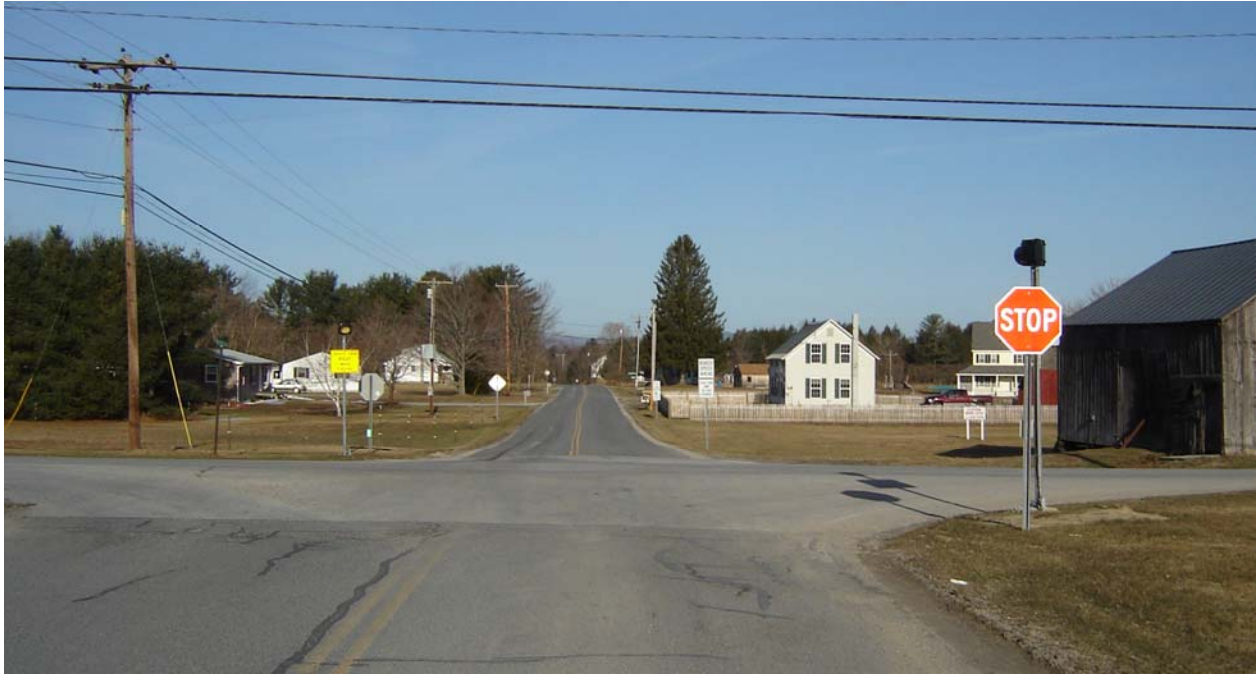
Figure 10: Installed beacon system (view is from South Street).

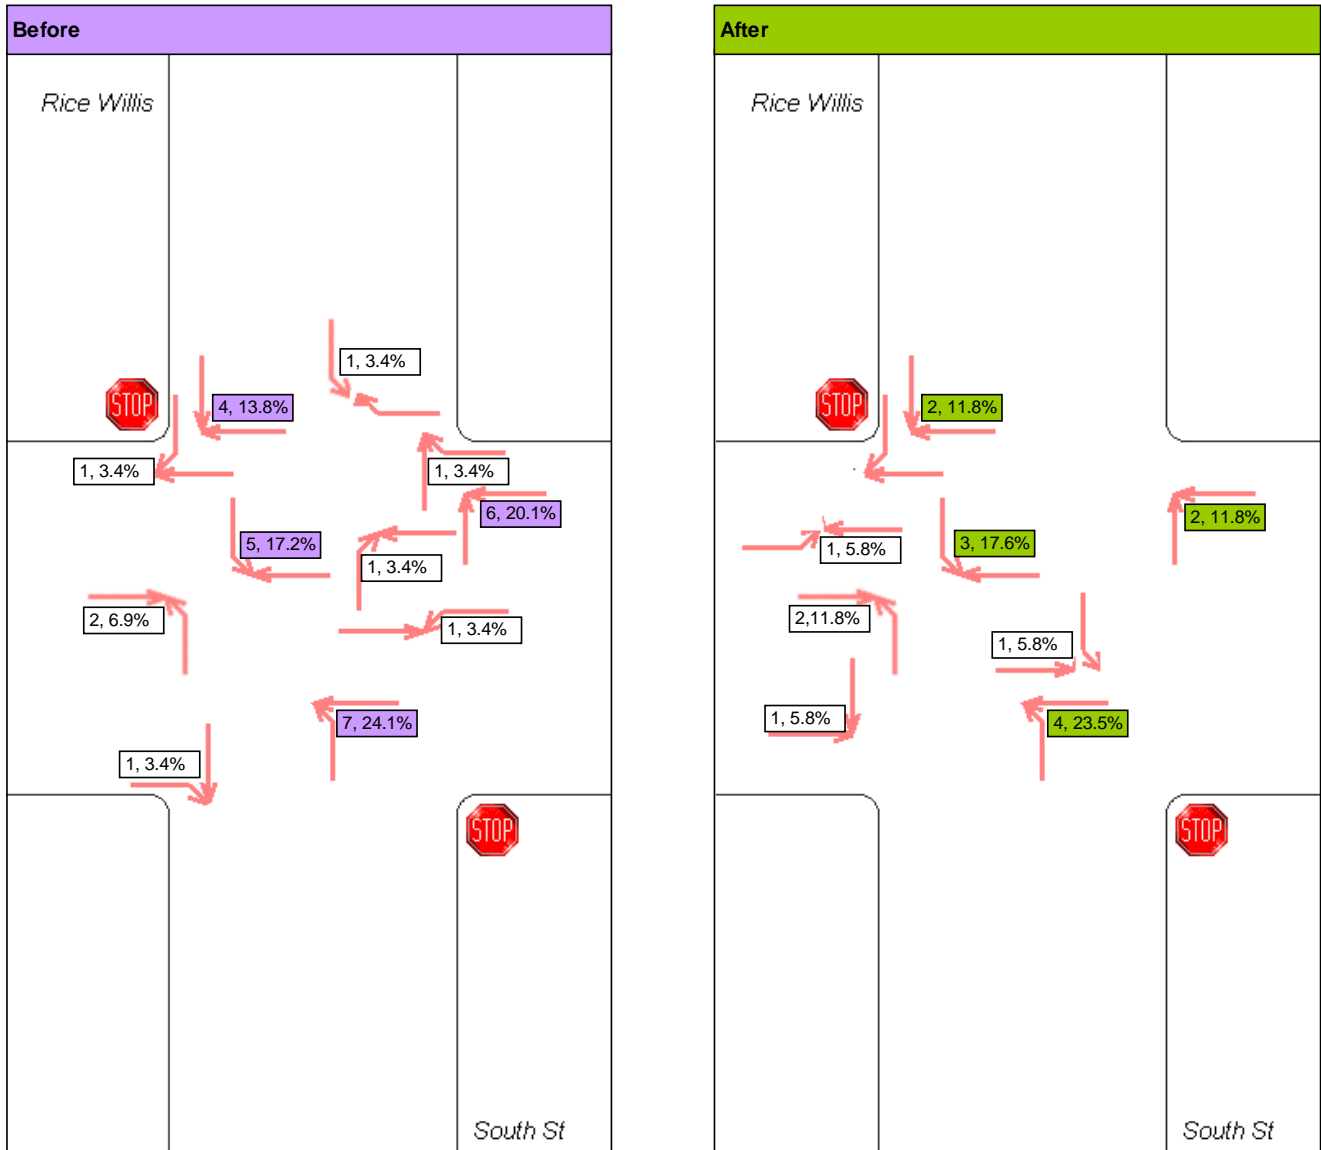
Figure 11 presents conflict diagrams for the before and after periods.

An analysis of these diagrams confirms that cross traffic conflicts are the primary types of conflicts at this intersection. There are four types of conflicts that are predominant in both the before and after periods. These are 1) a southbound through vehicle with a westbound left turning vehicle, 2) a southbound through vehicle with a westbound

through vehicle, 3) a southbound through vehicle with an eastbound left turning vehicle, and 4) a southbound through vehicle with an eastbound through vehicle.

Figure 11: Before and after conflict diagrams.

A comparison of the diagrams further indicates that the proportions of conflicts for most conflict types remained the same in the after period. The conflict involving a through southbound vehicle on VT Route 30 and a through vehicle on South Street is the only conflict for which the proportion of conflicts was reduced by a large percentage. While the relative proportion of each major conflict type remained approximately the same, the number of occurrences for each type was found to be lower than the before study.

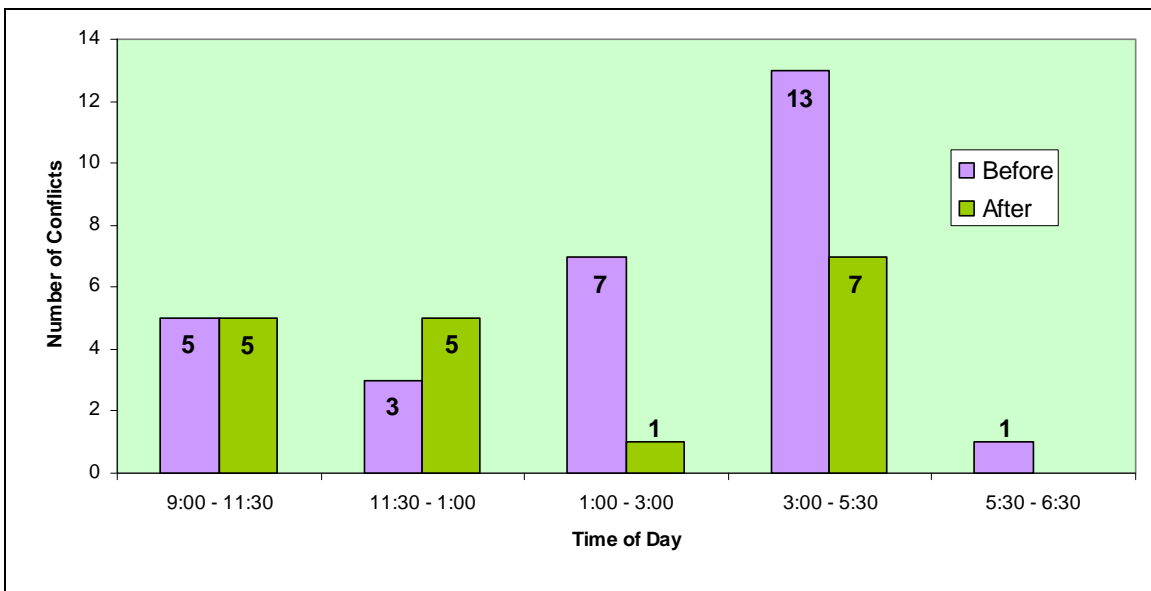
The before and after distributions of conflicts per time of day between the hours of 9:00 am and 6:30 pm, are shown in Figure 11. These distributions indicate that the number of conflicts observed between 9:00 am and 1:00 pm were approximately the same in both the before and after periods. From 1:00 pm to 5:30 pm, a larger number of conflicts were recorded prior to the installation of the beacon system. The number of conflicts is again about the same after 5:30 pm.

Figure 12: Temporal distribution of the observed conflicts.
