**Evaluation of SmartStud<sup>TM</sup> In-Pavement  
Crosswalk Lighting System and  
BlinkerSign<sup>®</sup>  
Interim Report  
February 2011**

**Report 2011 – 3  
Reporting on Work Plan 2005-R-3**

State of Vermont  
Agency of Transportation  
Materials and Research Section

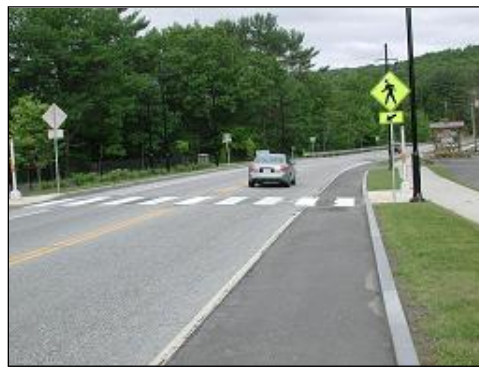
**FIGURE 2 Overall view.**

The roadway is fairly flat with limited horizontal curve alignments. It is suspected that the observed increase in speed may be caused by unfamiliarity with the area as much of the demographic is composed of tourists (3). Figure 2, provided below, displays the crosswalk location in reference to US Route 4.

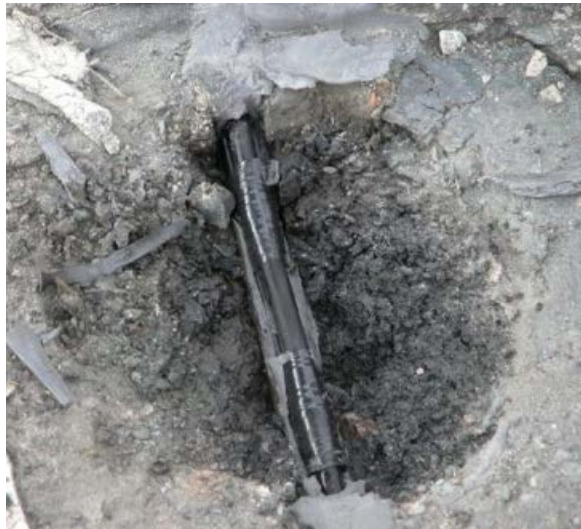
**FIGURE 3 Holes after LED removal.**

The system was repaired in July 2007. Research personnel were onsite to observe the removal and replacement of the preexisting Smartstud<sup>TM</sup> In-Pavement LEDs. At the time, two of the ten LED lights were not functioning. It was noted that the malfunctioning lights were located in the center of the driving lanes. The domes were removed by chipping away the rubber sealant with a chisel and screwdriver, and a standard 16oz v-claw hammer. When the domes were removed most of the bonded asphalt and the epoxy came up with the dome, leaving a coarse hole shown in Figures 3 and 4. The wire that was visible in the hole appeared to be in good condition. A black square stamp was placed over the preexisting holes for proper fit. Then adjustments were made to the holes by chiseling away more asphalt. This stamp was used to stamp a base coat of epoxy (Smartstud<sup>TM</sup> base epoxy) making an ideal setting for the new dome shown in Figure 5. This method was not used in the original installation. After blowing high pressure air to clean up the holes the epoxy were placed to have a good bond to the asphalt.

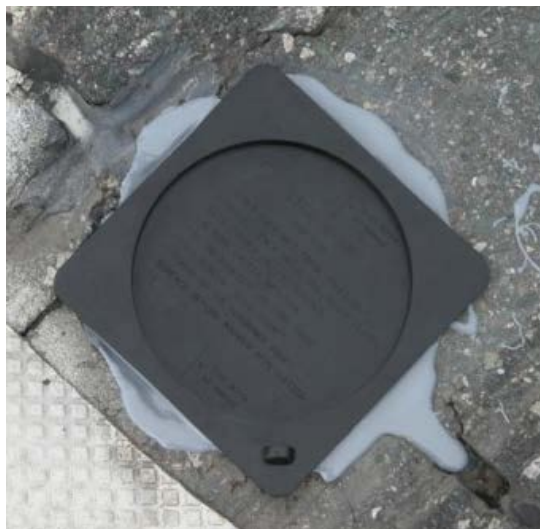
**FIGURE 5 Stamp curing.**

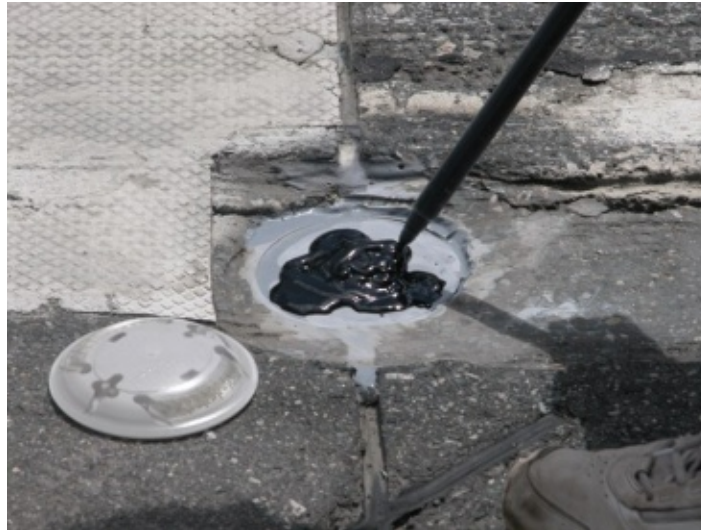
**FIGURE 6 Epoxy application.**

Immediately after the epoxy was applied to the hole, a Smartstud™ dome light had to be placed as shown in Figure 6. The LED lights were in full operation immediately following placement.

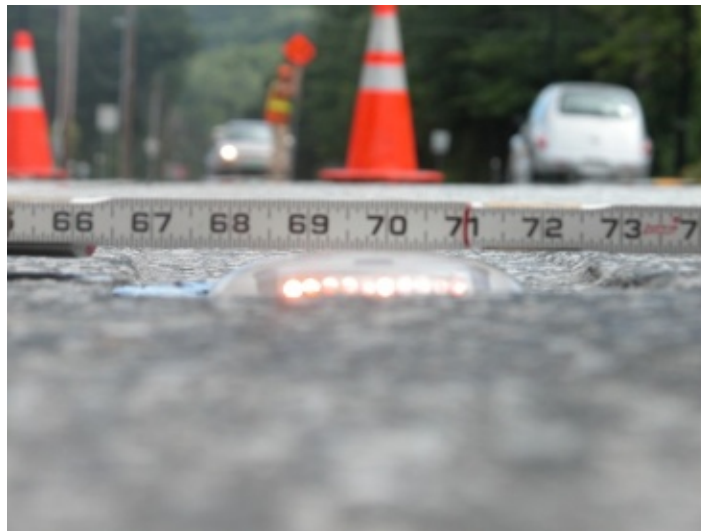
**FIGURE 7 Domes are slightly above road surface.**

The domes that were removed were inspected for visible flaws by Research personnel. All of the domes had some visible wear that consisted of abrasions, little bubbles in the plastic, dings, and discoloration. The newly placed domes rose slightly above the road surface shown in Figure 7. The highest dome was 10 mm above and the lowest was 5mm above the road surface. The average rise above the road surface was 6.8mm.

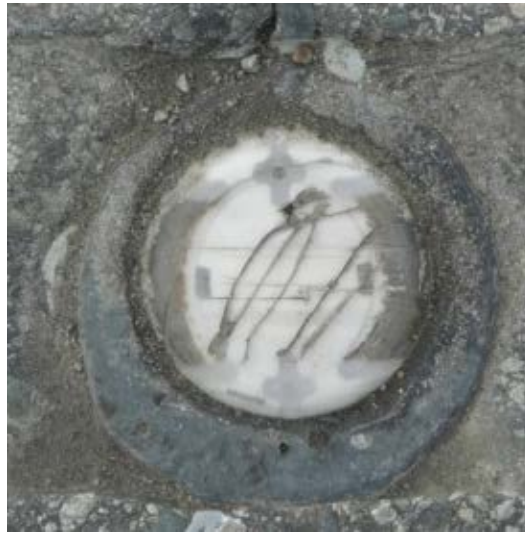
**FIGURE 8 Damage to LED.**

A follow-up site visit was conducted on January 10<sup>th</sup>, 2008. At that time, the lights facing both the eastbound and westbound directions were not working for three of the domes. There was one dome where the lights facing one direction had malfunctioned. Similarly, they were located in the center of each lane. Product representatives were

contacted and another on-site meeting was performed on January 29<sup>th</sup>, 2008. The representatives from SmartStud<sup>TM</sup> stated that the markers were being scalped because they were sitting too high in the recess making them susceptible to wear and cracking under the weight of vehicles. Subsequently, the markers failed due physical stress from the impact of the plows and/or vehicles running over the compromised housing. In addition, this wear shown below in Figure 8 also caused the lenses to become opaque reducing the visibility of the lighting and likely their overall effectiveness.

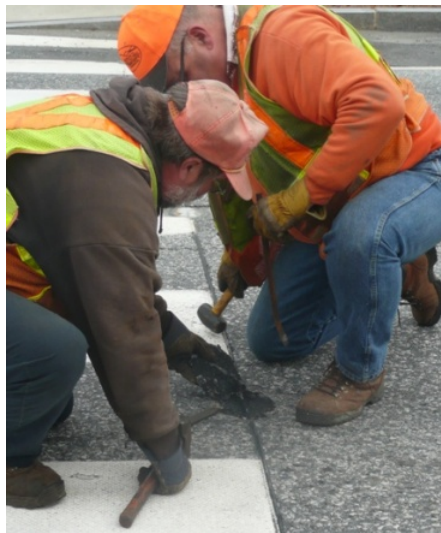
**FIGURE 9 Removing Smartstud™ LEDs.**

Due to the configuration of the power supply loop, the signs were installed on the same side of the crosswalk by VTrans’ Traffic Shop personnel. The first attempt to install the signs was on Wednesday, October 29<sup>th</sup>, 2008. However due to an incorrect control board configuration, new signs needed to be shipped out. The new signs were installed on Monday, November 3<sup>rd</sup>, 2008. Traffic Shop personnel commented that the system was relatively easy to install with minimal set-backs due to the existing hard-wired system. On Tuesday, November 4<sup>th</sup>, 2008 District 4 and Research personnel removed the SmartStud™ LEDs from the ground and the holes were filled with cold patch shown in Figure 9.

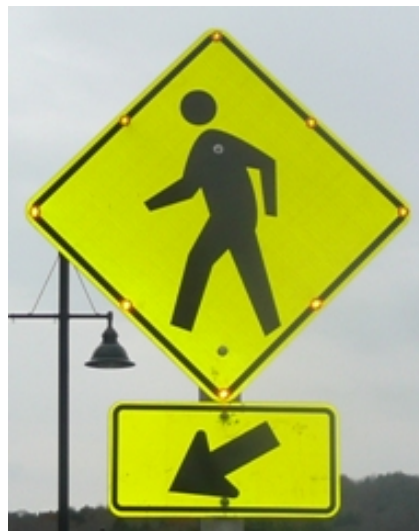
**FIGURE 10 BlinkerSign® during daylight hours.**

Two site visits were conducted on Tuesday January 6<sup>th</sup>, 2009 and Monday, August 2<sup>nd</sup>, 2010 to evaluate the condition of the BlinkerSign® system and visually assess the brightness of the LEDs. During the first site visit, the BlinkerSigns® were examined during daylight, dusk, and nighttime hours whereas the second visit was conducted solely during daylight hours. The signs appeared to be extremely visible under all light conditions especially during evening hours as shown in Figures 10 and 11, and were in excellent condition during both visits with no visible wear to the sign face or LED border. Unlike the Smartstud<sup>TM</sup> System, minimal wear was anticipated due to the upright nature of the signs. According to the District 4 maintenance crew and Traffic Shop personnel, no maintenance has been performed in the 21 month period after installation. No complaints have been recorded from the travelling public. As an aside, this area is inundated with pedestrians during daylight hours and system users and drivers might not use the full capability of the system as occurs in nighttime hours.

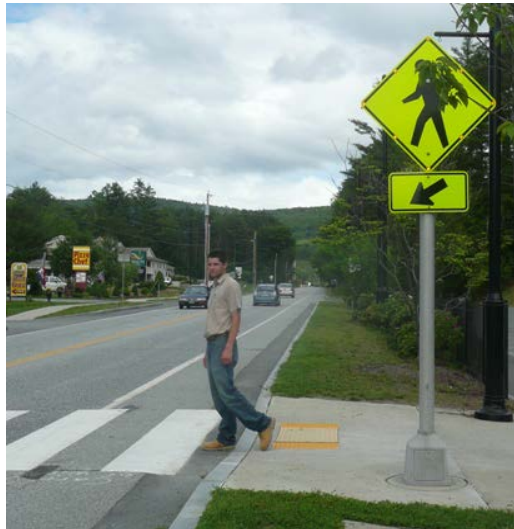
**FIGURE 12 Looking and stepping crossing scenario.**

As described in the initial report, a pedestrian crossing study modeled after an evaluation completed by the City of San Rafael, CA was utilized to assess and document any changes in driver behavior attributed to the crosswalk enhancement systems. The “before” and “after” studies were conducted to evaluate the difference in vehicle behavior between having no system in place and after installing both enhanced crossing warning systems. Each study incorporated an Agency member dressed in typical pedestrian clothing in two crossing scenarios: 1) Decoy pedestrian provided an impression that they were about to step in the crosswalk by looking in both directions and 2) Decoy pedestrian looked in both directions and placed one foot into the crosswalk. Oncoming traffic was visually monitored during these events in order to assess driver behavior. Each scenario was completed 200 times (100 times per lane direction).
