**EVALUATION OF BLINKERSIGN®
CROSSWALK LIGHTING SYSTEM**

Report 2014 – 13

December 2014

Reporting on Work Plan 2005-R-3

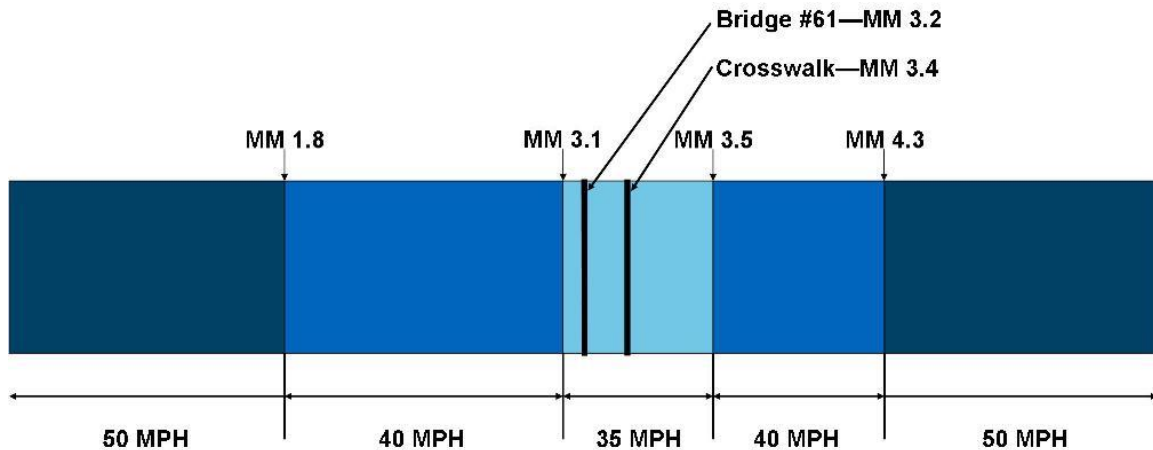
In accordance with the Experimental Feature workplan, WP 2005-R-3, the enhanced safety features were installed along US Route 4 at approximately MM 3.4 in the town of Hartford, near the Quechee Gorge Visitors Center. This area is characterized by a heavily travelled roadway consisting of local residents and tourists. The average annual daily traffic (AADT), on this two-lane roadway, is 12,500, a moderately high AADT for the State of Vermont. Although the posted speed limit is 35 miles per hour (mph), visual observations indicate that many motorists travel above this speed.

Figure 1 Speed Limit Diagram.

The roadway is relatively flat with limited horizontal curve alignments. It is suspected that the observed increase in speed may be caused by unfamiliarity with the area as much of the demographic is composed of tourists (3).

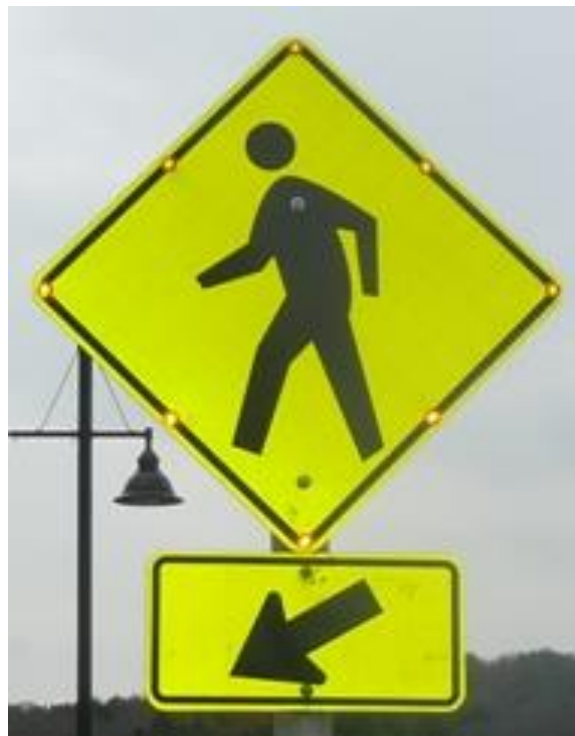
Figure 2 BlinkerSign[®] during daylight hours.

Two site visits were conducted soon after installation, on Tuesday January 6, 2009 and Monday, August 2, 2010 to evaluate the condition of the BlinkerSign[®] system and visually assess the brightness of the LEDs. During the first site visit, the BlinkerSigns[®] were examined during daylight, dusk, and nighttime hours whereas the second visit was conducted solely during daylight hours. The signs appeared to be extremely visible under all light conditions especially during evening hours as shown in Figures 2 and 3, and were in excellent condition during both visits with no visible wear to the sign face or LED border. According to the District 4 maintenance crew and Traffic Shop personnel, no maintenance was performed in the first 18-month period after installation. Subsequently, the traffic shop has been onsite twice to fix electrical issues that presented themselves, rendering one of the signs non-functioning. One issue was a broken wire that was found and fixed and the second was a water (from rain) leak in one of the units that was repaired. Upkeep on winter maintenance around the signs has also been an issue during a few winter seasons since their installation. During winter storms, the stepping pads that can activate the system (in addition to the push button) can become covered with snow and ice. This causes the system to become disabled as the pads are constantly pushed by the applied weight. This has since been remedied with continued and targeted clearing during winter months.

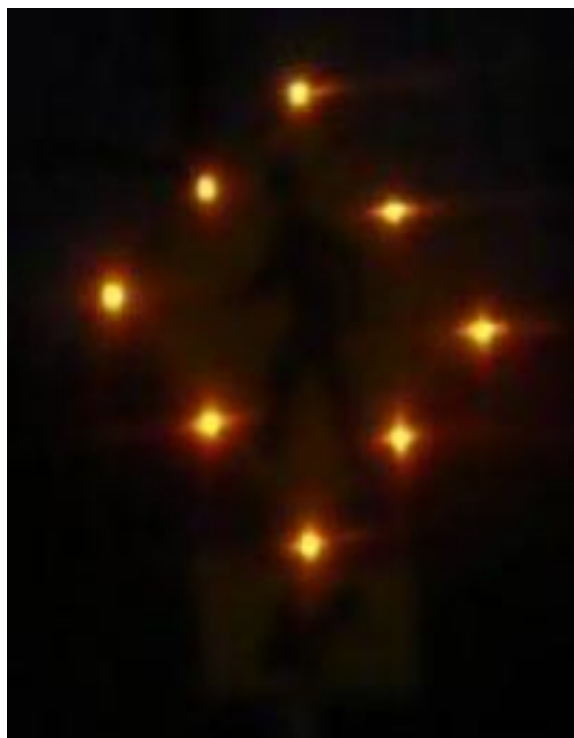
Figure 3 BlinkerSign® during nighttime hours.

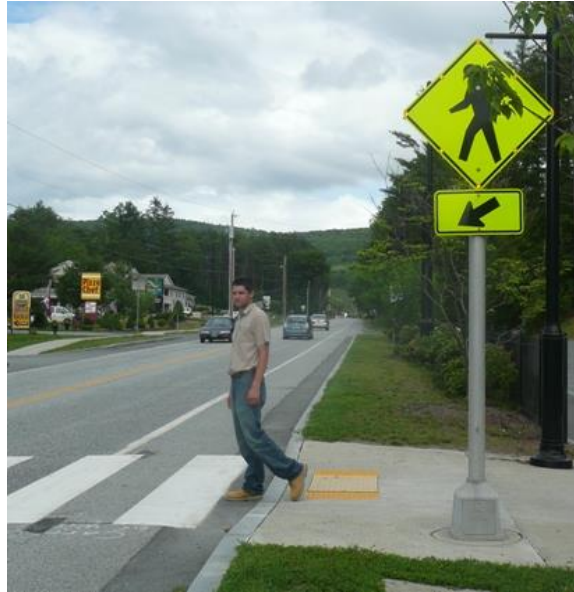
Figure 4 Looking and stepping crossing scenario, pre HAWK installation.

This pedestrian crossing study was modeled after an evaluation completed by the City of San Rafael, CA. The study assessed changes in driver behavior attributed to a crosswalk enhancement system. “Before” and “after” studies evaluated differences in vehicle behavior pre- and post-installation of the BlinkerSign® System. Each study incorporated a Vermont Agency of Transportation member dressed in typical pedestrian clothing with two crossing scenarios. In scenario 1, the decoy pedestrian provided the impression that they were about to step in the crosswalk by looking in both directions. In scenario 2, the decoy pedestrian looked in both directions and placed one foot into the crosswalk, as shown in Figure 4. Oncoming traffic was visually monitored during these events in order to assess driver behavior. Each scenario was completed 200 times (100 times per lane direction).

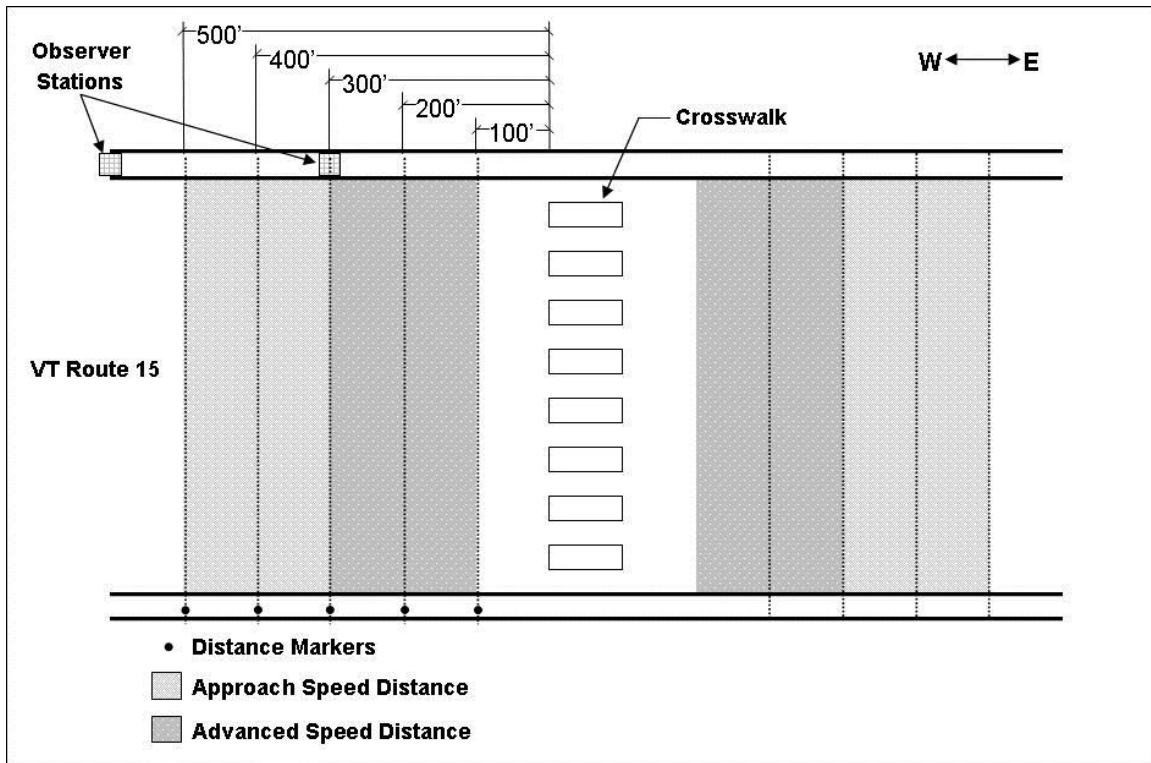
Figure 5 PHB study test area, for both pre- and post-installation experiments.

Methodology was parallel in both studies. The first task was to delineate observation stations. This was done with painted stakes, marked out within a 500-foot stretch from the crosswalk in both the east and westbound directions. Observation stations are shown in Figure 5, which details the test area. After stations were set, the decoy pedestrian carried out the two crossing scenarios for both traffic directions. During this time, agency workers were taking observations 500 and 300 feet back from the crosswalk. All non-crossing Agency personnel were inconspicuously stationed along the side of the roadway to avoid drawing attention from the passersby.

Numerical data was collected using a stopwatch. The time in seconds for the leading car to travel from the 500'- 300' from the crosswalk was recorded. This data was used to calculate the leading car's approach speed, in mph. The deceleration speed was calculated similarly, using the time to travel from the stakes marked off at 300 and 100 feet. Additional observations included the vehicle's first braking distance, its compliance to the crosswalk system, and state of licensure.

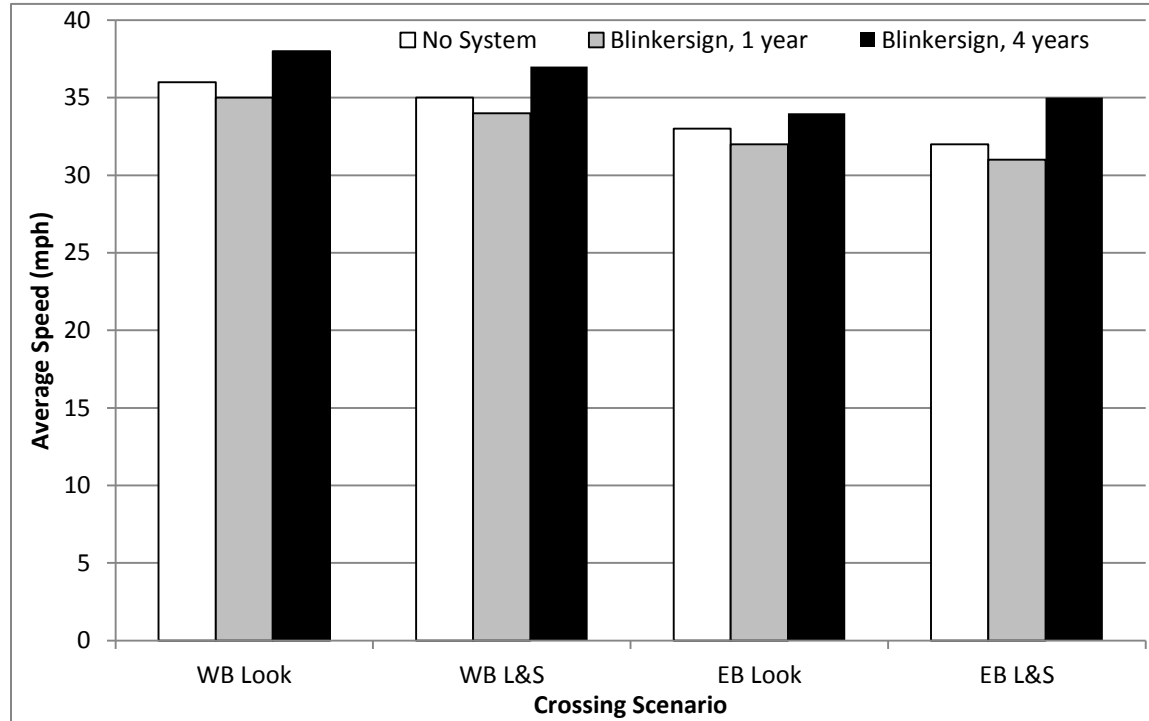
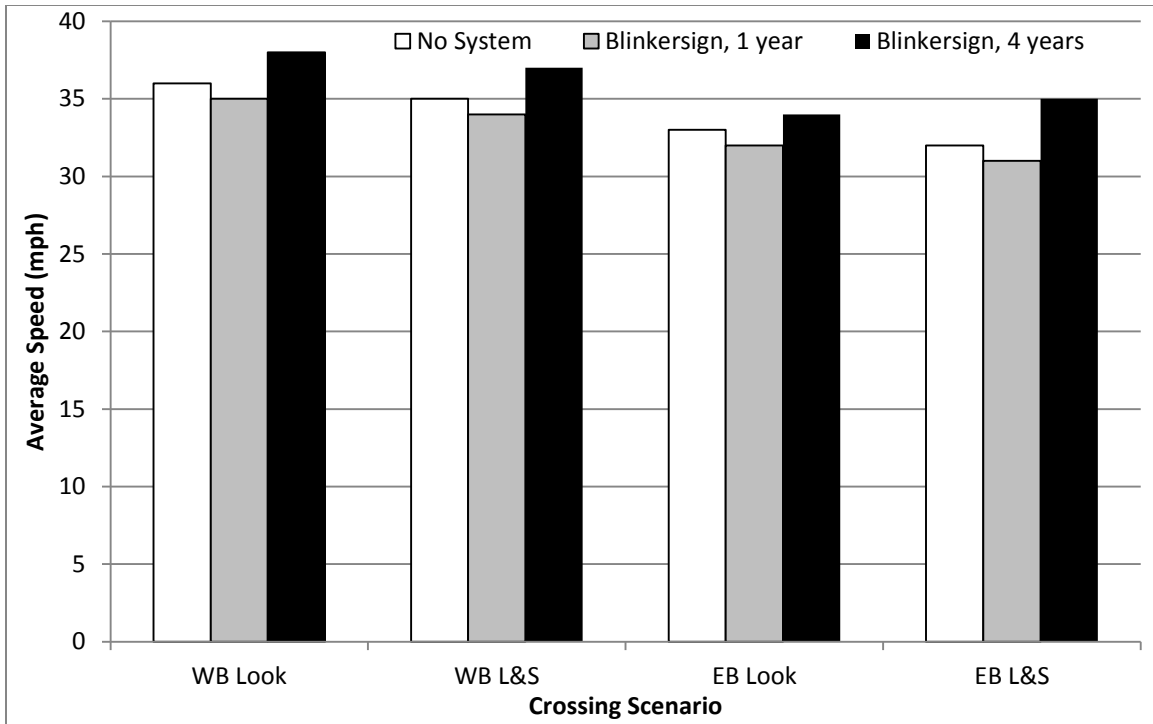
Figure 6. It should be noted that this figure includes speeds of all vehicles whether they yielded to the decoy pedestrian or not. A breakdown of each scenario for the two directions is provided later in the report. The data shows that, on average, vehicles approach the crosswalk at a faster speed from the west than they do from the east, regardless of what system is in place. Approach speeds decreased by one mile per hour with the addition of the BlinkerSigns[®], however after an additional three years approach speeds actually increased by 2 mph over no system at all, indicating that drivers may now be driving faster in general through this tourist area.

Figure 6 Average approach speeds.

A graphical representation for the system exhibiting the average approach speeds for both east and westbound travel directions are showing below in

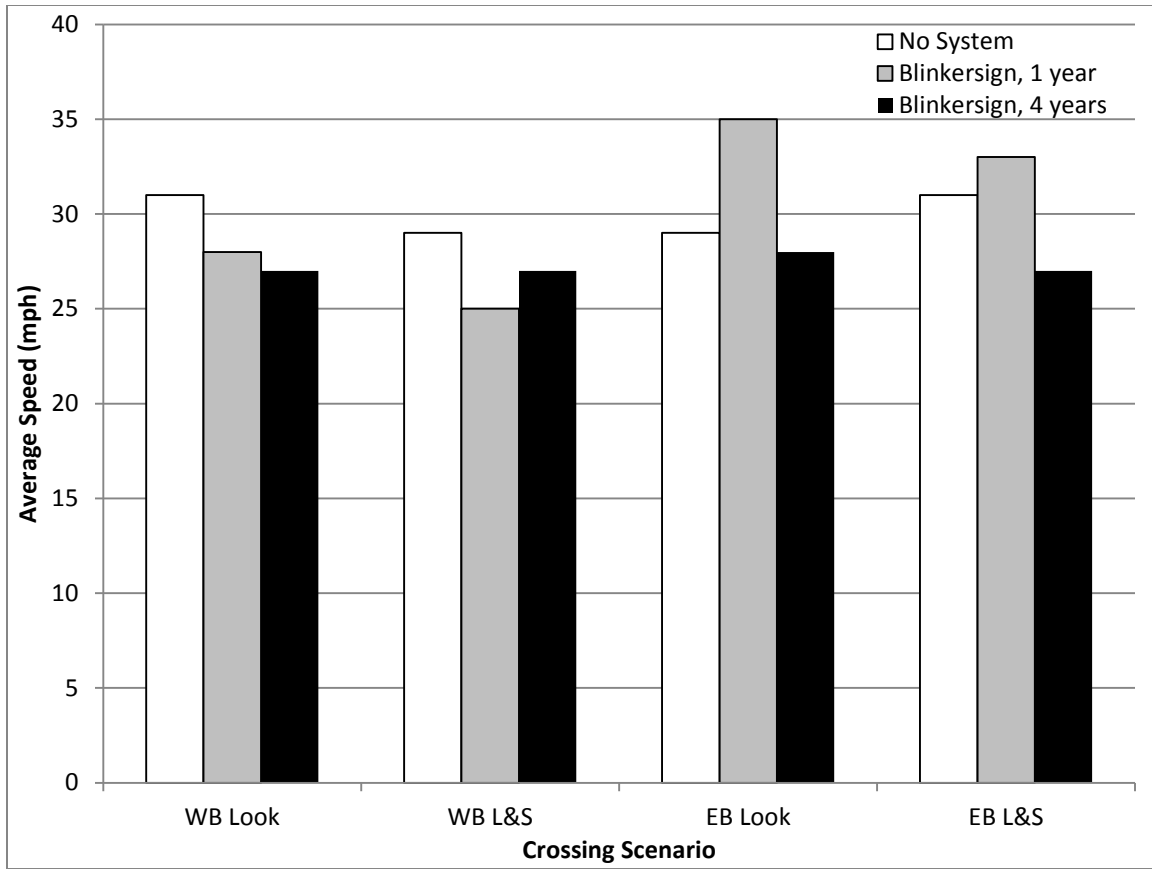
Figure 7 Average deceleration speeds.

A graphical representation exhibiting the average deceleration speeds for both east and westbound travel directions are shown in Figure 7. It should be noted that the figure includes speeds of all vehicles whether they yielded to the decoy pedestrian or not. Averages and associated standard deviation results are shown in Table 2.

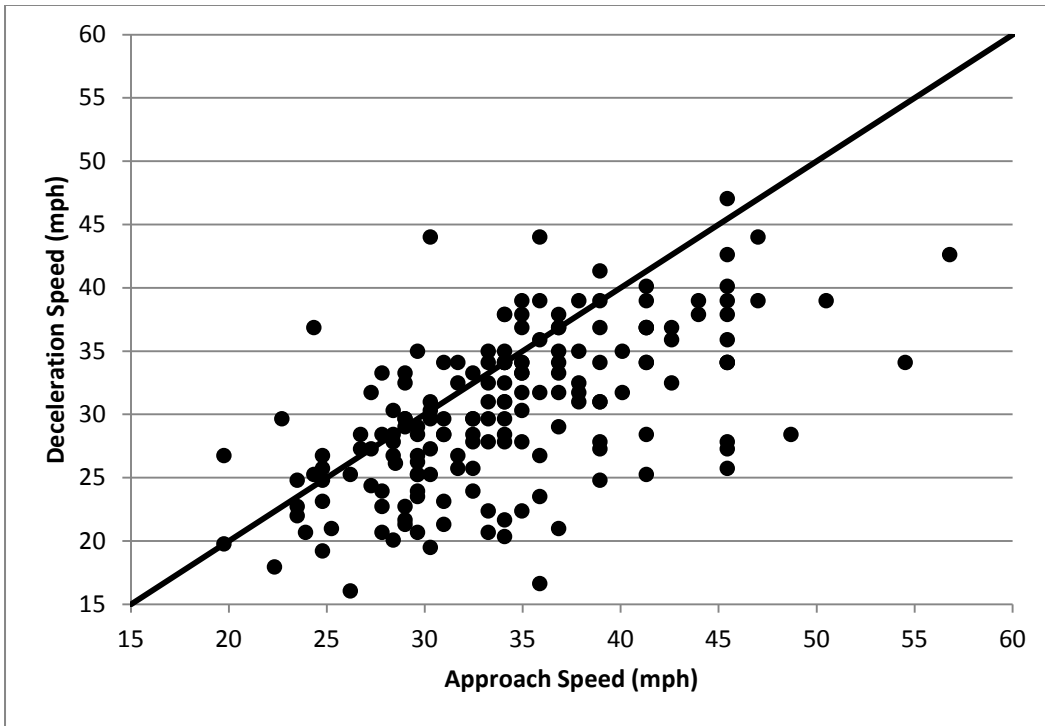
Figure 8. Deceleration vs. approach speed with no system.

A graphical comparison of the difference between approach and deceleration speeds is shown in Figure 8 and 9. Figure 8 plots approach speed (x-axis) and deceleration speeds (y-axis) couplets on a scatter plot for the no-system pedestrian study, while Figure 9 shows them for the BlinkerSign[®] year 4 study. The diagonal lines in each figure represent approach speeds equaling deceleration speeds. The more data points that are present below the line, the more vehicles slowed down during the studies. It is evident from the plots that the data shifts below the line in general with the BlinkerSigns[®] installed, indicating many more drivers slowed down when the system was activated than previously had with the pedestrian only as the visual key. The data shows that 71% slowed down with no system (a very respectable number when compared to data found from other locations and studies) while that number increased to 91% with the system and year 4.

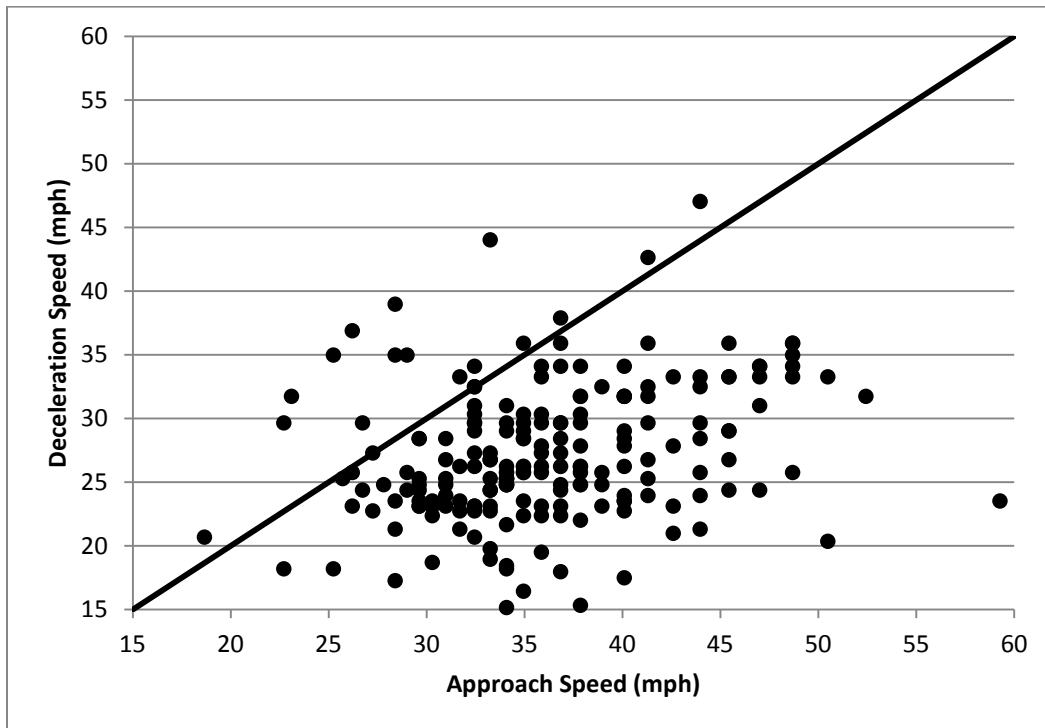
Figure 9. Deceleration vs. approach speed ~4 years after BlinkerSigns installed.
