# VERMONT AGENCY OF TRANSPORTATION

### AEXCEL ROADZILLA™ METHYL METHACRYLATE PAVEMENT MARKING

**Final Report 2014 – 15**

Reporting on Work Plan 2009-R-1

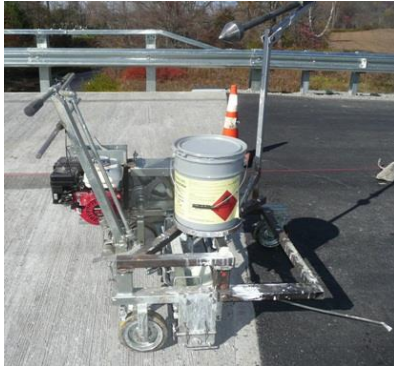
**Figure 1: Push handcart applicator.**

the system adhesion activator, was added in a 5-gallon pail which initiated the chemical heating process. The amount of peroxide needed is dependent upon ambient conditions and the temperature of the application surface. Typically, 4 ounces of peroxide per gallon of MMA is used. Once the system was mixed, the markings were applied using a push handcart (see Figure 1.) A spiked bar on the handcart was used to create a splatter effect as the markings were applied to the bridge deck (see Figure 2.)

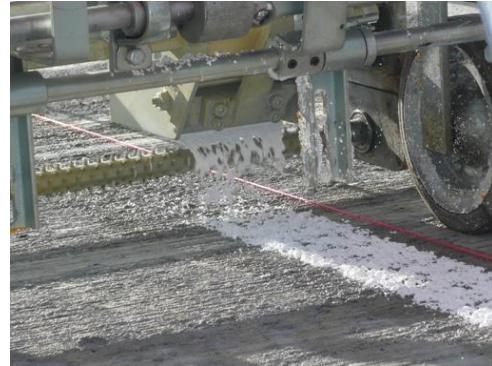
**Figure 2: Spiked bar located on the handcart.**

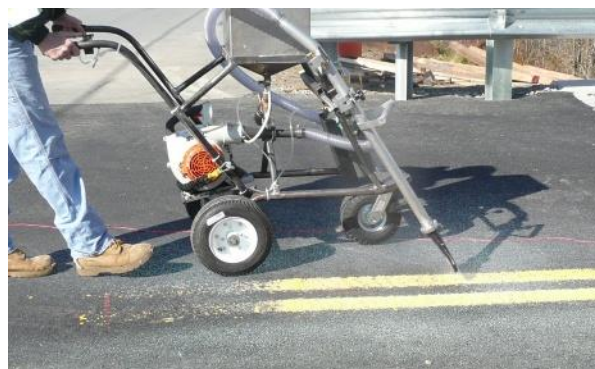
**Figure 3: Bead applicator.**

After the handcart passed, the optics were dropped onto the marking substrate (see Figure 3.) White markings typically provide higher retroreflective values due to the nature of pigments in white paint as compared to yellow. Because of this, the yellow markings used strictly Duralux beads whereas the white markings received a 50/50 blend of Duralux and Megalux beads. The white markings did not use strictly Duralux beads because these beads are much more expensive. Approximately 10 to 12 lbs of beads per gallon of MMA paint were applied. Figures 4-7 show the markings immediately following application (2).

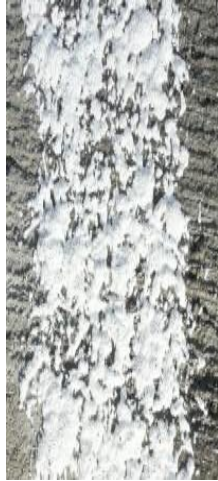
**Figure 4: White edgeline on concrete**

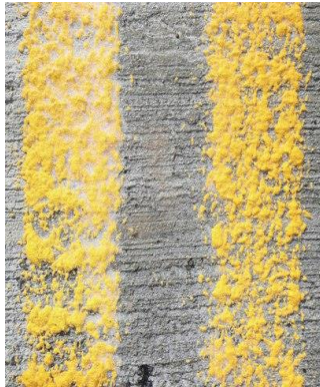
**Figure 6: Yellow centerline on concrete**

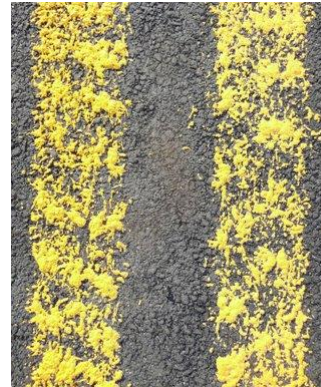
**Figure 7: Yellow centerline on asphalt**

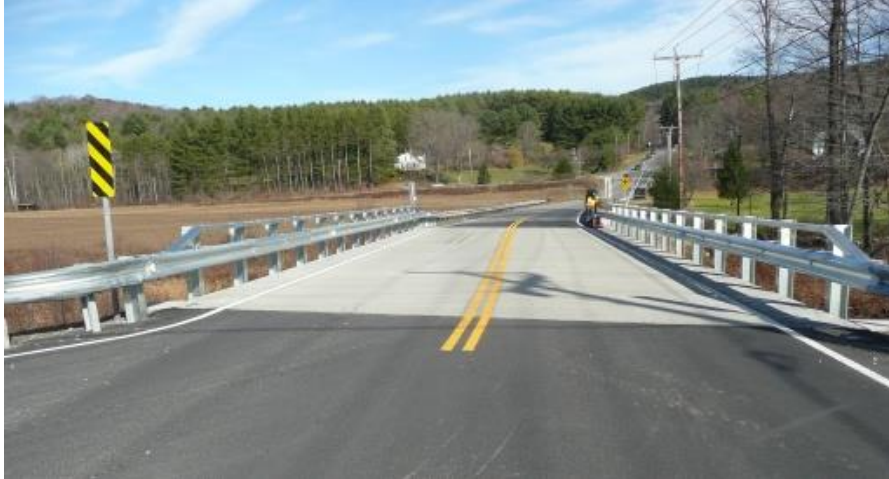
**Figure 8: Bridge overview looking eastbound.**

The initial site visit was conducted on November 10, 18 days after the MMA markings were applied because the Delta Retroreflectorometer LTL 2000 was being serviced and calibrated. Figure 8 below shows an overview of the markings.

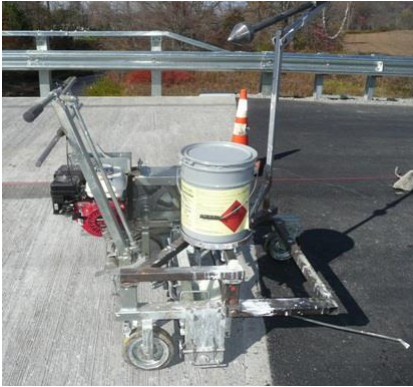
**Figure 13: Push handcart applicator.**

The retroreflectivity values depict severe plow damage and a more gradual reduction throughout the summer. After speaking with product representatives from Aexcel Corporation, the marking manufacturer and Evonik Degussa, the resin supplier, the premature wear was presumably due to the roughness of the bare concrete bridge deck and the fact that not enough time may have elapsed between deck and asphalt approaches placement and marking application. Product representatives originally believed a 21 day curing time for the concrete was adequate (which was observed prior to marking placement), but after this failure reassessed this belief. Due to the unexpected wear and loss of reflectivity, Aexcel Corporation agreed to reapply the centerline markings. The reapplication was completed on Tuesday, October 11, 2011. Research personnel were onsite to document the process and take retroreflectivity readings. Figures 13 through 17 show the application and initial as-applied condition of the markings.

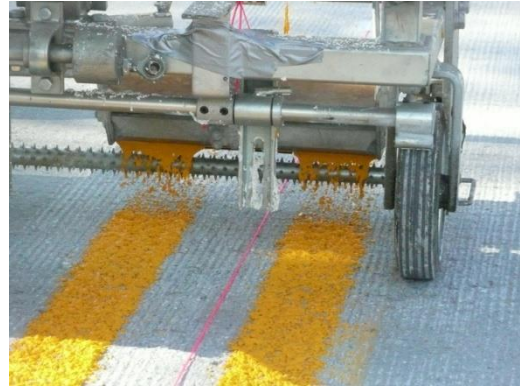
**Figure 14: Spiked bar located on the handcart.**

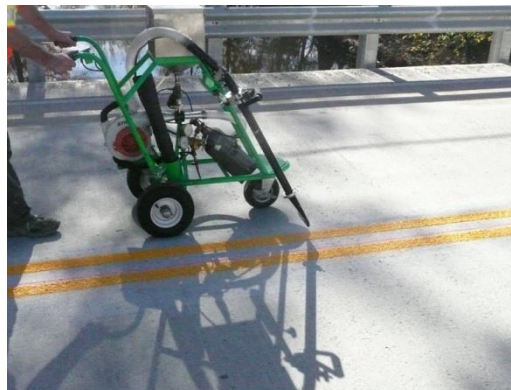
**Figure 15: Bead applicator**
