VERMONT AGENCY OF TRANSPORTATION

**EVALUATION OF THE EFFECTIVENESS OF CENTERLINE
RUMBLE STRIPES ON RURAL ROADS**

Report 2015 – 07

Reporting on RAC SPR-714

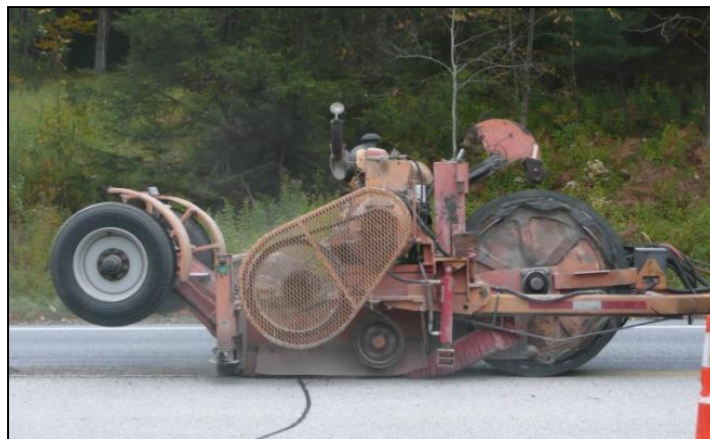
The entire length of the rumble stripes was completed by Thomas Grinding on Friday, October 9th, 2009, with the milling machine shown in Figure 5 and Figure 6. Weather conditions were overcast and the air temperature was 50°F. After the milling machine ground the stripes, the stripes were swept by BD Sweeping. All sweeping operations were conducted directly after milling, shown in Figure 7. Figure 8 shows the rumble stripes after milling and sweeping processes finished.

Figure 5: Milling machine.

Figure 6: Milling machine

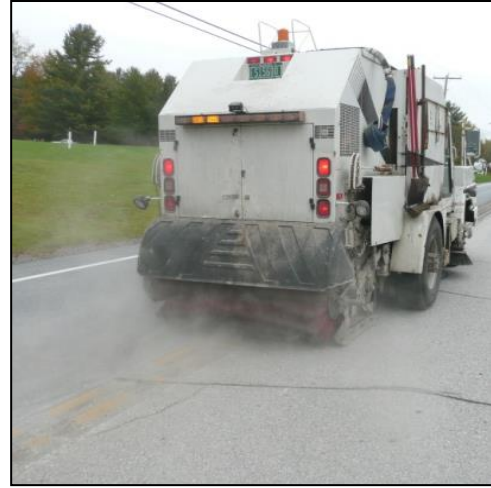
Figure 7: Street sweeper

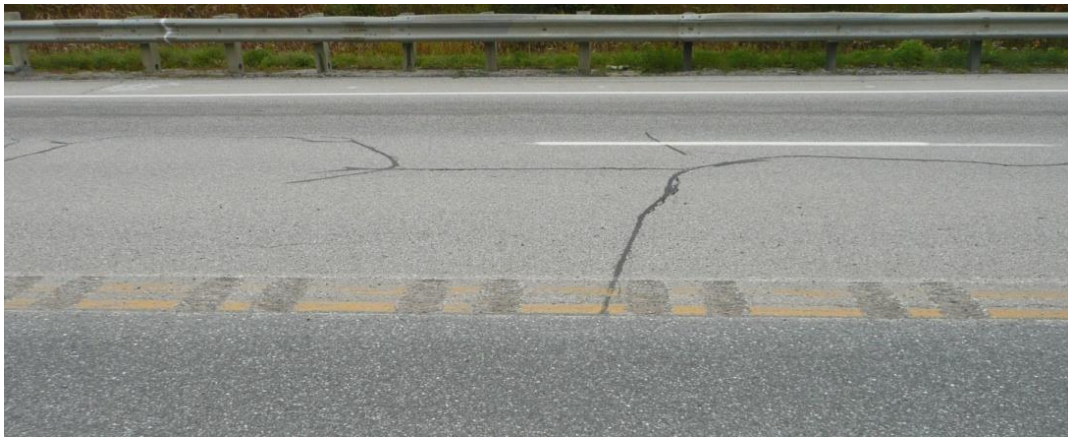
Figure 8: Rumble stripes after milling and sweeping.

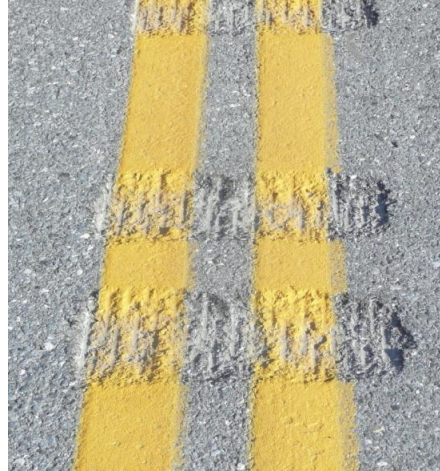
L&D Safety Markings Corporation completed all pavement marking striping operations on Monday, October 12. According to www.wunderground.com, weather conditions were recorded as clear with a mean temperature of 38°F; the temperature was approximately 45°F at noon (11). Research personnel were unable to be onsite for striping operations therefore no photographs were taken, however photos were taken at the first site visit following installation (See Figure 9).

Figure 9: Centerline rumble stripes approximately one month after installation in Mendon, VT.

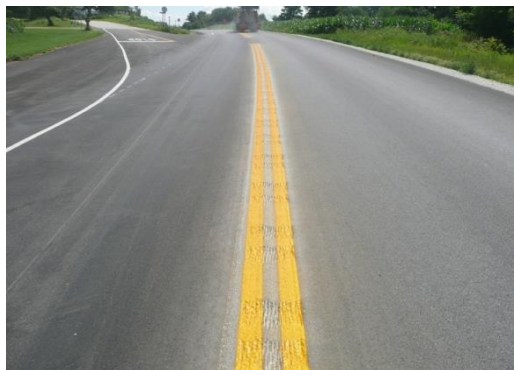
In an attempt to extend the duration for retroreflectivity of the polyurea durable pavement markings, L&D Safety Markings Corporation recessed along the centerline for the pavement markings on Monday, July 12, 2010 and Tuesday, July 13, 2010. The subcontractor then milled the rumbles on Monday, July 19, 2010 from MM 5.200 to 11.015. The rumble stripes were then swept and the subcontractor applied polyurea along the centerline on Wednesday, July 21, 2010. According to www.wunderground.com, weather conditions were recorded as clear with a mean temperature of 70°F; the temperature was approximately 81°F at noon (11). The centerline rumble stripes are shown in Figure 10.

Figure 10: Centerline rumble stripes immediately after painting in Sheldon, VT.

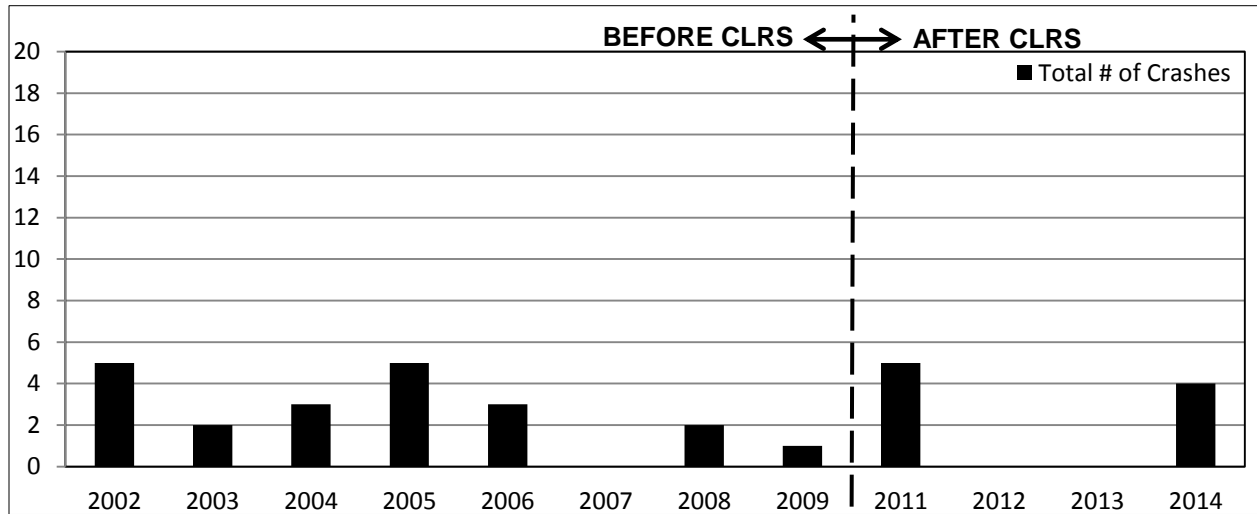
Figure 14 shows the number of crossover crashes per year both before and after the CLRS were installed. Although 2011 and 2014 totals are equal to or more than some of the years prior to the CLRS installation, the totals are less than five per year across the board. Again, with so few incidents there is no statistical significance to this data set.

Figure 14: Total number of crossover crashes in Sheldon from 2002-2014.

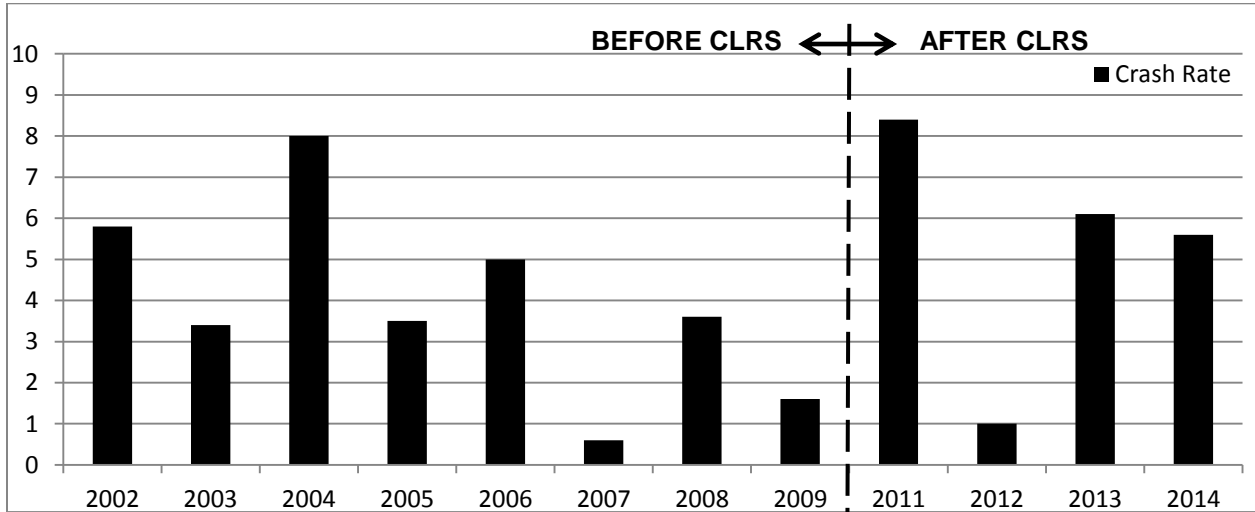
Figure 15: Annual crash rate (Number of crashes per 1 million vehicles) in Sheldon from 2002 to 2014.
