### ASSESSMENT OF URETEK DEEP INJECTION PROCESS

Report 2015 – 09

**ASSESSMENT OF URETEK DEEP INJECTION PROCESS**

Reporting on Work Plan 2012-R-04

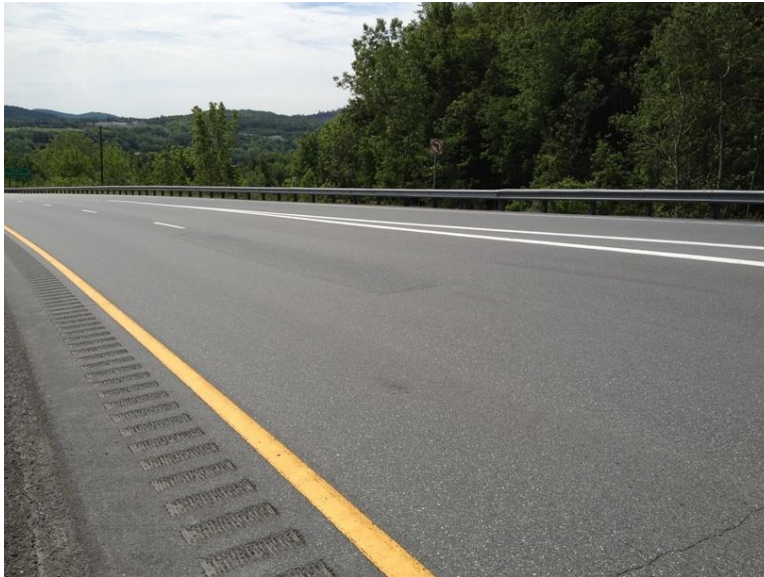
**Figure 1: Deep Injection Site – Prior to Injection.**

A stretch of Interstate 89 southbound from mile marker 0.124 to 0.153 in Hartford, VT has been showing signs of substructure instability for over two decades. The annual average daily traffic is amongst the highest in eastern Vermont, averaging 38,000 vehicles per day. Historically, the roadway section was originally constructed in the 1950's and it is believed that the majority of the fill material used was taken from the rock cut sections in the connecting ramps on the south side of the I-89/I-91 interchange (3). The site is shown in Figure 1.

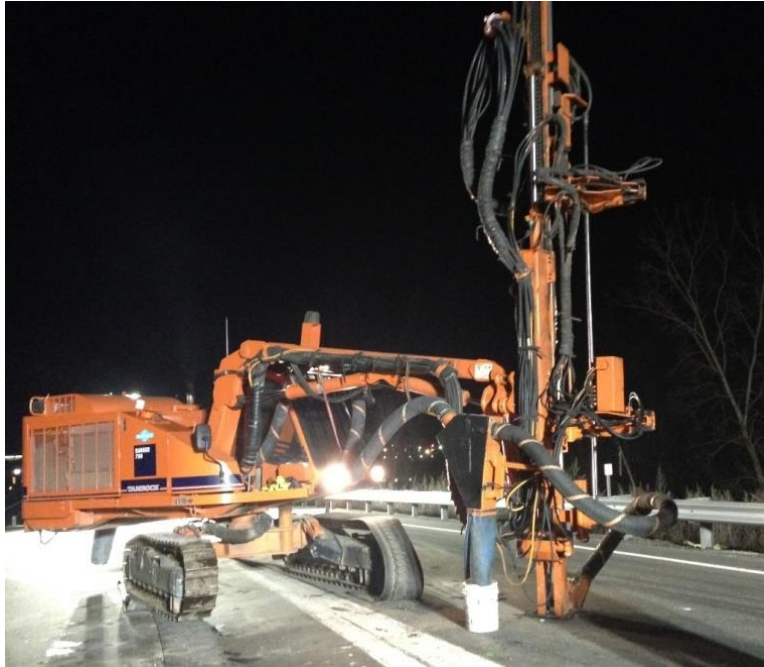
**Figure 4: Tamrock 700 Drill Rig – Drilling 2.5-inch Injection Holes.**

J. A. McDonald, the prime contractor drilled all injections holes using a Tamrock Ranger 700 Drilling Rig, a hydraulic, self-propelled, self-contained, crawler based surface drilling rig equipped with a cabin and rod handling system. The Contractor began drilling the 2-inch diameter injection holes 20 feet in depth in the travel lane on October 29, 2013 once the injection plan based on DCP testing was approved. Once drilling commenced, vibration from drilling operation paired with the undersized drilling equipment caused unstable material along the shaft to collapse into the hole (11). The Contractor ceased operations until the following day and began drilling 2½-inch diameter holes in order to expedite drilling, produce a straighter hole, and reduce sloughing of the material into the holes (12). Drilling operations continued through November 4. Some holes had to be redrilled because URETEK encountered problems with inserting the injection tube bundles. The Contractor redrilled holes on November 5 and 6 and then inserted some injection tube bundles for the Subcontractor. The passing lane holes were drilled without incident from November 19 to 21 (11).

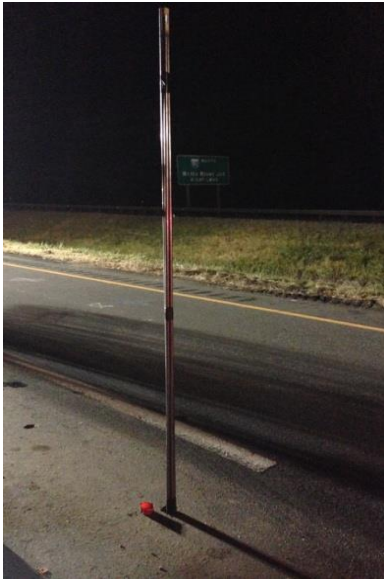
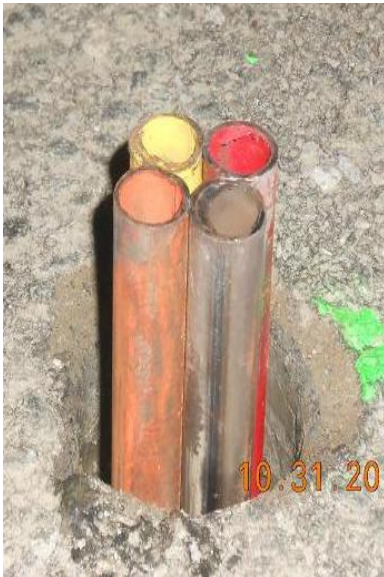
URETEK USA began injecting the site at the 7-foot depth from the southern end of the project in the travel lane once the Contractor had drilled a sufficient amount of holes ahead to ensure no disruption of the stabilization process on October 30 (11). Figure 4 through Figure 9 show the tube insertion and injection process.

**Figure 6: Injection Tubes.**

**Figure 7: Inserting Tubes.**

**Figure 8: Injected Tubes.**

**Figure 9: Injecting Polymer.**

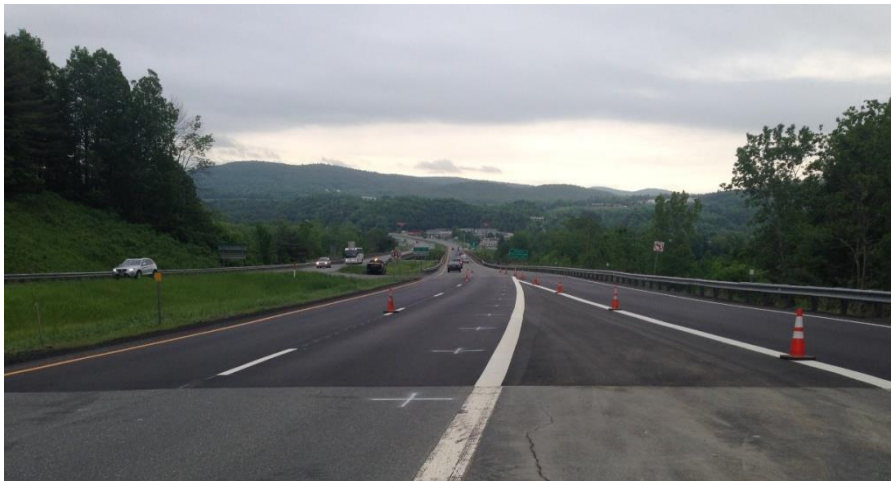
**Figure 10: Deep Injection Site – Post Paving.**

Due to the late season injection phase, all cold planing and paving activities were postponed until the spring of 2014. J.A. McDonald hired subcontractor Frank W. Whitcomb Construction of Colchester, Vermont to complete cold planing and paving operations, completed on May 29 and May 30, 2014. Figure 10 below shows the site after paving while conducting Falling Weight Deflectometer (FWD) testing.
