# MATERIALS & RESEARCH DIVISION

Ronald I. Frascoia  
October 29, 1992  
Number U92-4  
Page 1 of 5

## RESEARCH UPDATE

### GLASPHALT PAVEMENT CONSTRUCTION ON VT ROUTE 12

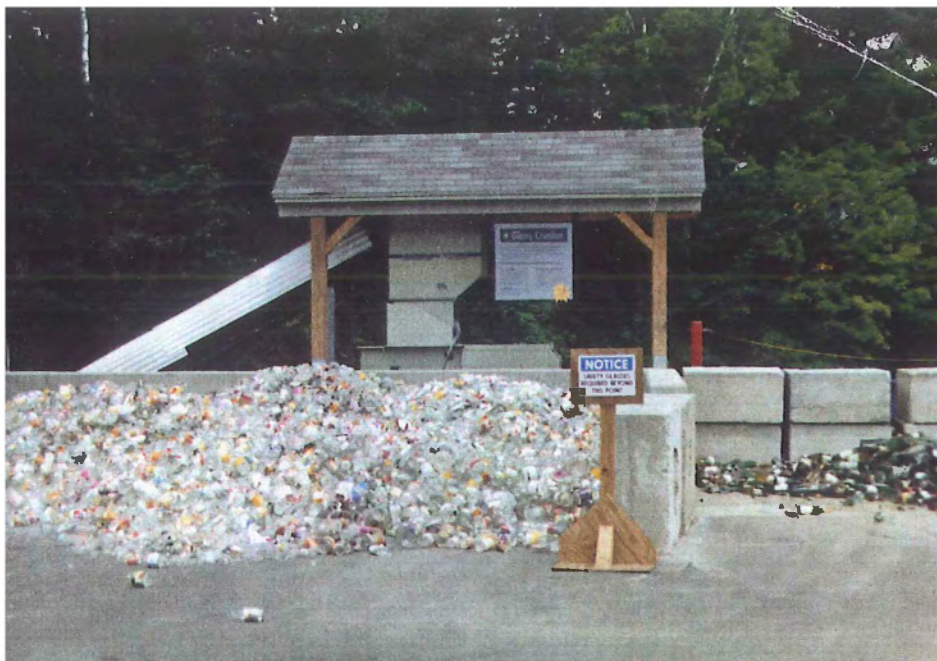
HARTFORD VERMONT  
GLASS CRUSHING  
FACILITY

The recent development of regional solid waste recycling programs has resulted in the collection of significant stockpiles of glass which are now available for a variety of uses. The crushed glass for the Route 12 project was obtained from the Hartford Community Center for Recycling & Solid Waste Management (phone (802) 295-5740) which is located on VT Route 5, approximately four miles south of the I89 and I91 interstate interchange in Hartford. The facility is the largest recycling center in the Vermont Greater Upper Valley Solid Waste District and includes the collection of materials from five area towns. The Hartford Center accumulates about 500 tons of glass per year consisting of 75% clear and 25% green or brown glass. A desire to utilize the waste glass in the local area resulted in a decision to purchase and install a CB-5000-10 CLEANGLOSS<sup>tm</sup> SYSTEM crusher manufactured by J.R. Engineering Corp., P. O. Box 560, West Swanzey, New Hampshire 03469 (phone 1-800-732-0123 or (603) 357-3139). The unit is capable of crushing 10 tons of glass per hour. Market prices paid for the glass vary, but are currently in the range of \$22 a ton for clear, \$15 a ton for brown and \$8 a ton for green glass crushed and stockpiled. The Hartford facility has not found it economically feasible to separate the green and brown glass due to a limited quantity of the latter.

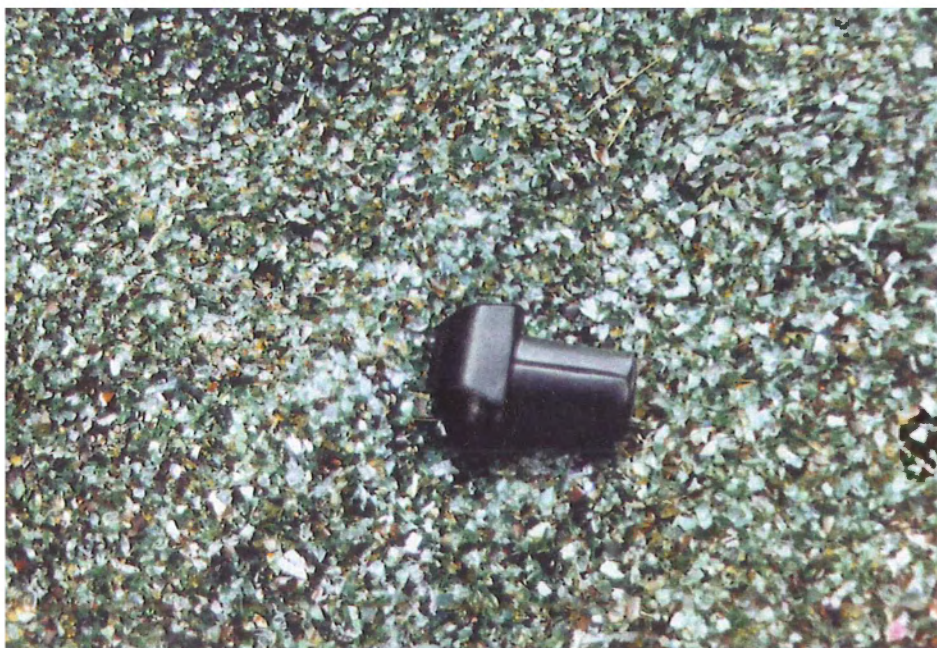
40 TONS OF GLASS  
WITH 90+% PASSING  
THE 3/8" SIEVE

Pike Industries, Inc. developed a glasphalt mix design in compliance with the Vermont Agency of Transportation requirements using the Marshall test procedures. The coarse aggregate portion of the mix included 31% 1/2" stone, 9% 3/8" stone and 10% crushed glass. The fine aggregate portion included 38% washed stone screenings and 12% washed sand. The gradation of the crushed glass consisted of 100% passing the 1/2", 92% passing the 3/8", and 24% passing the #8 sieve. Because quartzite materials are susceptible to asphalt stripping, an anti-strip additive was added to the AC20 asphalt at a rate of 0.5%. The effectiveness of the anti-strip product, PAVE BOND Lite by Morton International, was checked using Vermont test procedure VT-AOT-MRD 10-81 for both initial and 96 hour performance. The boiling test revealed 10 to 15 percent asphalt stripping from the glass aggregate, a level exceeding the 5 percent allowed, but not considered serious enough to cancel the glasphalt production and placement.

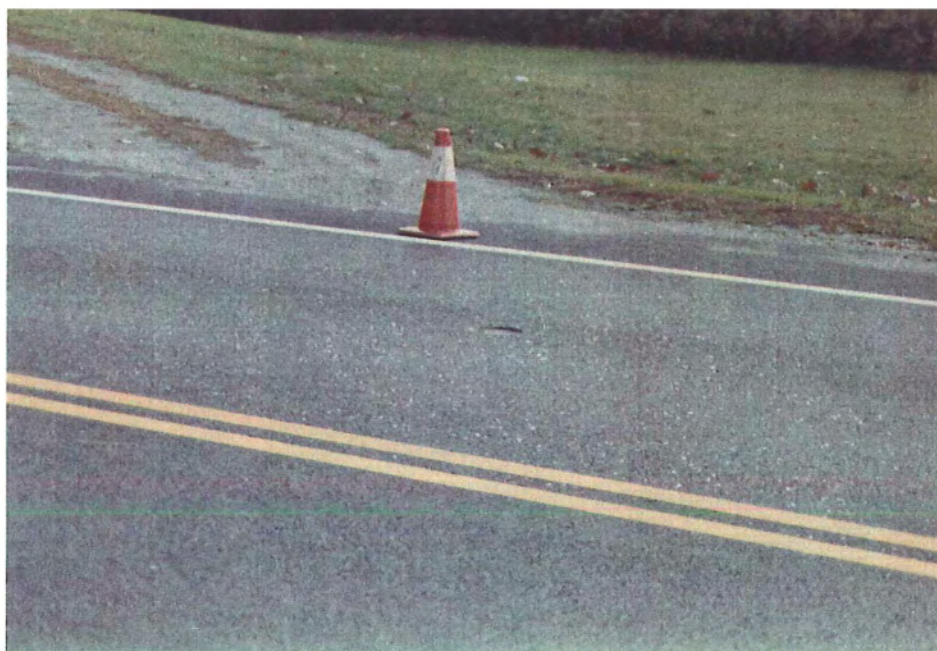
STANDARD MIX IN  
FOREGROUND,  
GLASPHALT IN  
BACKGROUND

Project inspections were made in late September and October 1992. Detailed observations revealed from 15 to 30 large particles of glass and 80 to 150 small particles of glass in the surface of each square foot of the experimental pavement. Sunlight reflecting off individual glass particles clearly distinguished the glasphalt mix from the standard pavement. Several of the large glass particles were cracked, but there was no loss of individual pieces noted. Some loss of the larger particles of glass is anticipated when cold weather arrives and the traffic includes snow plowing and sanding operations.
