**RESEARCH UPDATE**

U 96-27

**TYFO S FIBERWRAP****REFERENCES:**

Bridge #60 in Williston underwent rehabilitation in June, 1994 to repair damage from salt intrusion in the columns and piers. Rather than employ a standard concrete encasement, TYFO S Fiberwrap was applied to the columns of pier #1 of bridge #60. If successful, the fiberwrap process could prove to be a cost efficient alternative to rehabilitation through concrete encasement.

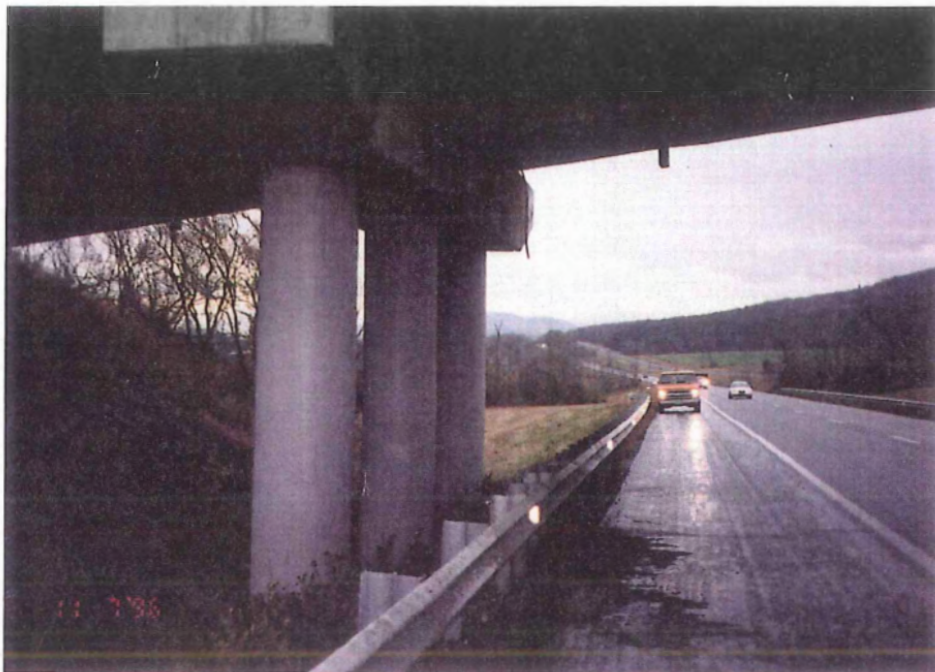
PIER #1, BRIDGE No. 60, INTERSTATE 89  
TYFO S FIBERWRAP  
November 7, 1996

All five piers of Bridge #60 were inspected by Research and Development personnel on November 7, 1996, approximately 2 years and 5 months after the product was applied. The three columns of pier #1 were examined and found to be in excellent condition. The fiberwrap material shows no signs of cracking, bulging, or discoloration. Similarly, the gray paint covering the product was in surprisingly good shape in spite of weathering two winters of salt spray from high speed traffic. Although it is not certain if the product has increased the structural integrity of the column, it is clear from the condition of the material that further contamination from chloride has been greatly reduced, if not totally abated.

Additionally, the TYFO S Fiberwrap is a very aesthetic repair material compared to the concrete patch on the adjoining columns. The columns of piers #2 and #3 have highly visible shrinkage cracking and discoloration, while the TYFO S Fiberwrap is noticeably more solid in appearance to the traveling public.

The long term durability of TYFO S Fiberwrap will continue to be evaluated through periodic inspections.
