RESEARCH UPDATE

Update U96-28

WASSER STRUCTURAL STEEL COATING

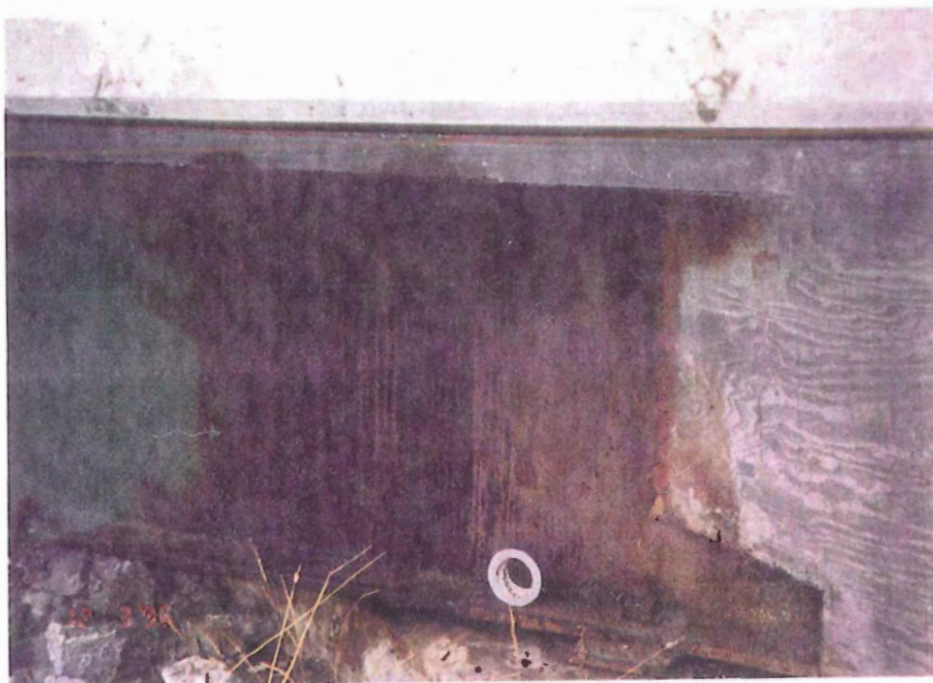
The coating was inspected on December 3, 1996. The condition of the coating is good with only a few more pinpoint corrosion spots than in 1994. The grease coatings on the beams had vanished and was replaced with a surface coat of rust at all beam ends. The dry film thickness of the Wasser coating averaged 9.5 to 9.8 mils.

**Rusting at end of Beam.**

The coating will continue to be inspected annually, with an emphasis on corrosion resistance of the system.
