RESEARCH UPDATE

U 1999-9

**PERFORMANCE OF COLD RECYCLED BITUMINOUS PAVEMENT
CHESTER-SPRINGFIELD, VT ROUTE 11**

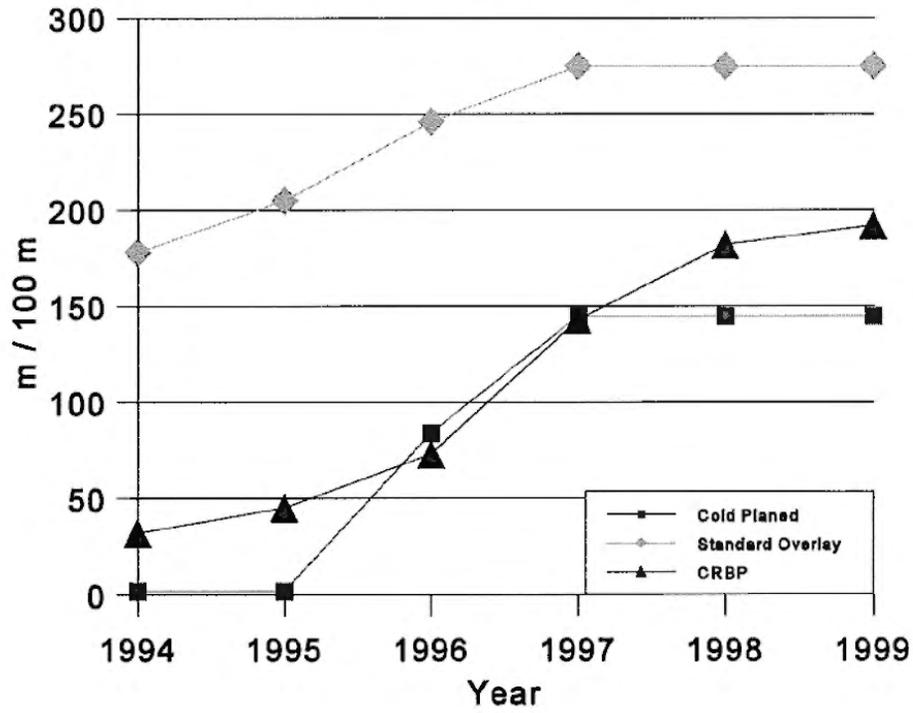
AVERAGE CRACKING

After six years of service, both the cold planed and CRBP treatments are superior in performance to the standard overlay. The standard overlay control section, averaging 275m/100m in cracking (53% transverse cracks), has developed transverse reflective cracks and shows signs of distress in the same areas as those found during the pre-construction pavement survey. The poor condition of the standard overlay after relatively short service provides strong evidence that this section of Vermont Route 11 has an inherently weak substructure and that rehabilitative efforts to address reflective cracking are warranted.

In 1997, crack sealant was applied on Vermont Route 11, sealing the cracks in the two control sections and a portion of the CRBP section. As seen in the data, crack sealant has helped to delay the onset of additional cracks. No additional cracking has occurred in either the cold planed or standard overlay test sections since the application. The CRBP section has developed additional cracking, mainly in areas which were not sealed.

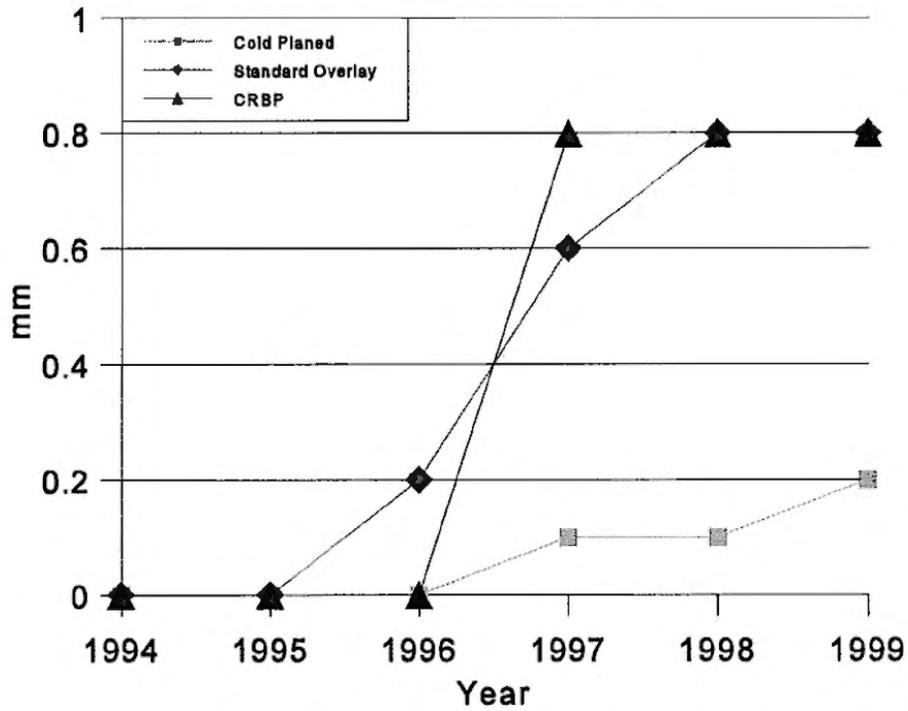
AVERAGE RUTTING

The performance of all three treatment methods appears equal in rutting and ride roughness. Rutting has been minimal throughout the life of the project, and virtually no rutting appeared until the fourth year. Each year the ride quality has been equivalent among all three treatments. It is important to note that because the Mays meter, a device that measures the road roughness, is calibrated each year, data may not be consistent from year to year, but are nonetheless relative within a given year.

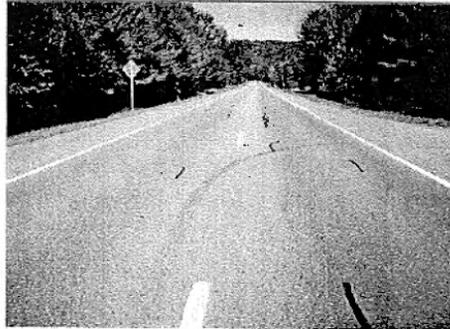
Figure 2 Cold Planed Treatment

The CRBP and cold planed treatments appear to be performing nearly equal. The predominant cracking at these test sites is longitudinal, with prominent patches of "alligator" cracking in some of the wheel paths of the CRBP sections. It is also noteworthy, that transverse cracking is virtually nonexistent in the cold planed sections. Yet, in the CRBP test sites, it is in the formative stages with 11% of the cracking being transverse. The CRBP on the Chester-Springfield project has yet to show superior performance over the cold planed treatment.
